ADVANCES IN KNOWLEDGE
OF THE MONUMENTAL ARCHITECTURE

OF SANTA ROSA XTAMPAK

Based on Photography and Mapping of June-July 1989

Nicholas M. Hellmuth
Foundation for Latin American Anthropological Research
1989

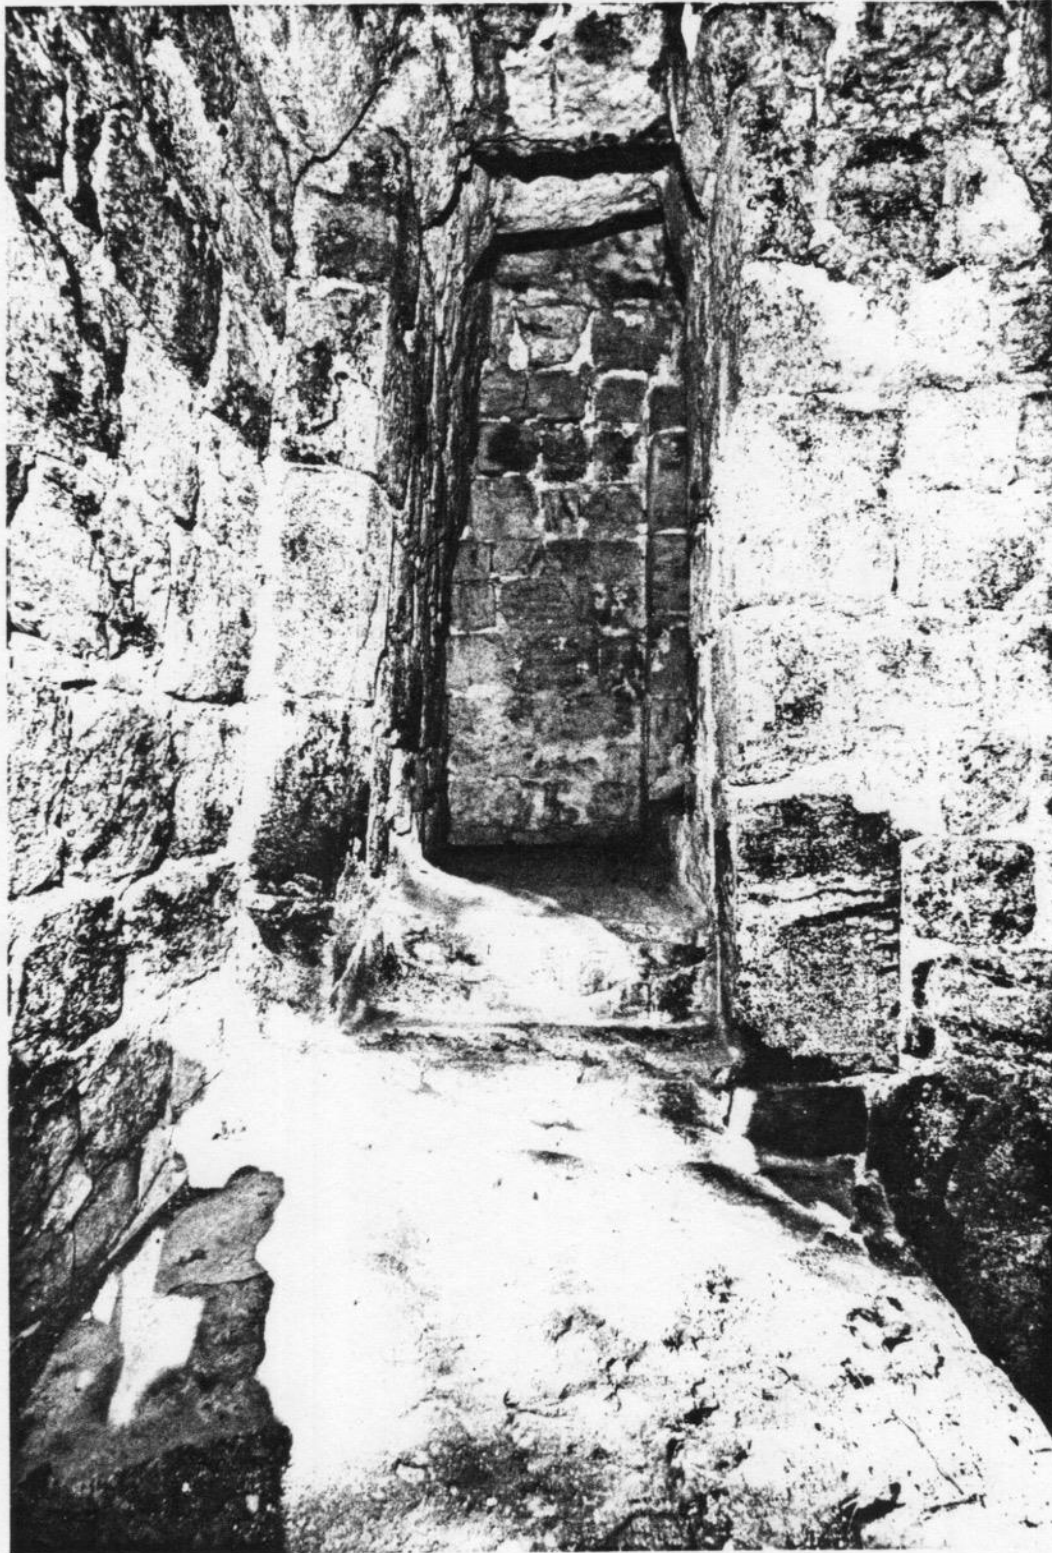
Plate 3. Long landing at second story level, roofed by the entry/exit "house" or hall. Main Palace. All the remaining photographs in this report are also of Santa Rosa Xtampak, and all by Nicholas Hellmuth, so that will not be further cited.

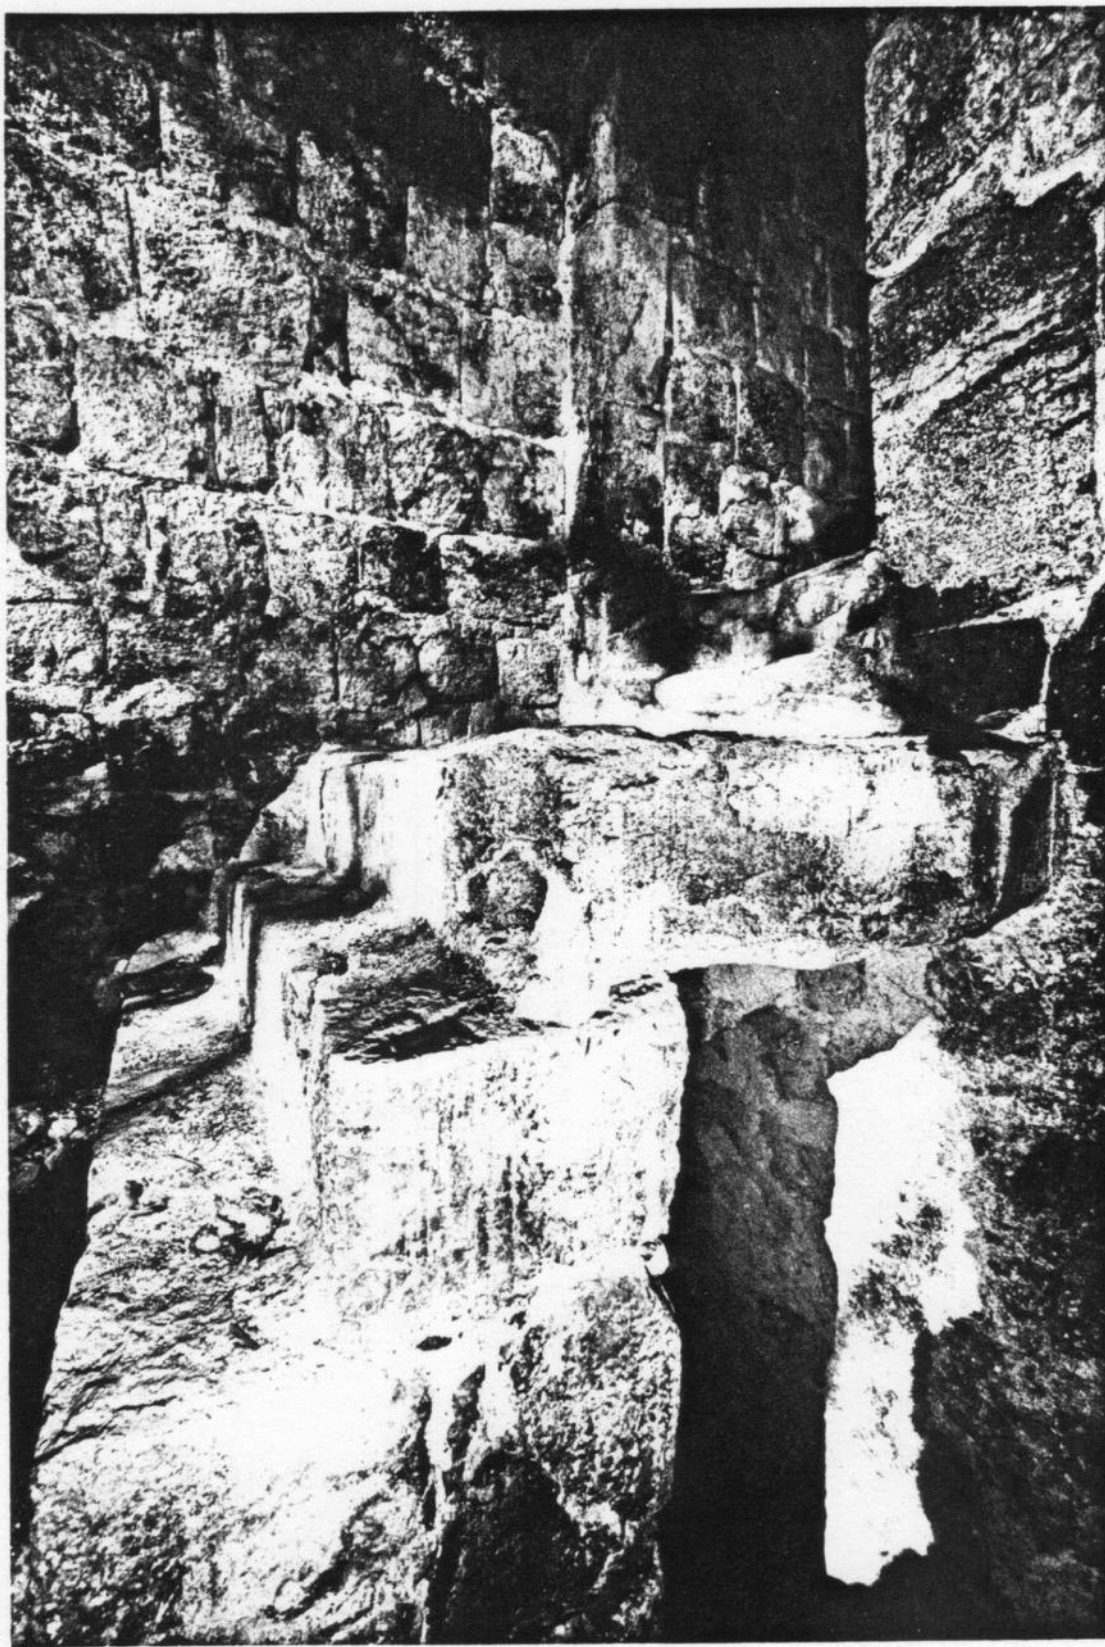
Plate 4. The only place on either stairway where the steps go under each other is on the second story level.

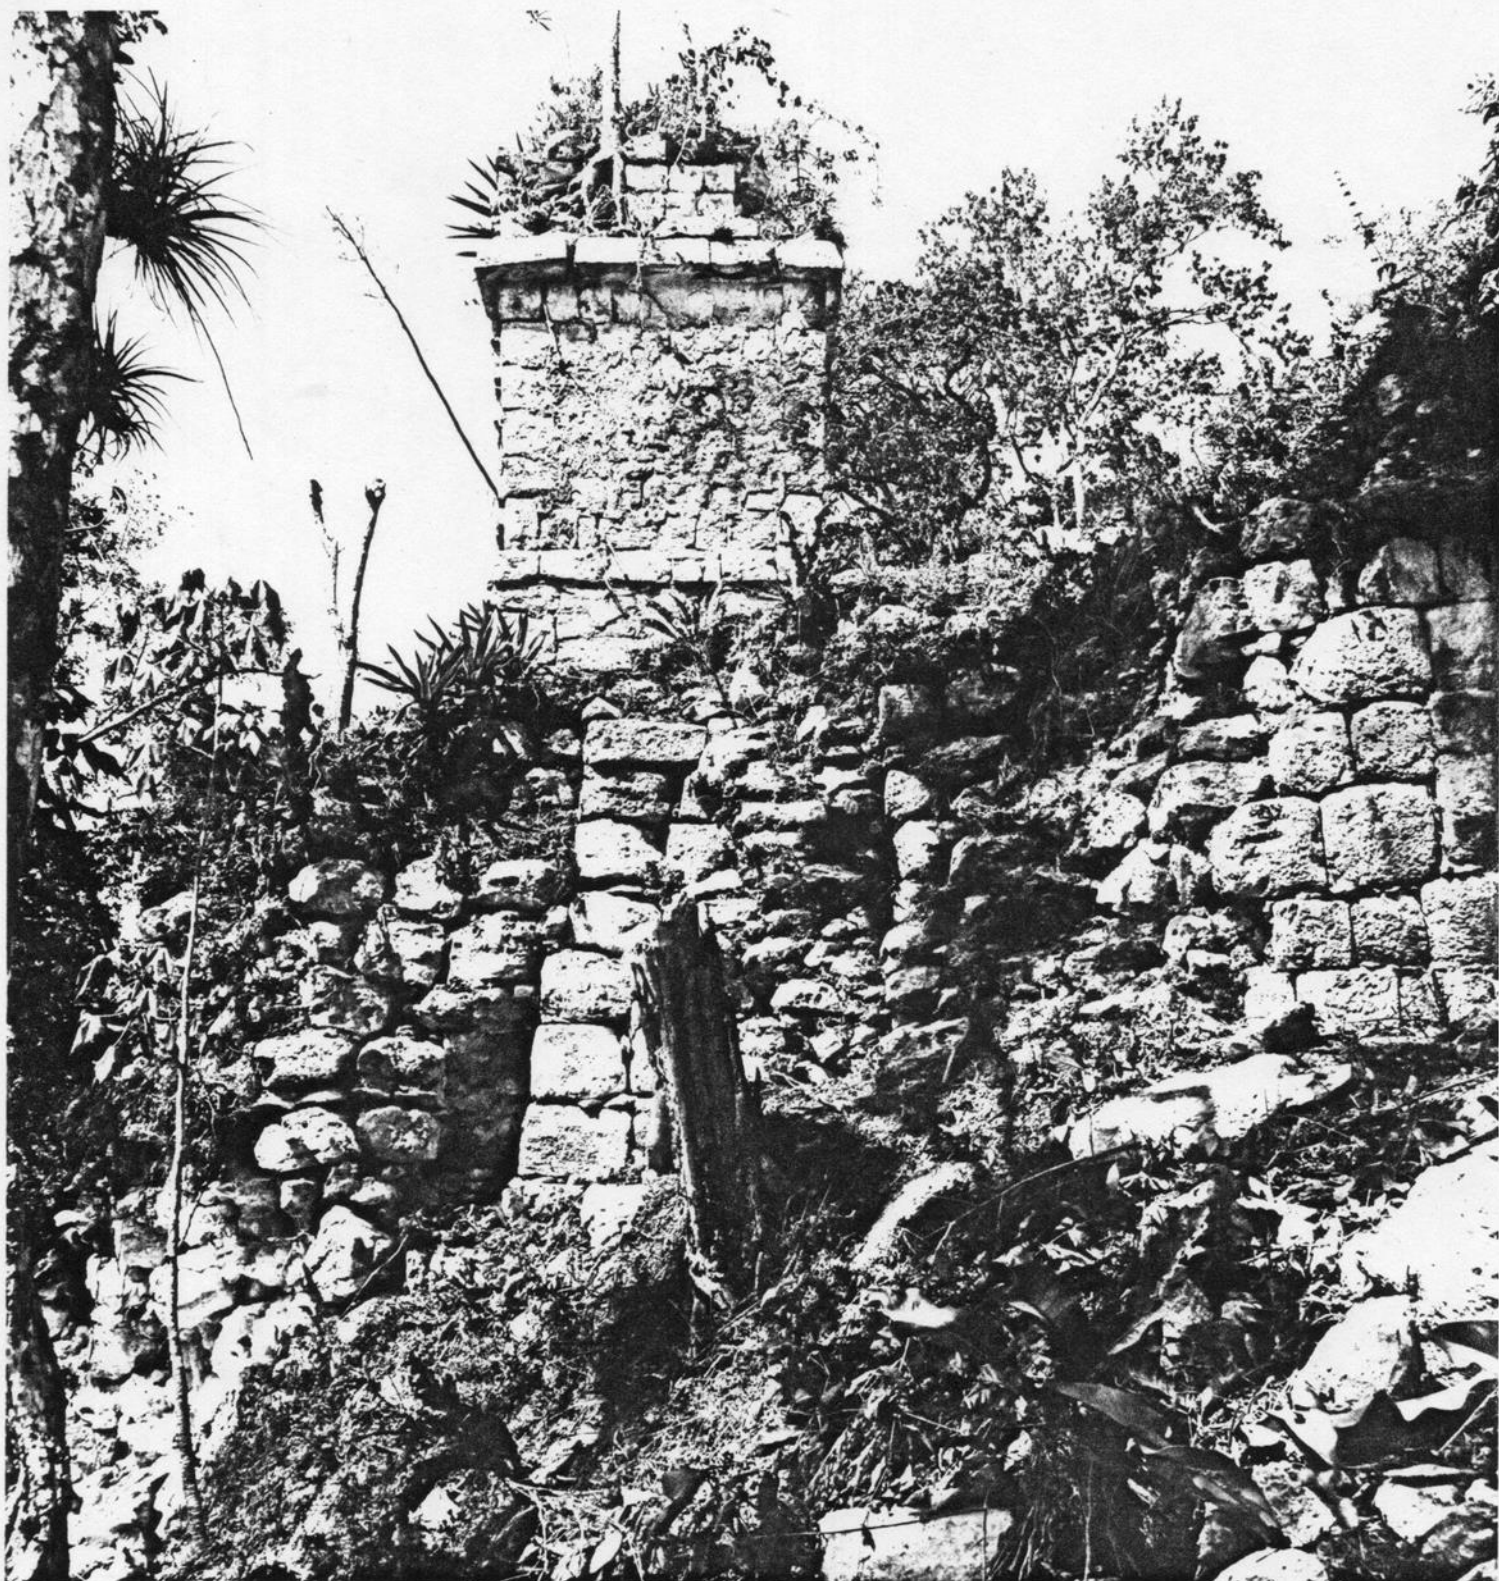
Plate 5. Looking south at the central portal, third floor. In the right foreground is the end wall of one of the second floor rooms. Behind the stump is the crisp outline of the early stage fill retaining or core wall. Main Palace.

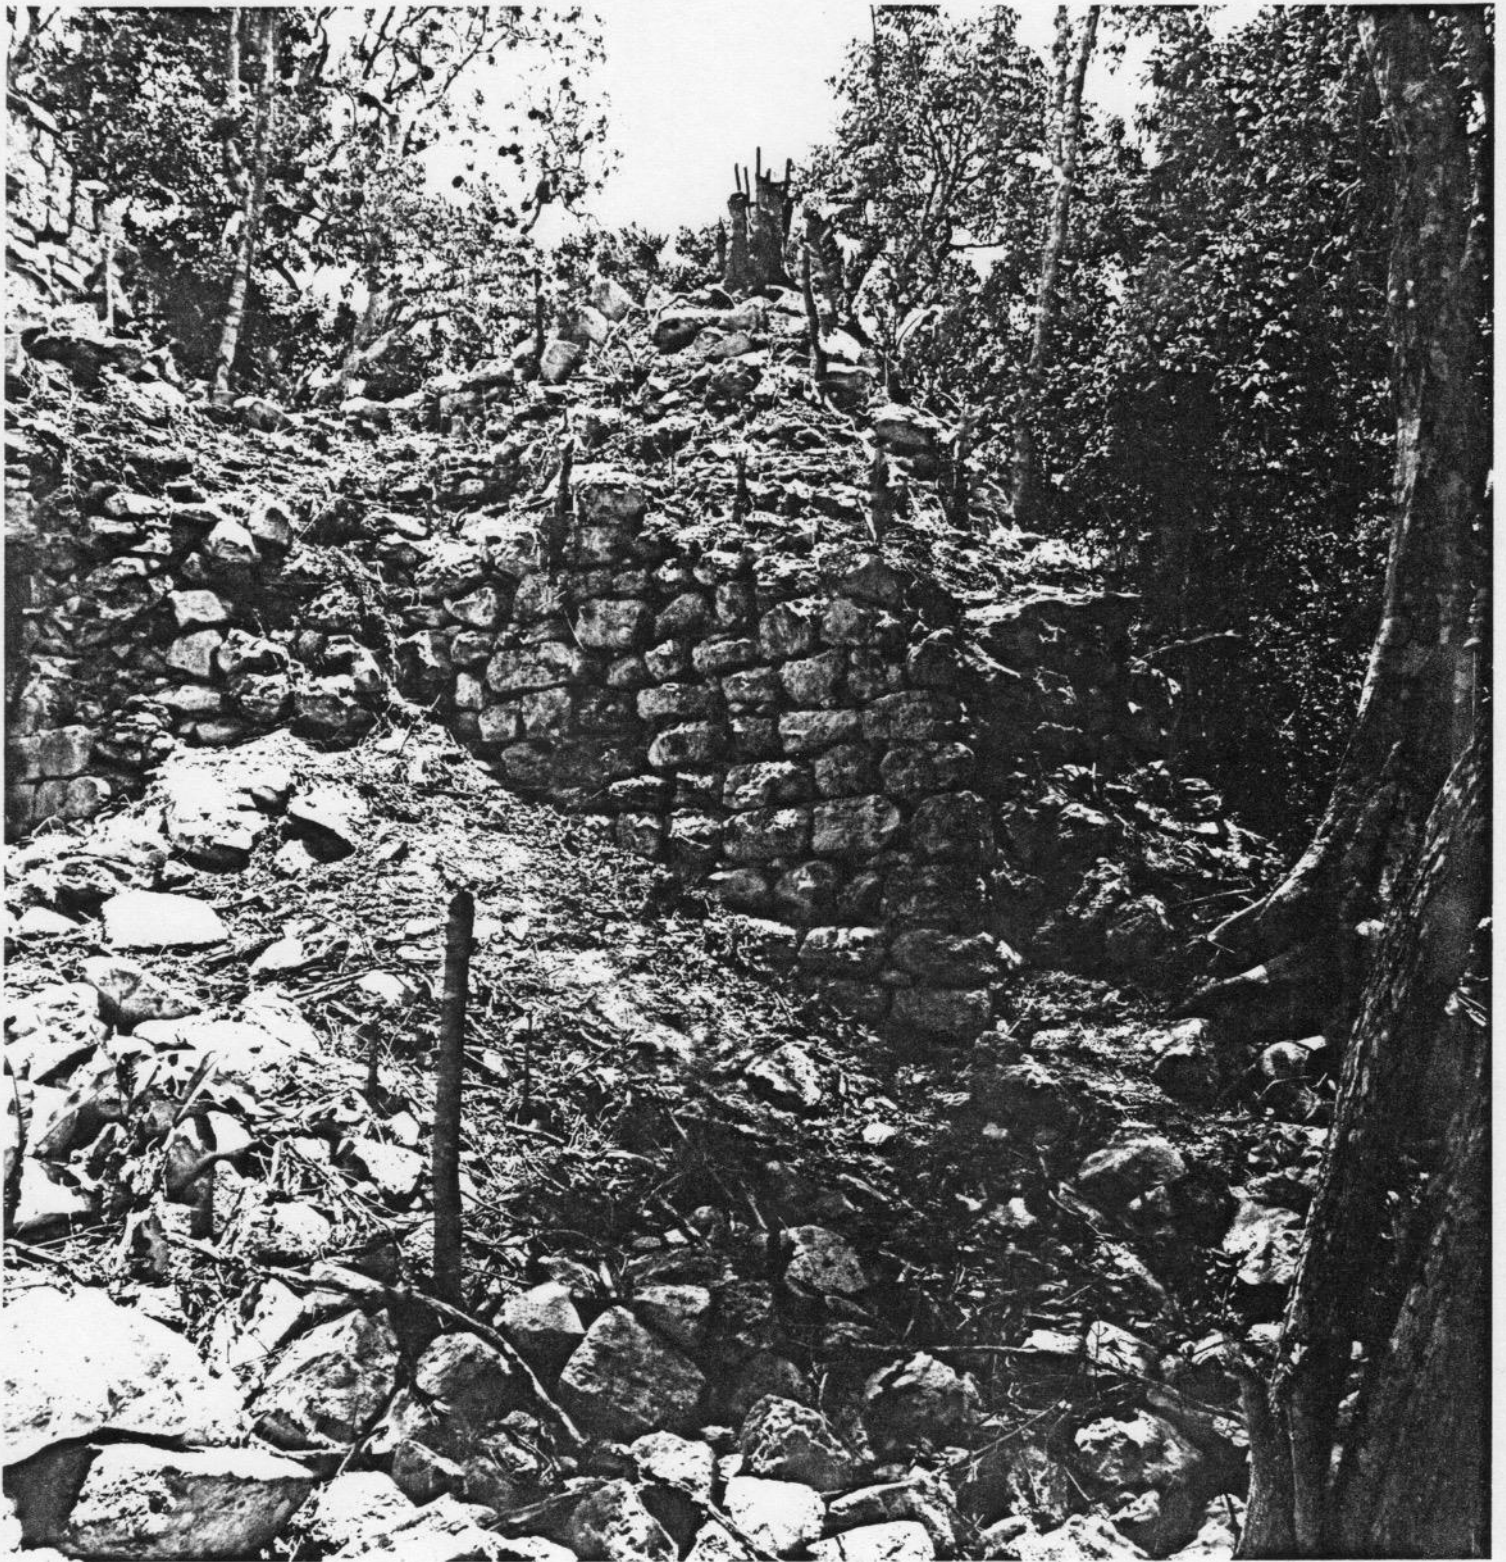
Plate 6. Looking north at the right of the two front flanking Rio Bec towers. The remains of the inside temple facing masonry are visible on the back of the mound which represents the remains of the temple. Main Palace.

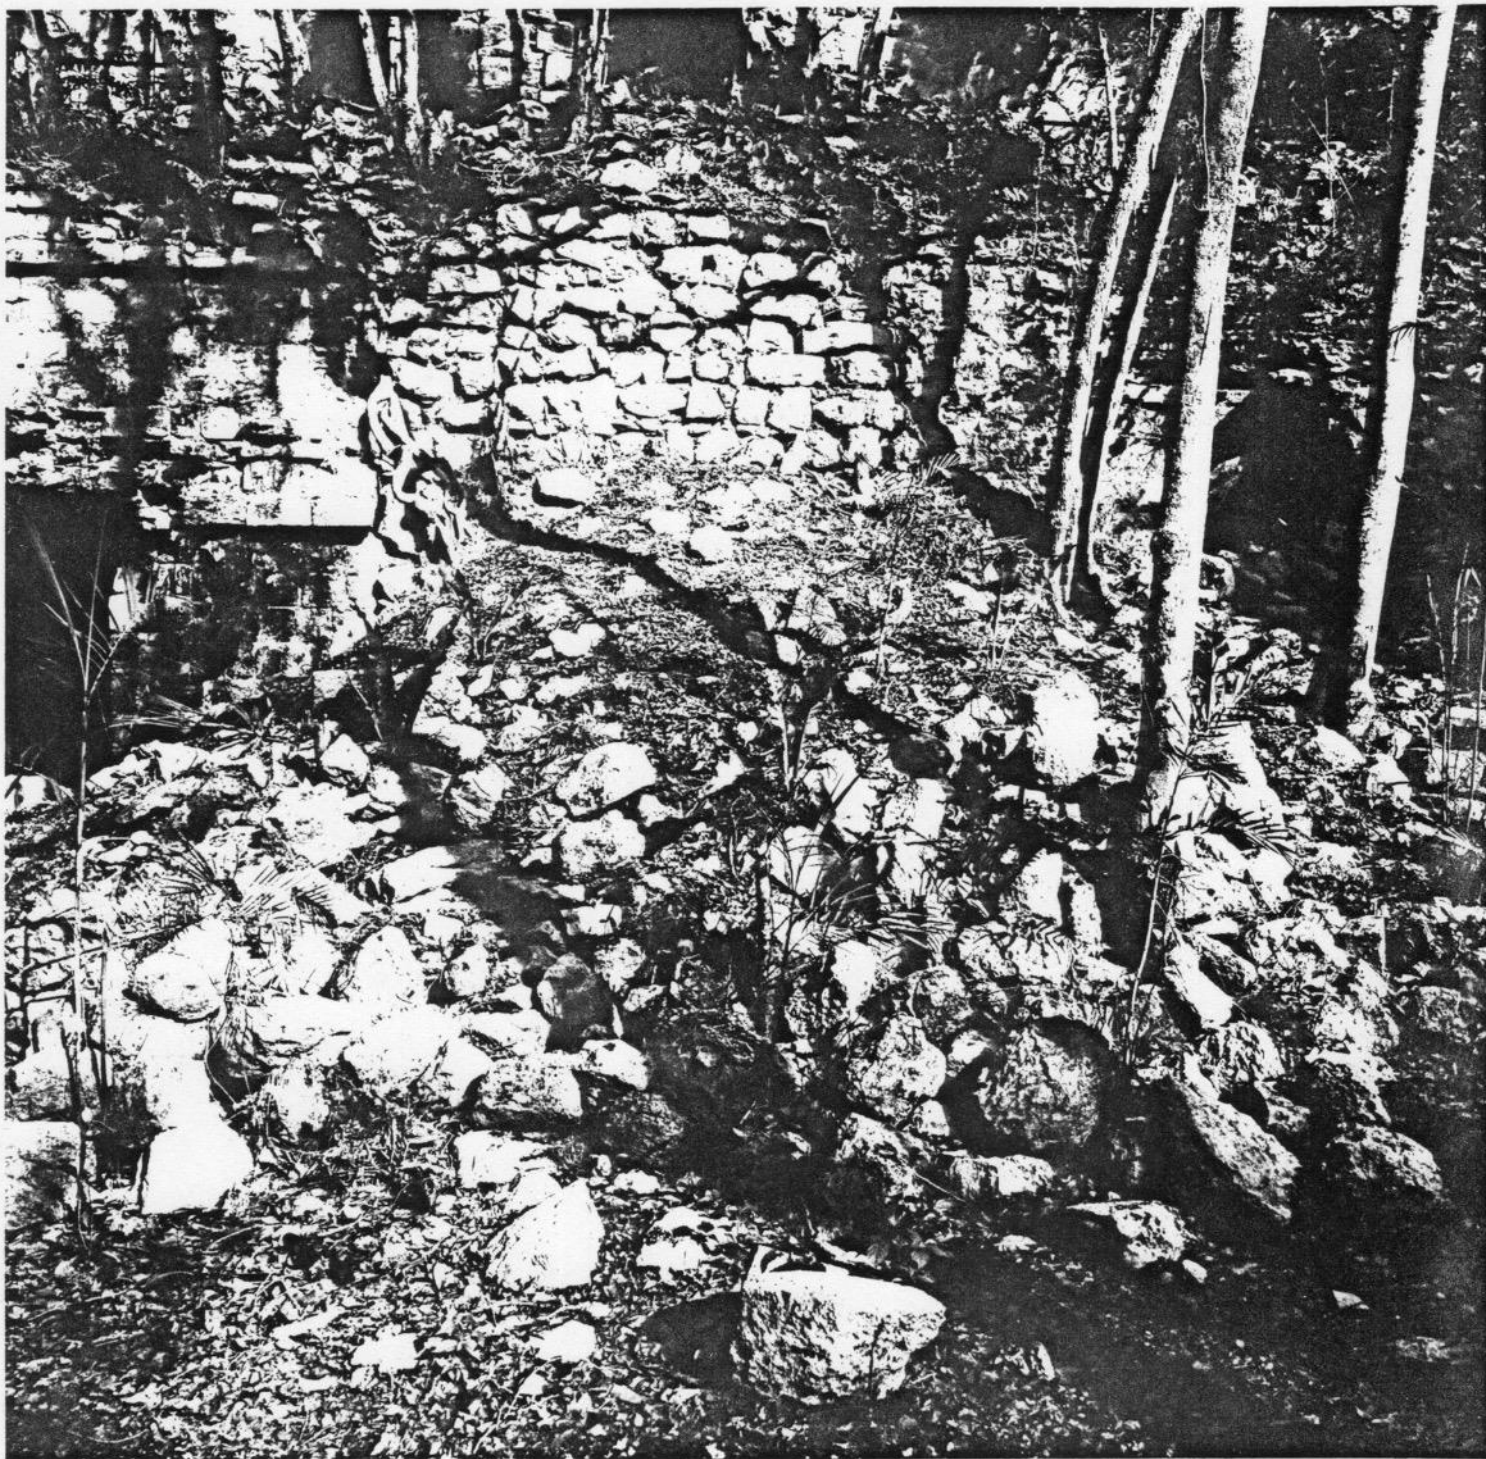
Plate 7. Looking east at the west facade of the palace showing the change from facing masonry (left) to the core wall which is behind the fallen stairway (center). If this type of core wall represents the back of a stairway elsewhere on the Main Palace then there were stairways on three sides of the two flanking Rio Bec towers of the front.

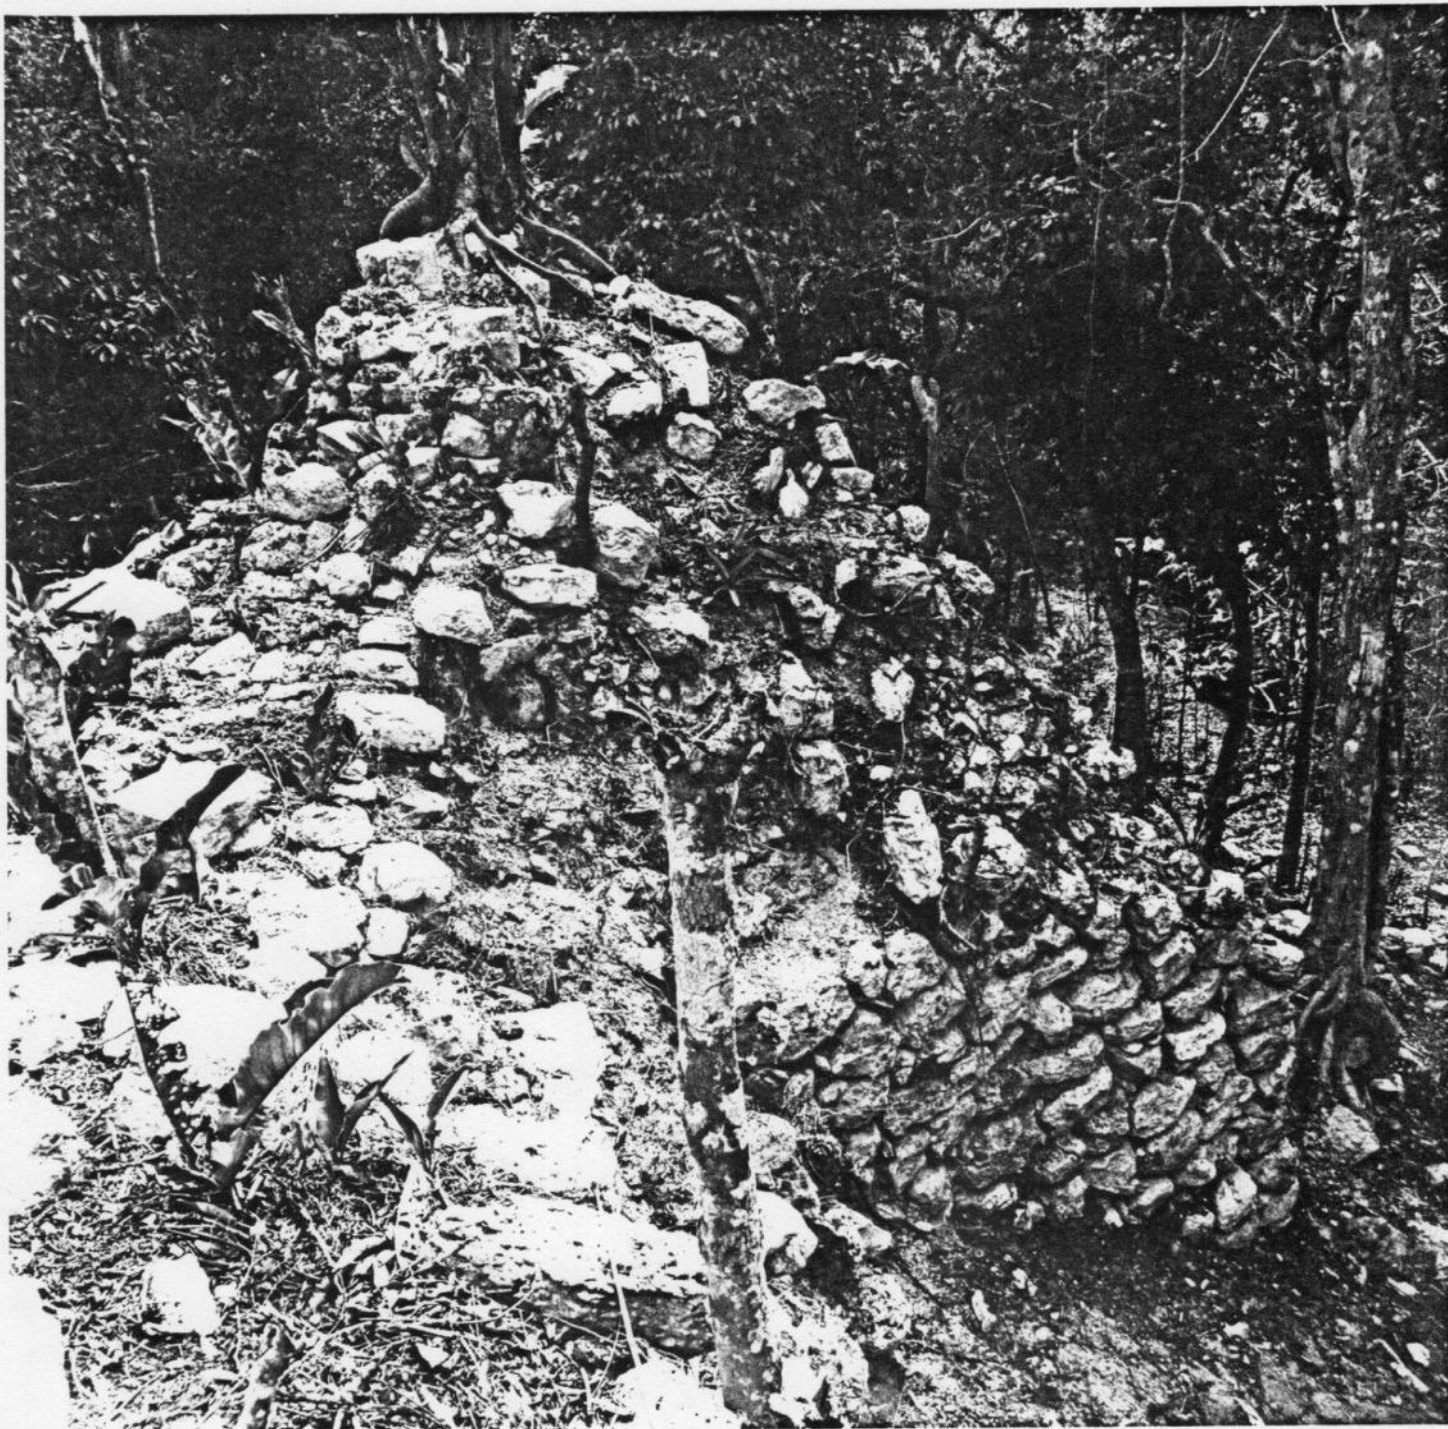
Plate 8. Looking east from the second floor down onto the stump of the north flanking Rio Bec tower. This stump should be compared and contrasted with that recently discovered on the South Range of the Southeast Quadrangle at Xtampak. But this photograph is shown here to document the core wall (fill retaining wall) that may have backed a stairway also on this south side of the tower.

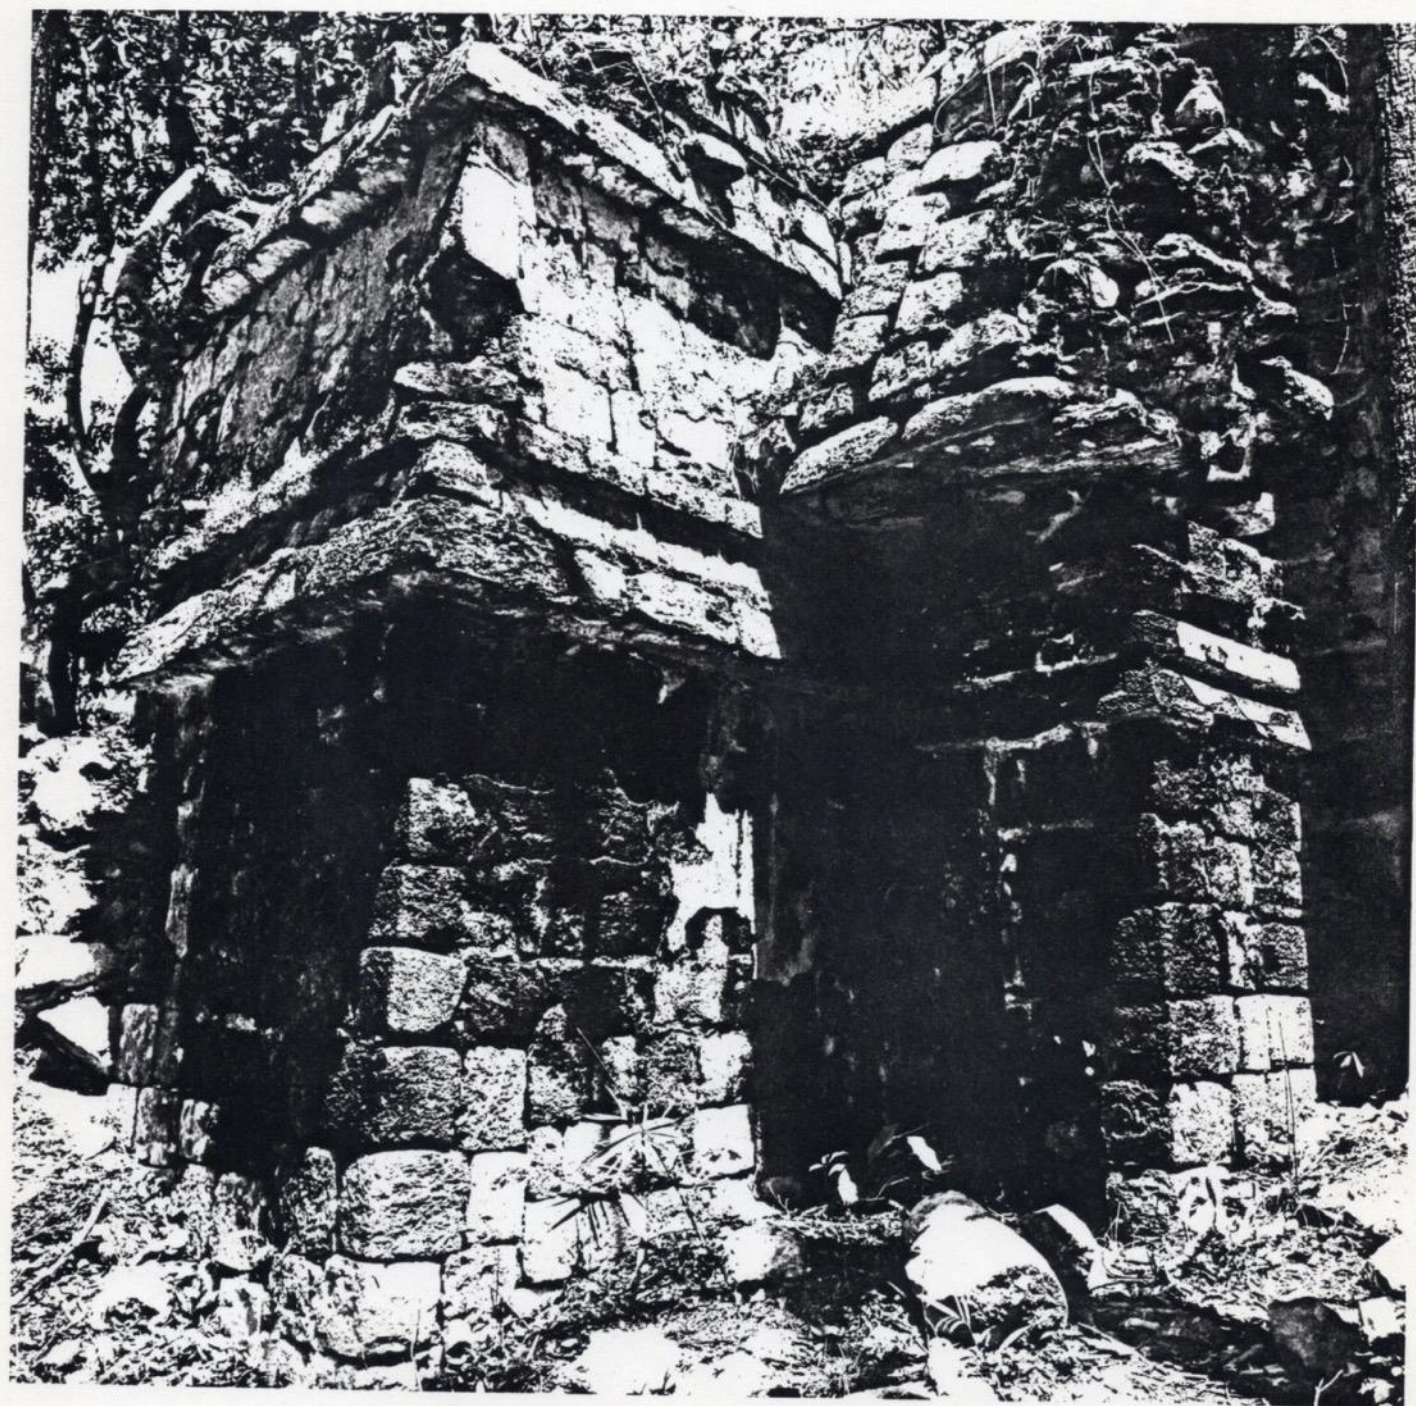
Plate 12. First story, south end of the Main Palace, outside Room 1 actually looking at the projection of Room 26. The upper zone of Room 26 is typical of the entire Main Palace as well as the Cuartel. The immediately adjacent upper zone of Room 1 (and also of mirror image Room 9 at the extreme north end of the palace) is completely different begging the question of whether both were originally designed next to each other. So far, though, no one has noticed any evidence suggesting that any of the end rooms is earlier than the back ranges.

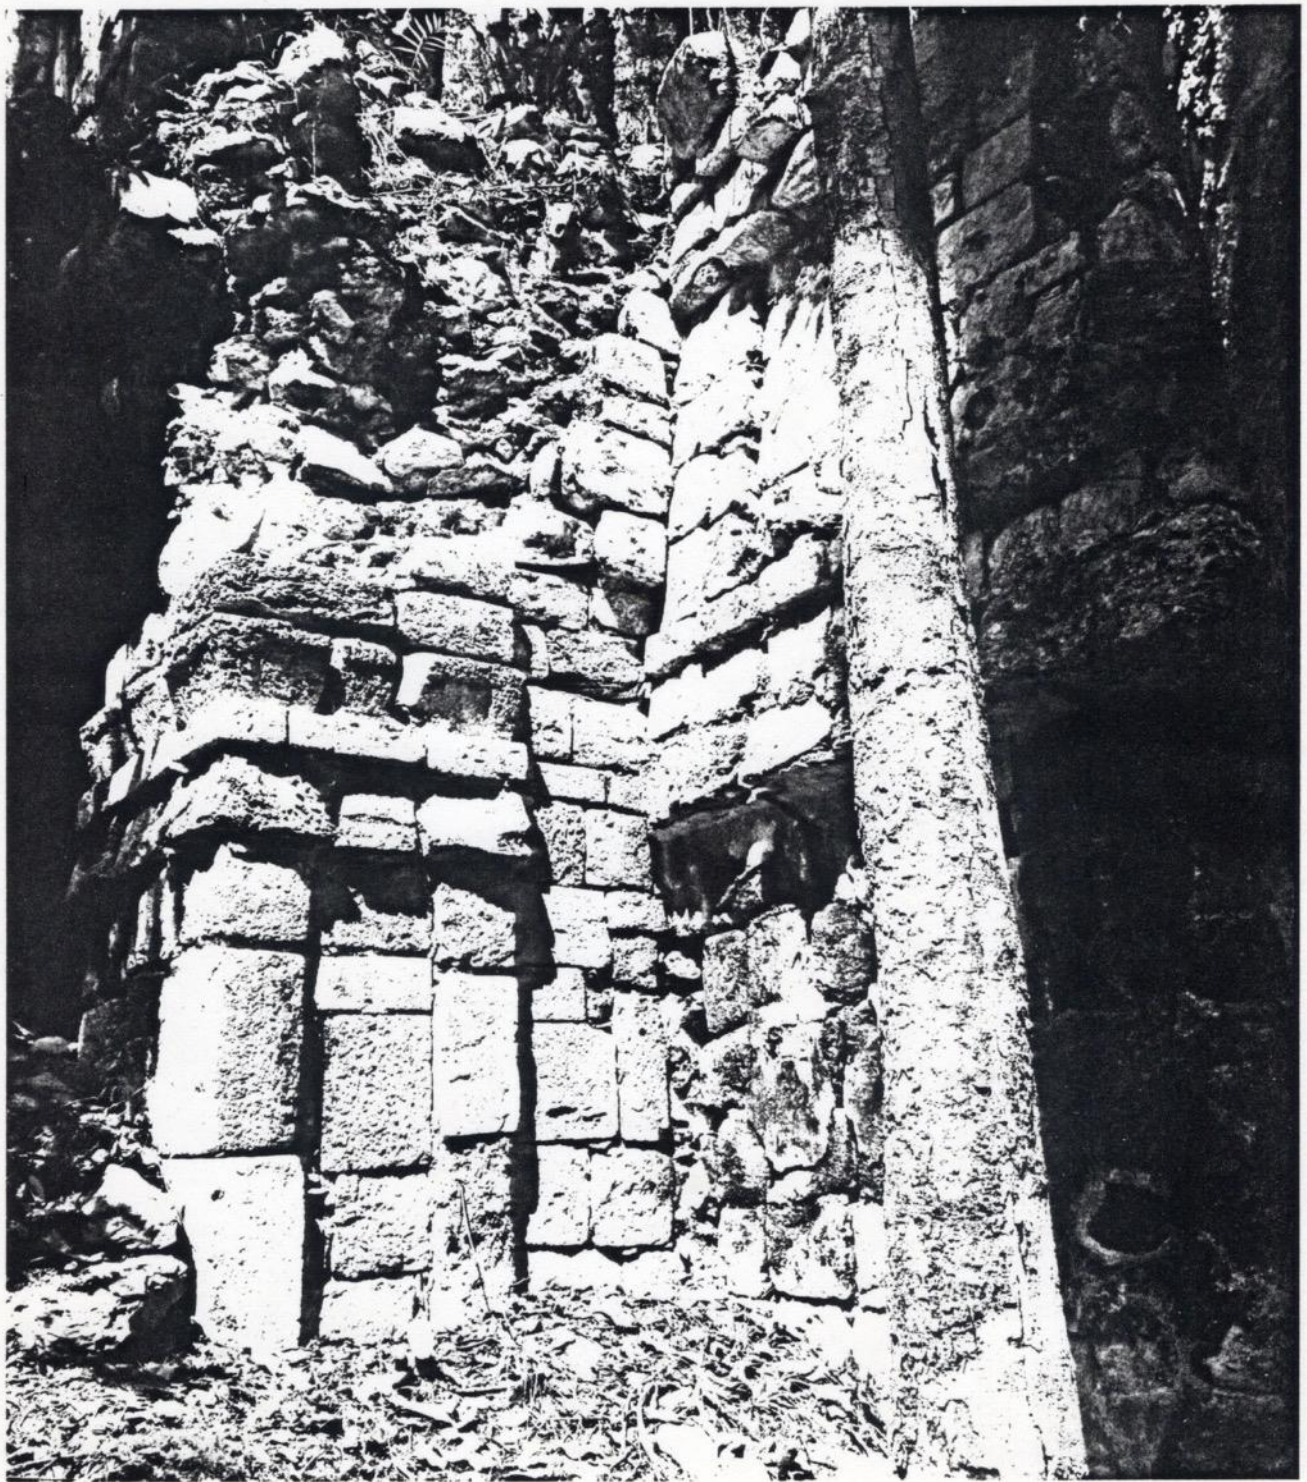
Plate 13. This is the equivalent view of the north end, first story of the Main Palace, outside room 9, with the outside of Room 14 in the shade. Thus, there are two opportunities to ascertain--without excavation--whether there is any possibility that Rooms 1 and 9 represent an earlier stage, or an addition to Rooms 2/3 and 10/11. The particular angle of sunlight shows off the raised frame of the diagonal bound motif, actually a miniature bound thatch roof, not a mat symbol.

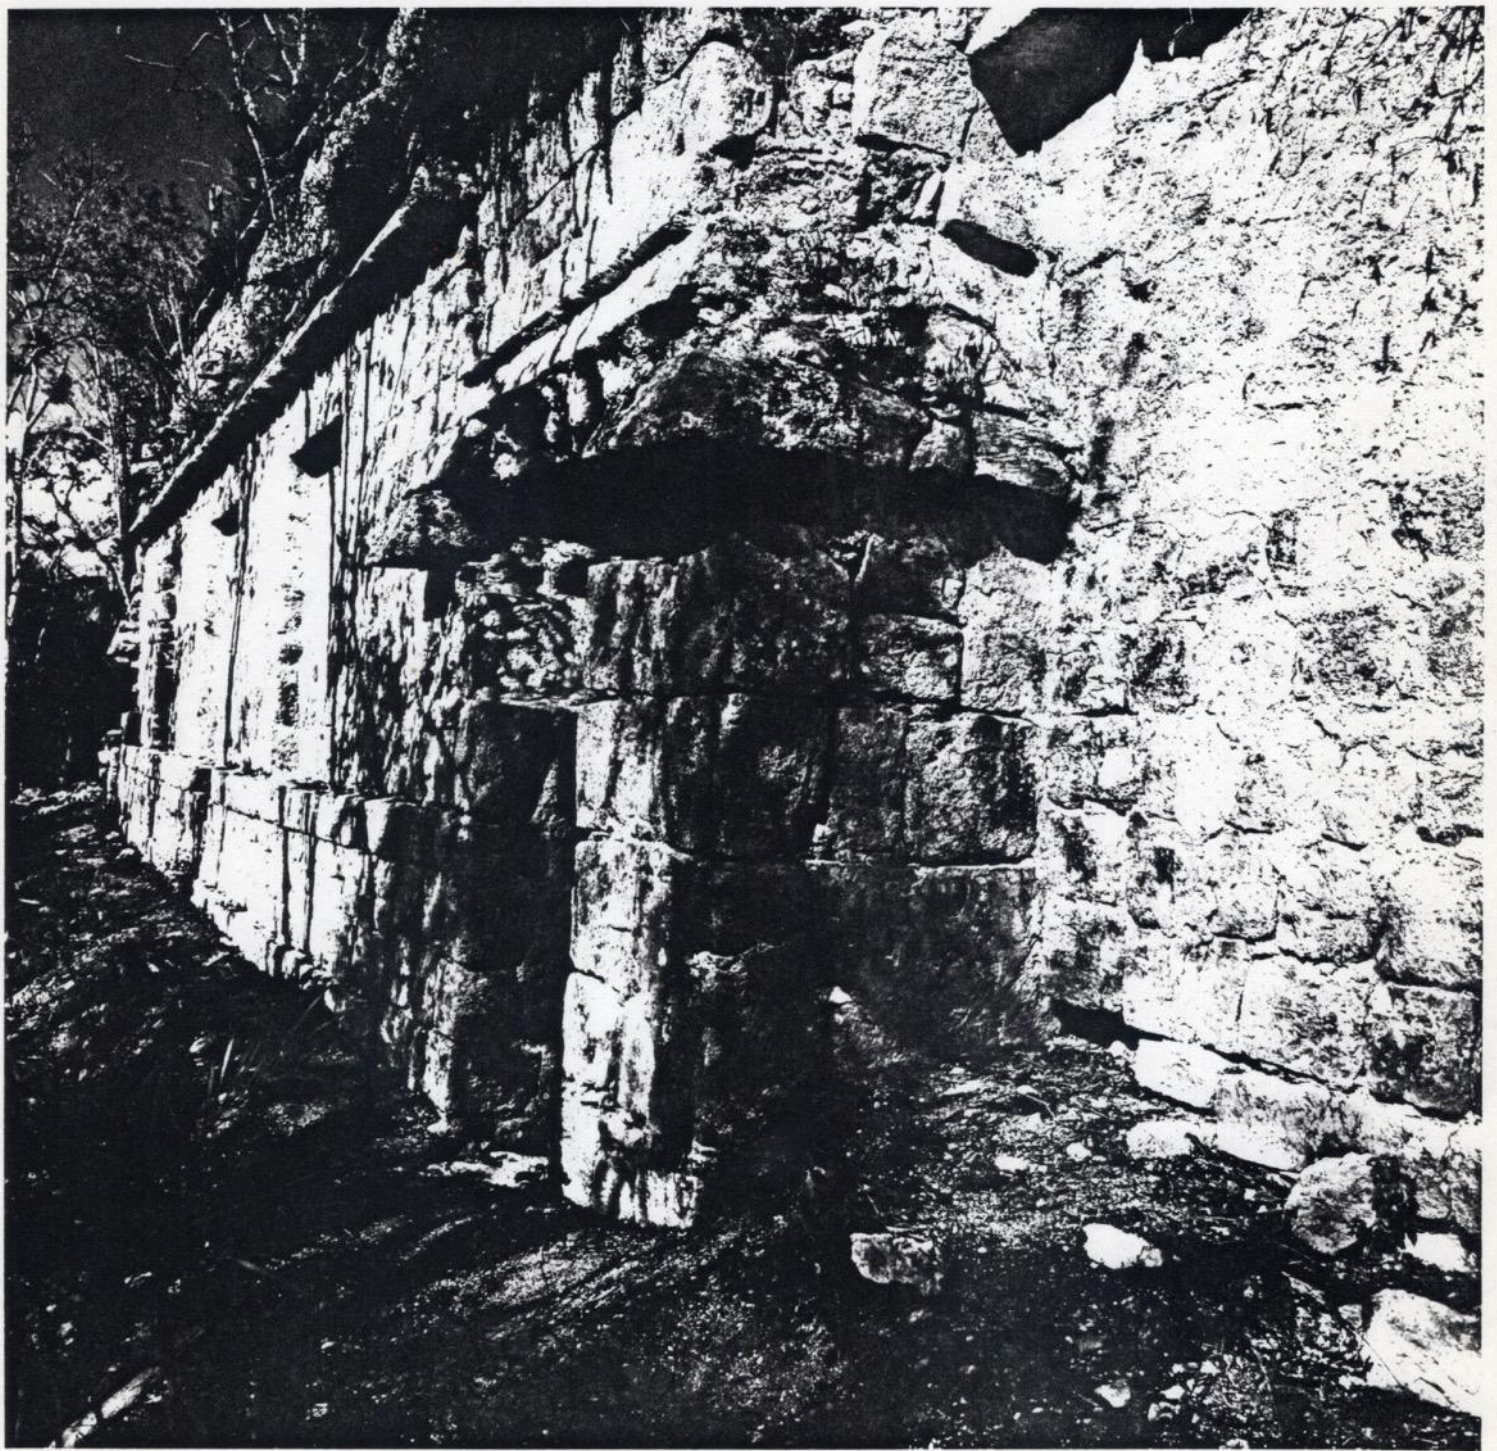
Plate 14. Looking northeast along the third floor. The entry/exit house of the South Interior Stairway is in the foreground. The roof of this exit hall is the same motif as the capital on the pilasters of Rooms 1 and 9--minus the raised frame.

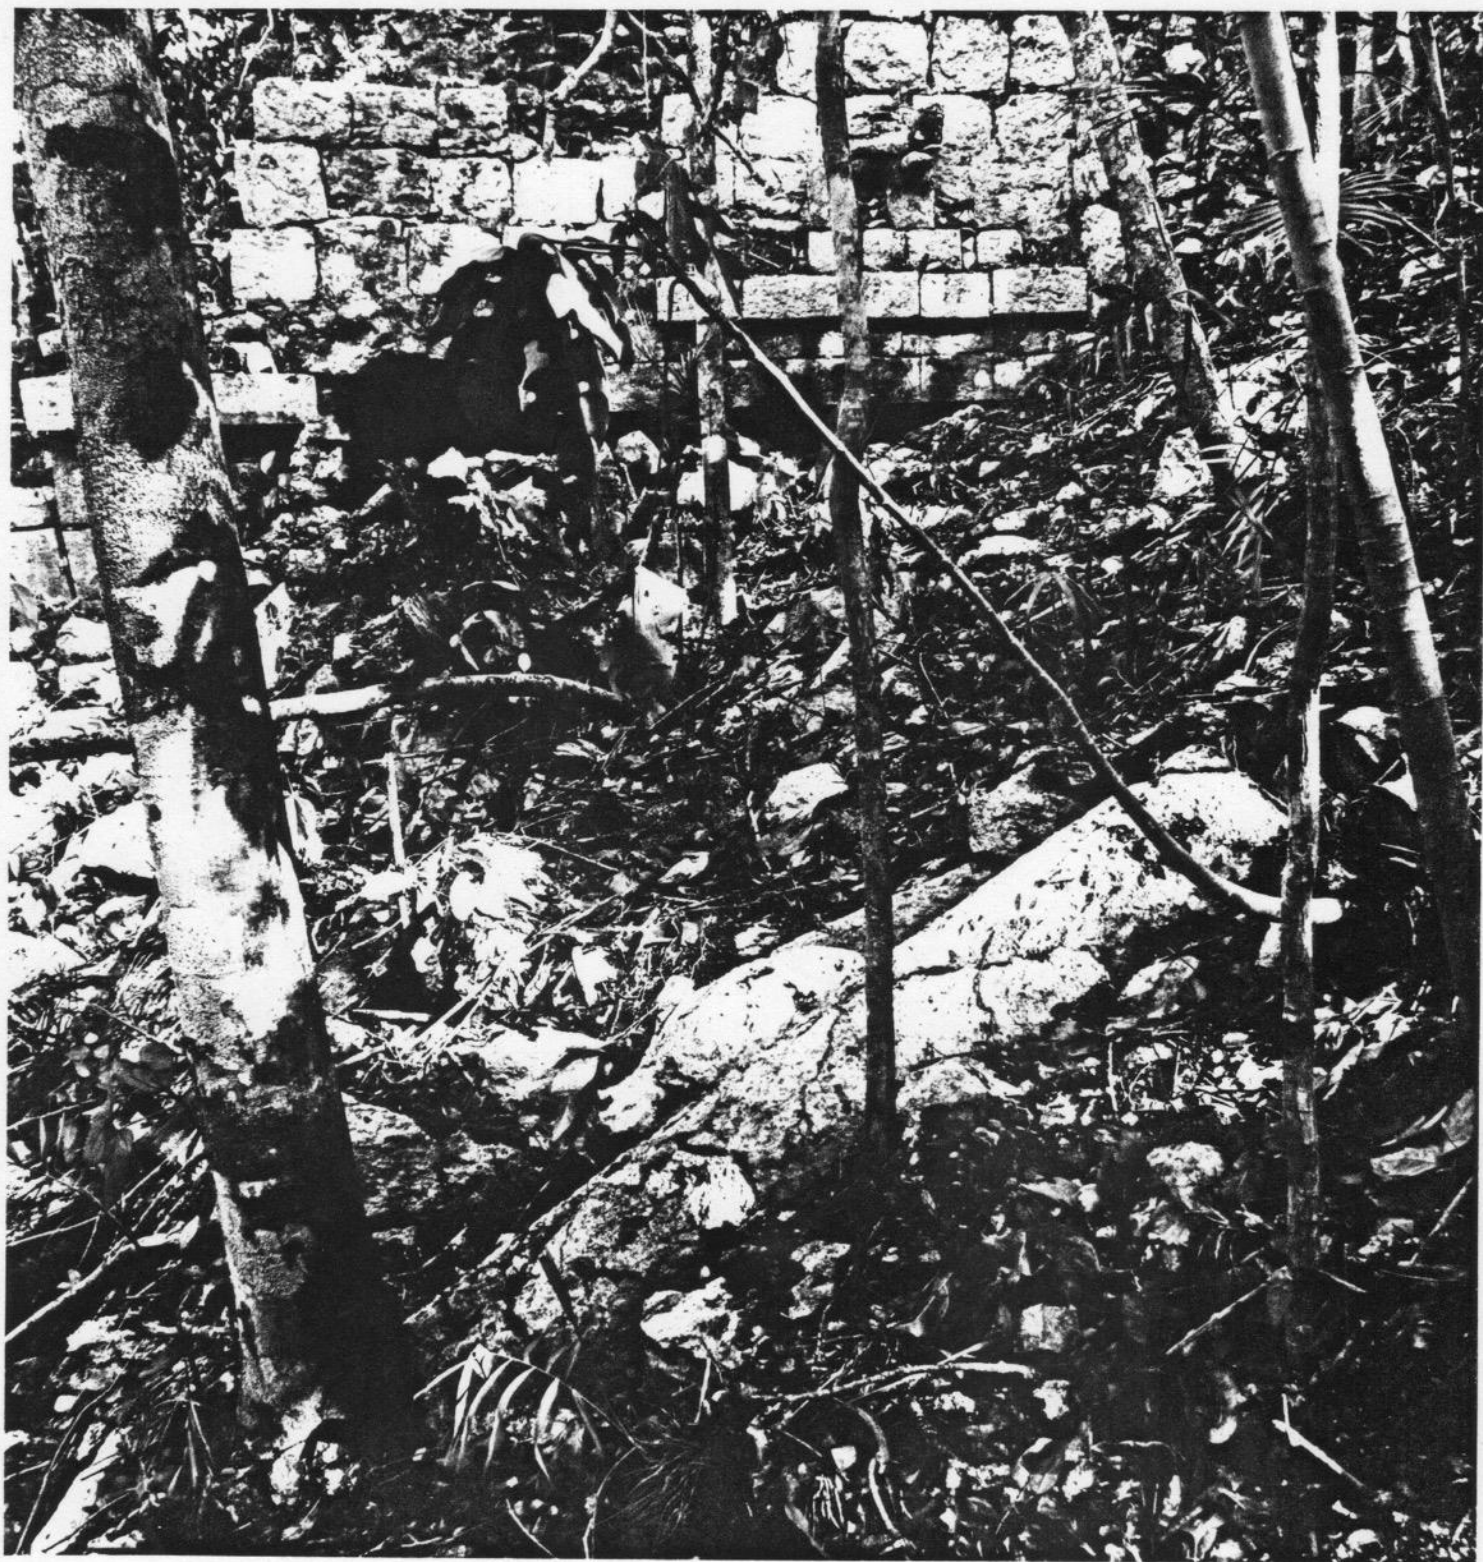
After the disappointment that the "columns" north of the Cuartel were square, and possibly specialized corner stones, we were surprised when the same INAH guardian, Fidel, found a round column three meters from where we were photographing, right in front of the upper double room area of the Southwest Building. We had walked within 4 feet of this column over six times, but it was obscured from view by vines, low branches, and leaves. In the process of bushing the guardians found the column and carefully swept the leaves away so it could be photographed. The fallen position was perfect for it being from the front rooms. I cannot picture it as a stela or set into the wall, as it is too large for an embedded column, which are usually in Chenes buildings and of several stones a meter or less in length. This column is 36 cm in diameter, 1.40 m in height. For comparison, the isolated column in the middle of the Southeast Quadrangle is 50 cm in diameter, 1.61 m high.

Plate 17. The first doorway column found at Santa Rosa Xtampak, in front of the upper area of the Southwest Building. In the back-ground is the facade of the lower area.
