ADVANCES IN KNOWLEDGE
OF THE MONUMENTAL ARCHITECTURE

OF SANTA ROSA XTAMPAK

Based on Photography and Mapping of June-July 1989

Nicholas M. Hellmuth
Foundation for Latin American Anthropological Research
1989

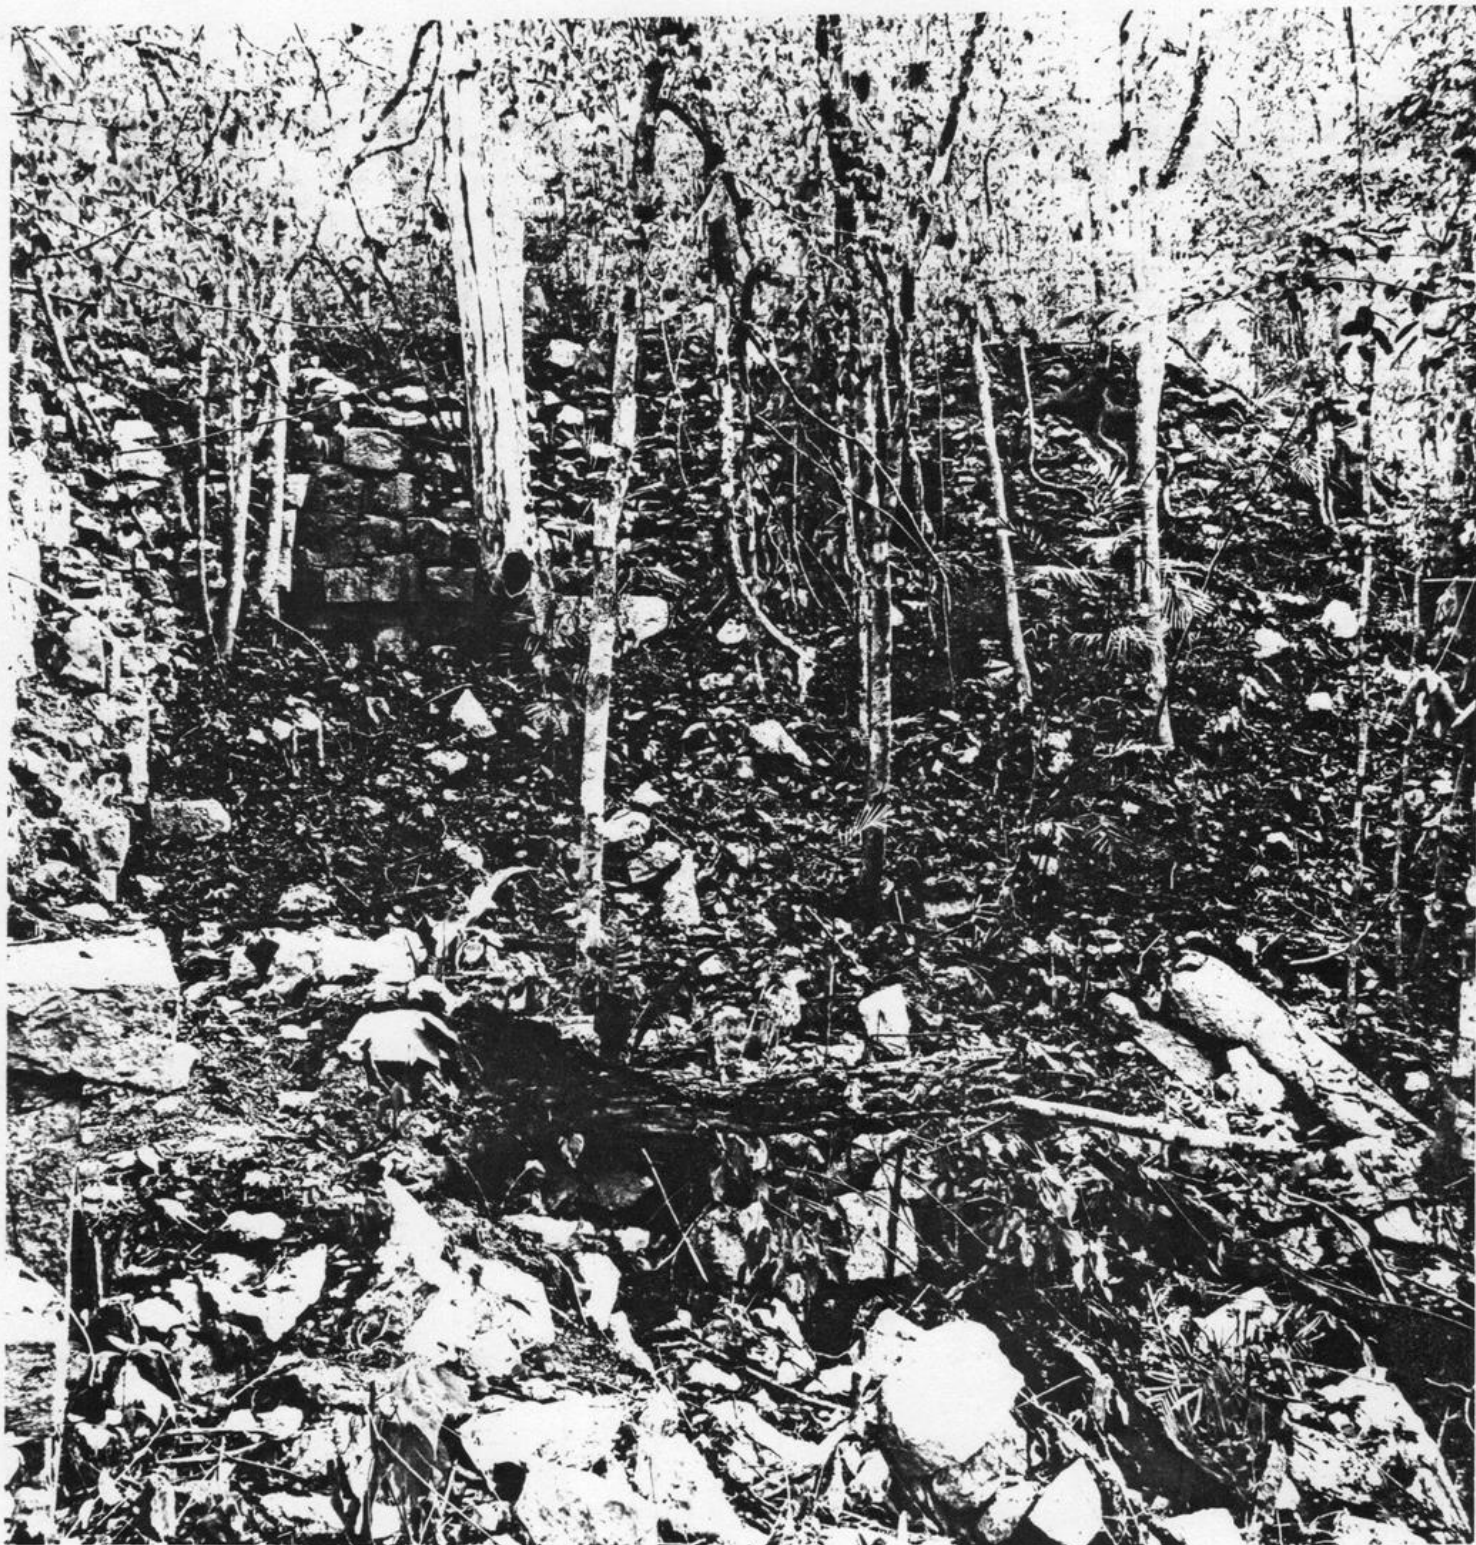
Plate 18. On the extreme left is the plain medial molding of the lower section of the Southwest Building. Across the background are the fallen remains of the upper section. The column must be from the front rooms of the upper section.

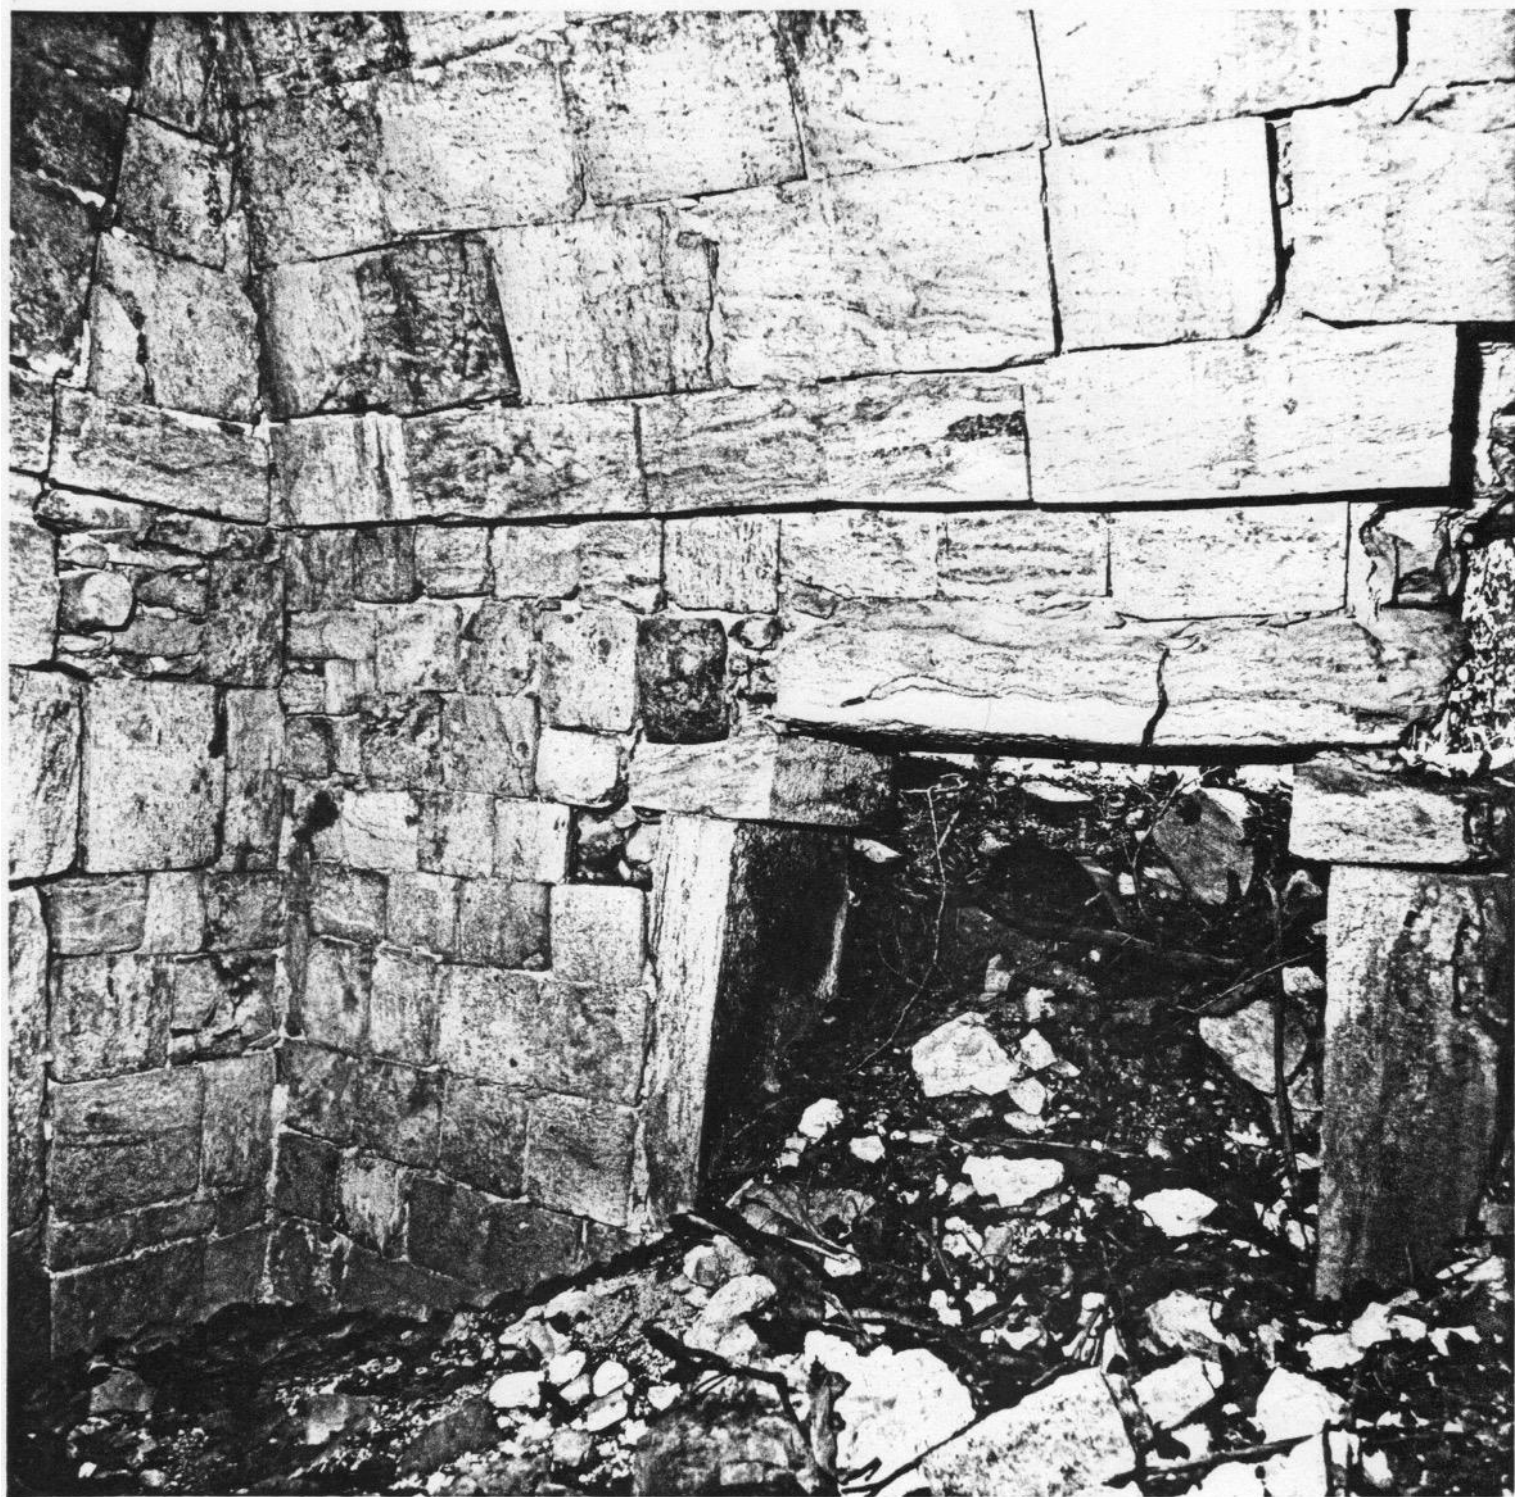
Plate 19. The front entrances of the lower rooms have half capitals on rectangular jambs; the inner doorways have no capitals at all. In the upper section the inner doorways have the half capitals—the front doorways are collapsed but may have been the location of the fallen column out in front. Inside Room 3 looking out. Southwest Building.

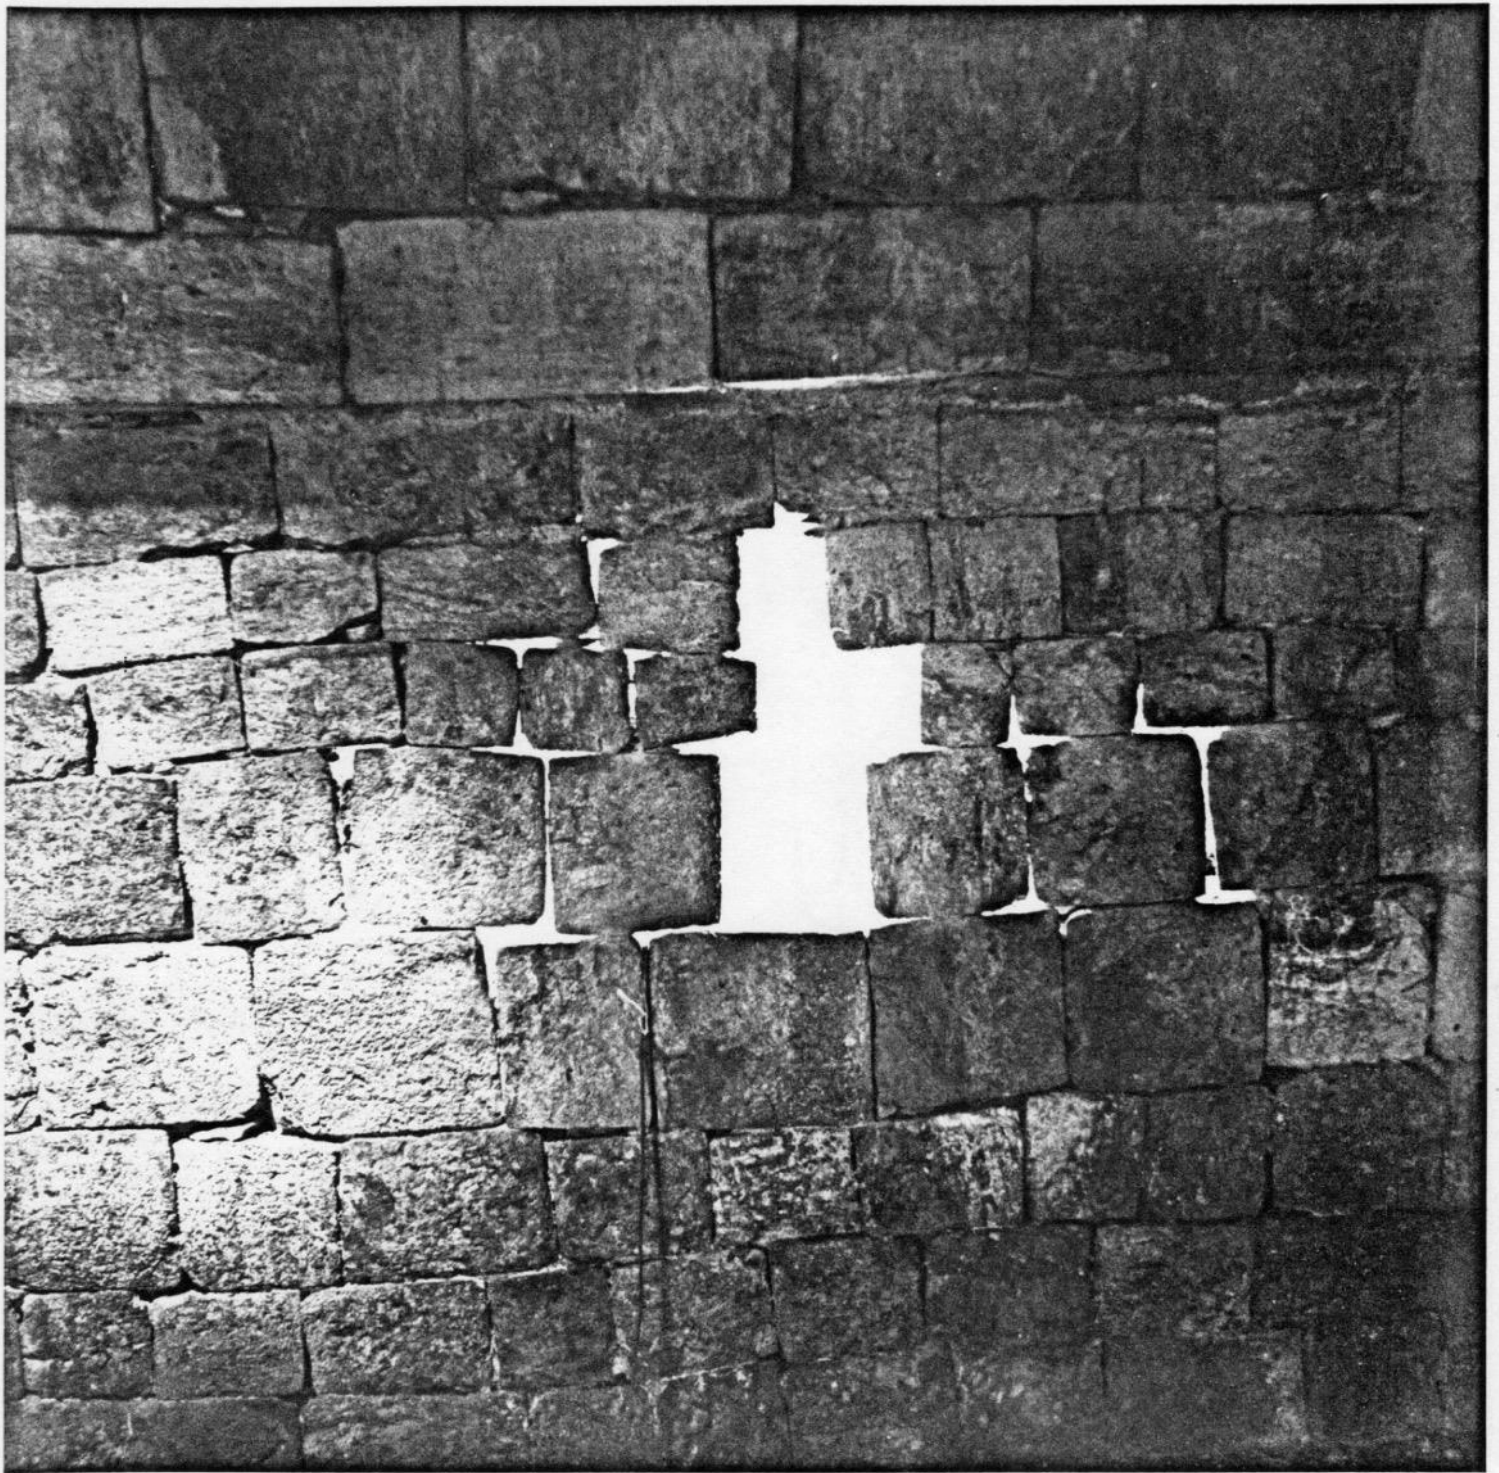
Plate 20. The west wall of Room 3 has crumbled about as far as possible without falling to ruin. The entire outside facade is gone, even the mortar between the stones of the inner facing. You can see right through the wall- (collapse in slow motion). Southwest Building. Unless this structure is repaired immediately these will be the last photographs--actually the only photographs since other expeditions were not equipped for interior photography.

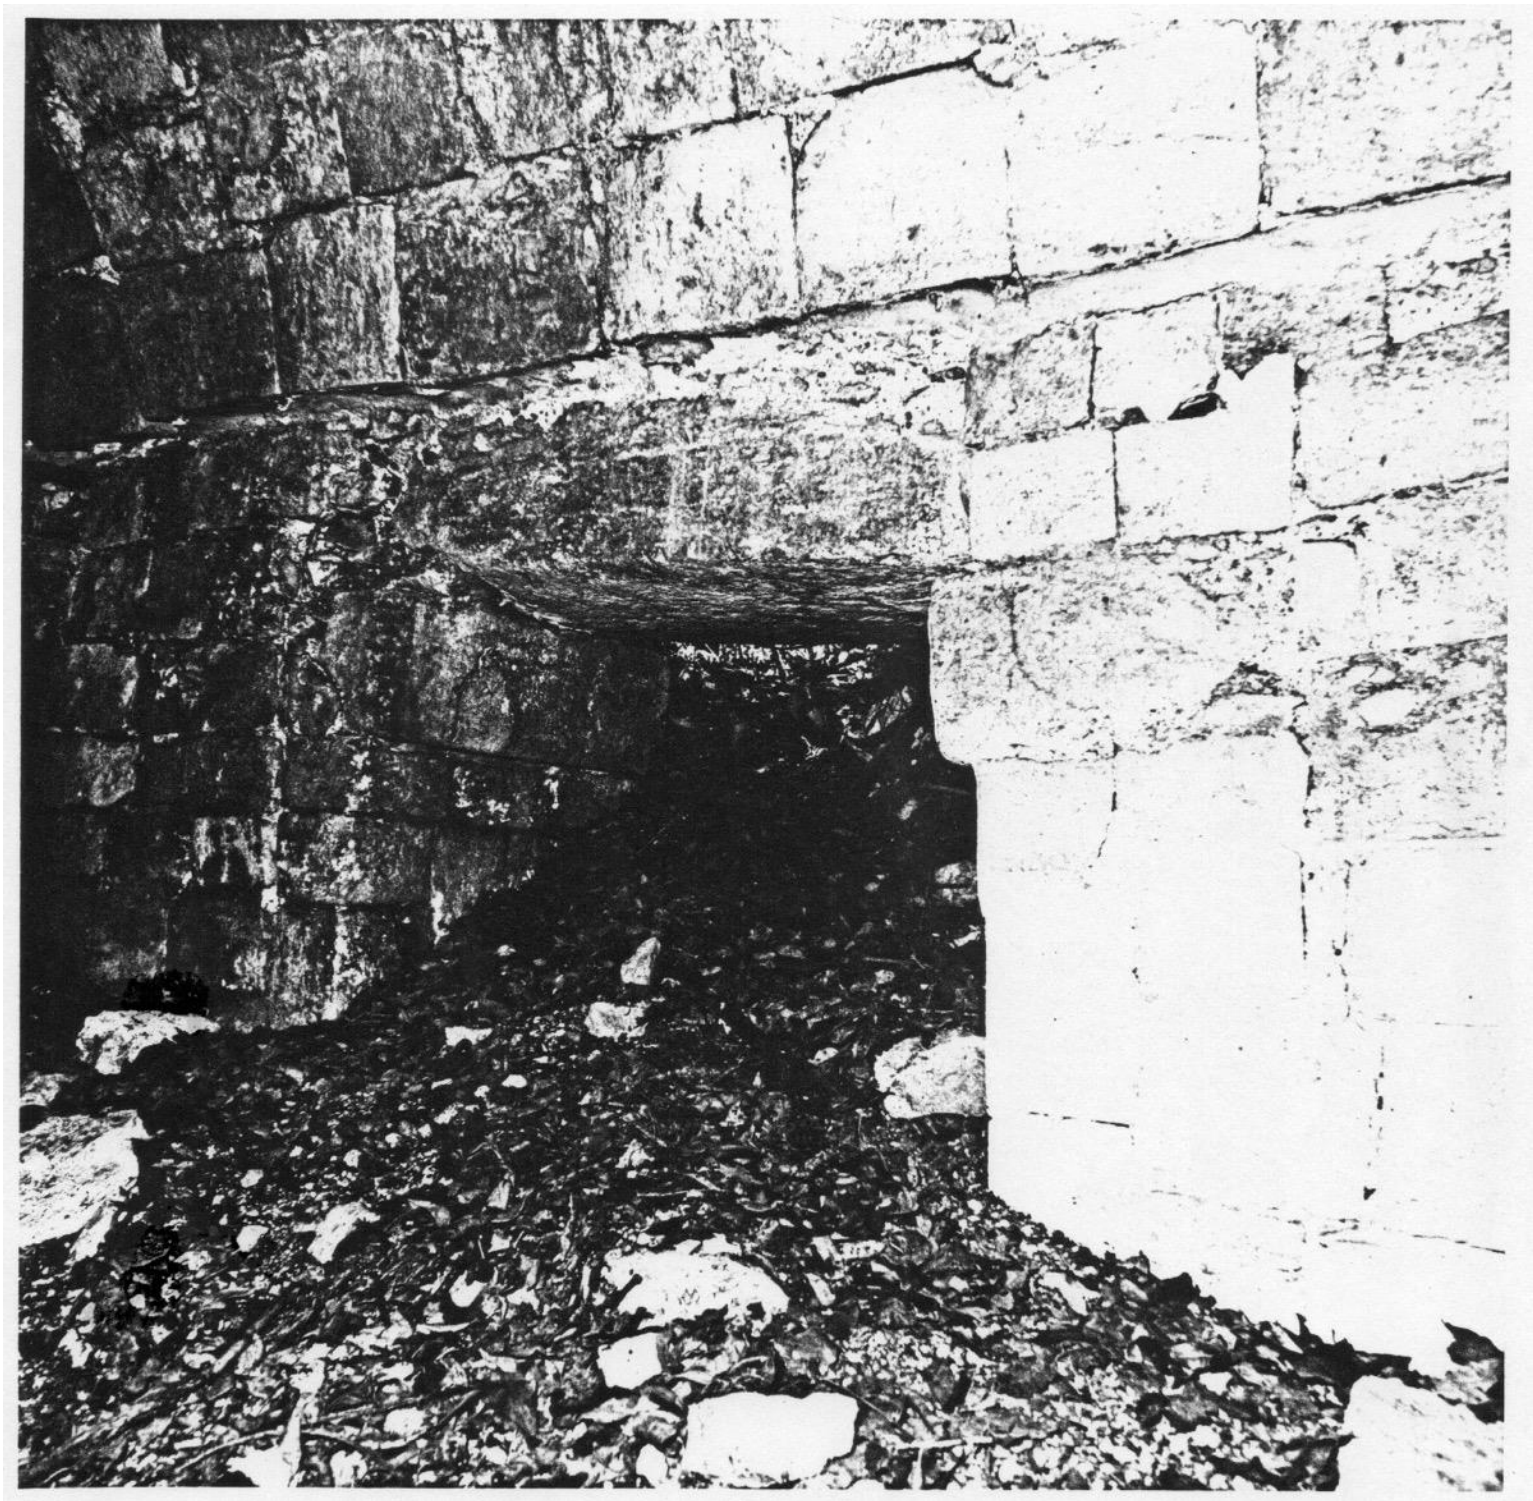
Plate 21. Inside upper room 7 or 9 looking out. The debris is from the collapse of Room 6 or 8. Southwest Building.

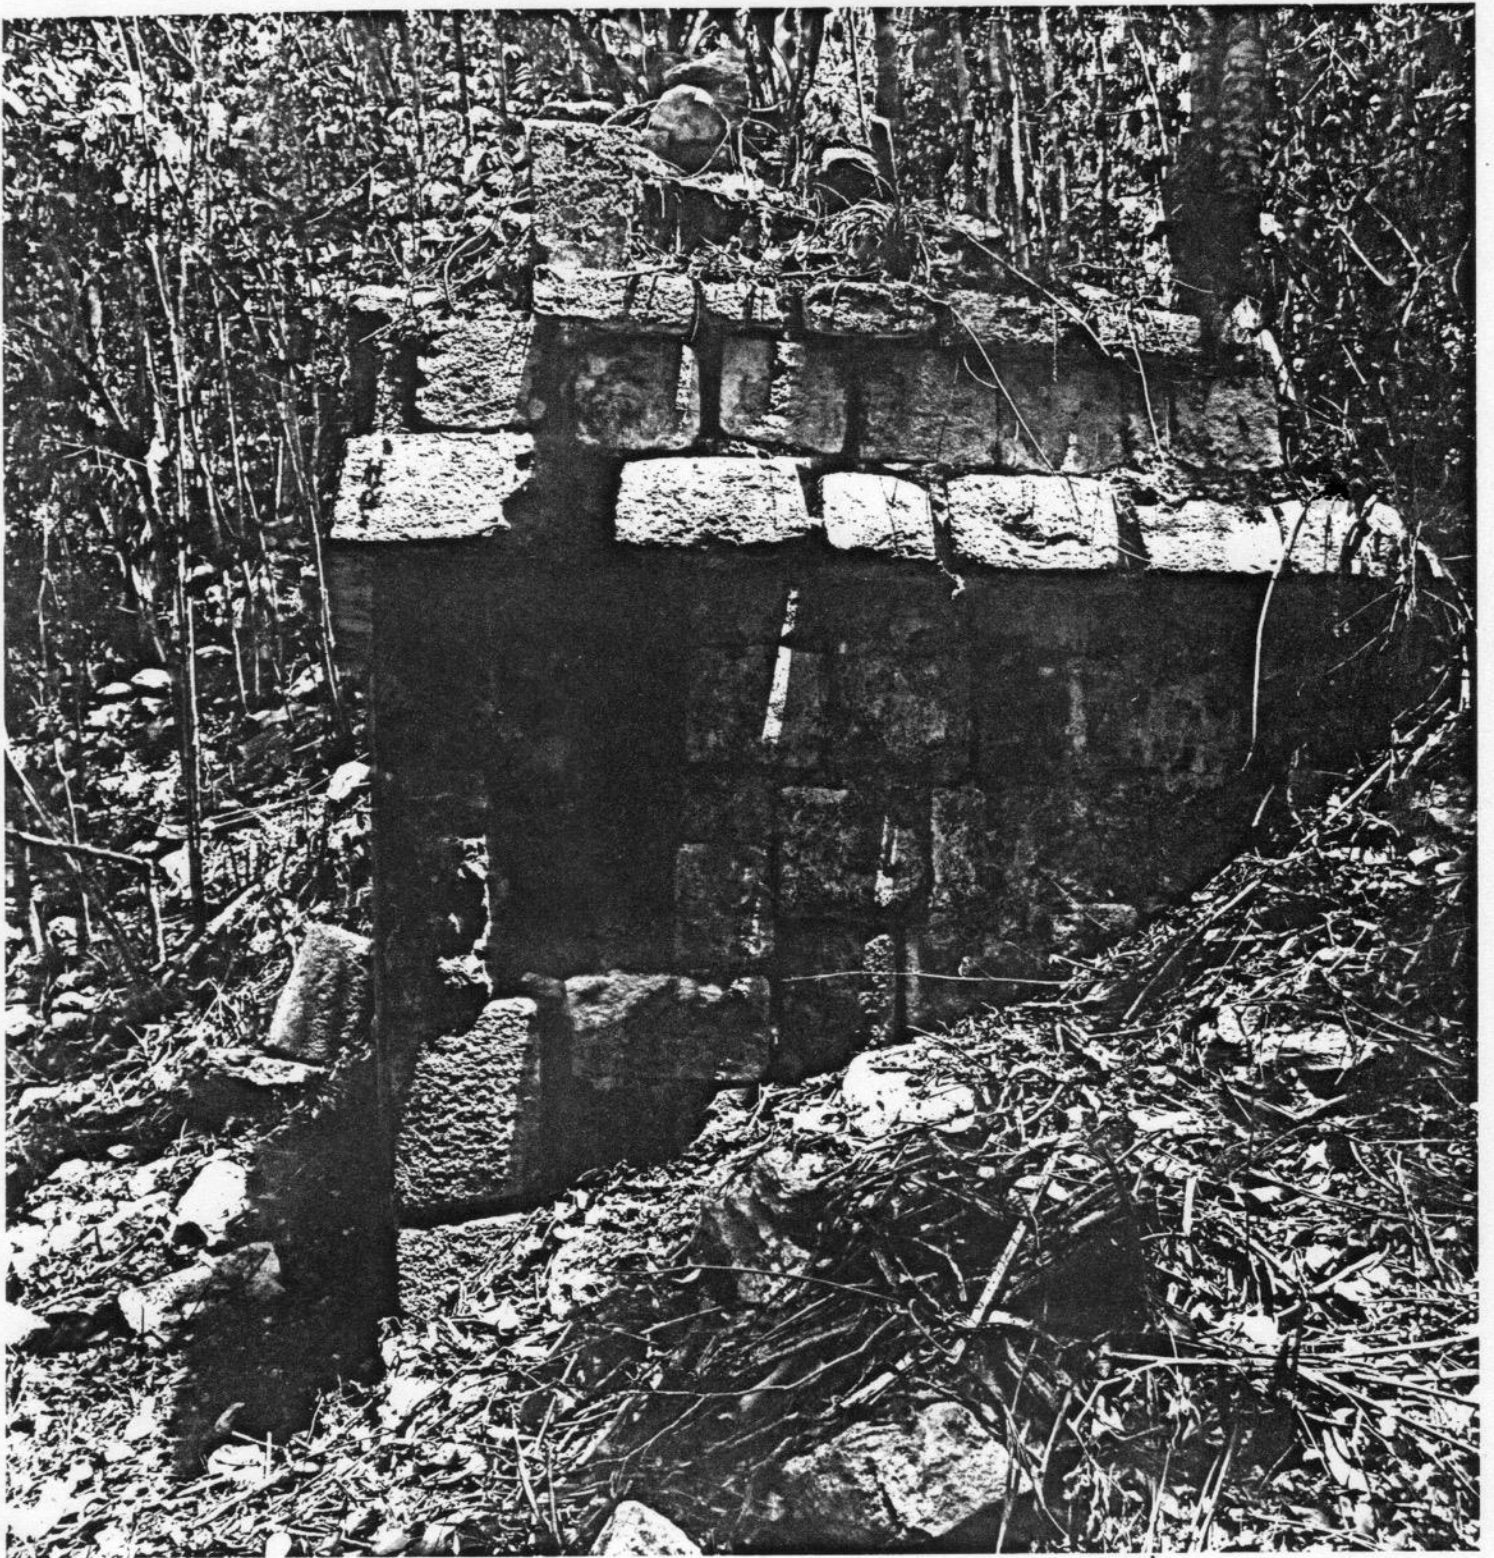
Plate 24. North Range of the Southeast Quadrangle, southeast corner, looking east. This is the only section of the upper zone still preserved.

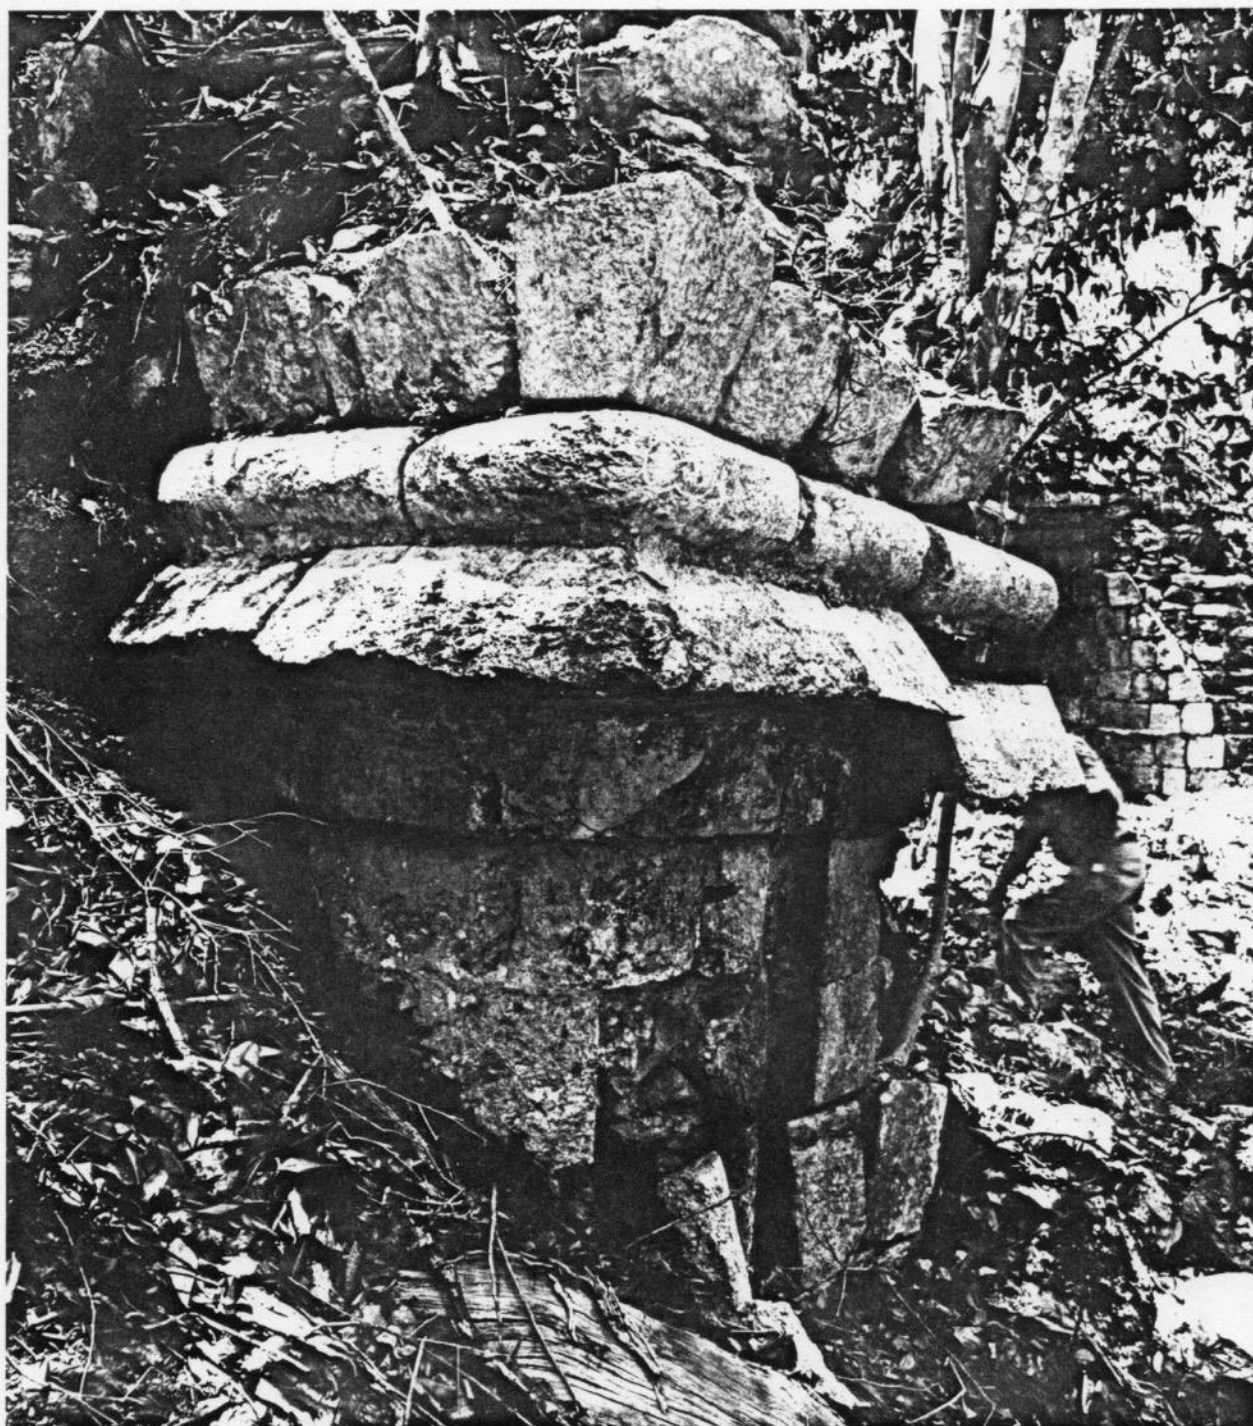
Plate 25. East Range of the Southeast Quadrangle; right next to the center stairway (front). This is the remains of the medial molding which runs around the entire building. The upper molding is the same and is preserved along the back of the palace. In the middle ground Eldon Leiter measures the remains of Room 3; in the background is the end wall of this room, complete with the custom cut stones prepared to receive the slant of the adjacent vault which has long ago collapsed. Custom cutting of end wall stones is a trait of Puuc rooms.

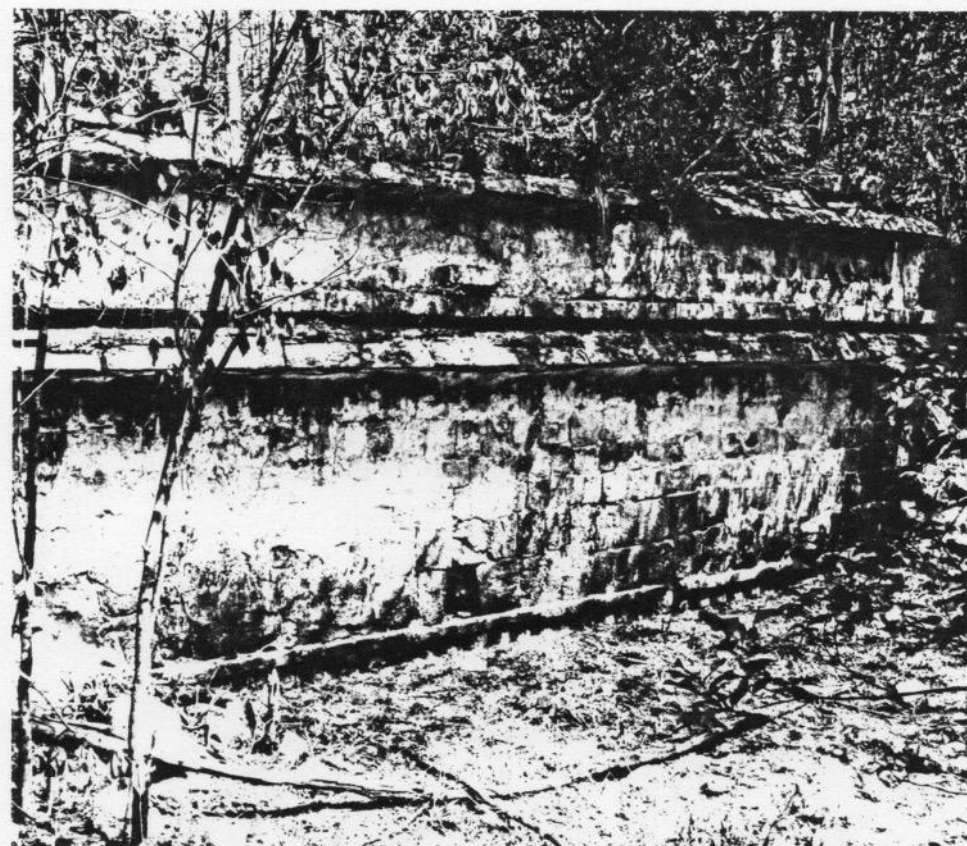
Plate 27. Two more views of the same long, door-less section of the West Range, Southeast Quadrangle.

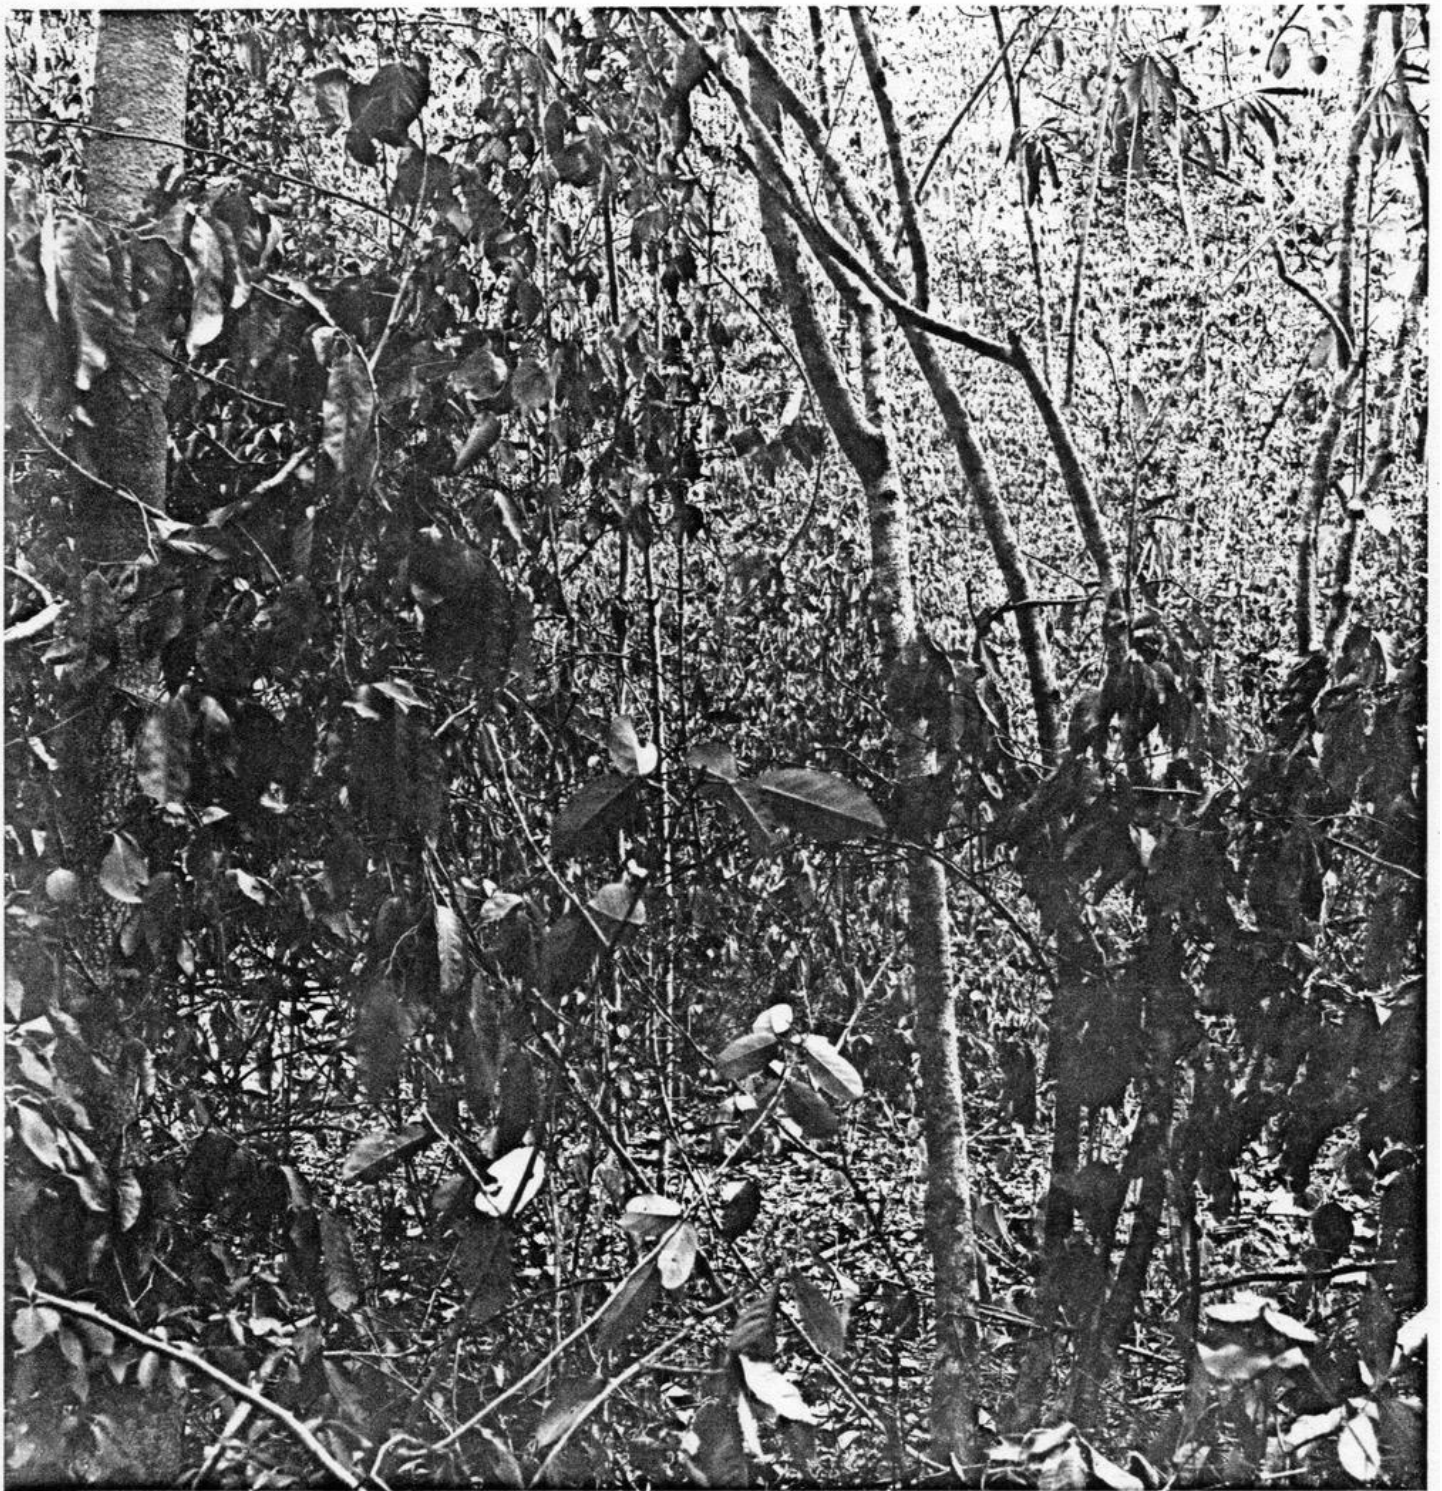
Plate 29. Inside the Southeast Quadrangle, as it appeared to all expeditions which labored at Santa Rosa Xtampak until the INAH site guardians removed the branches and vines to reveal all the architecture that is hidden behind this constantly growing curtain.

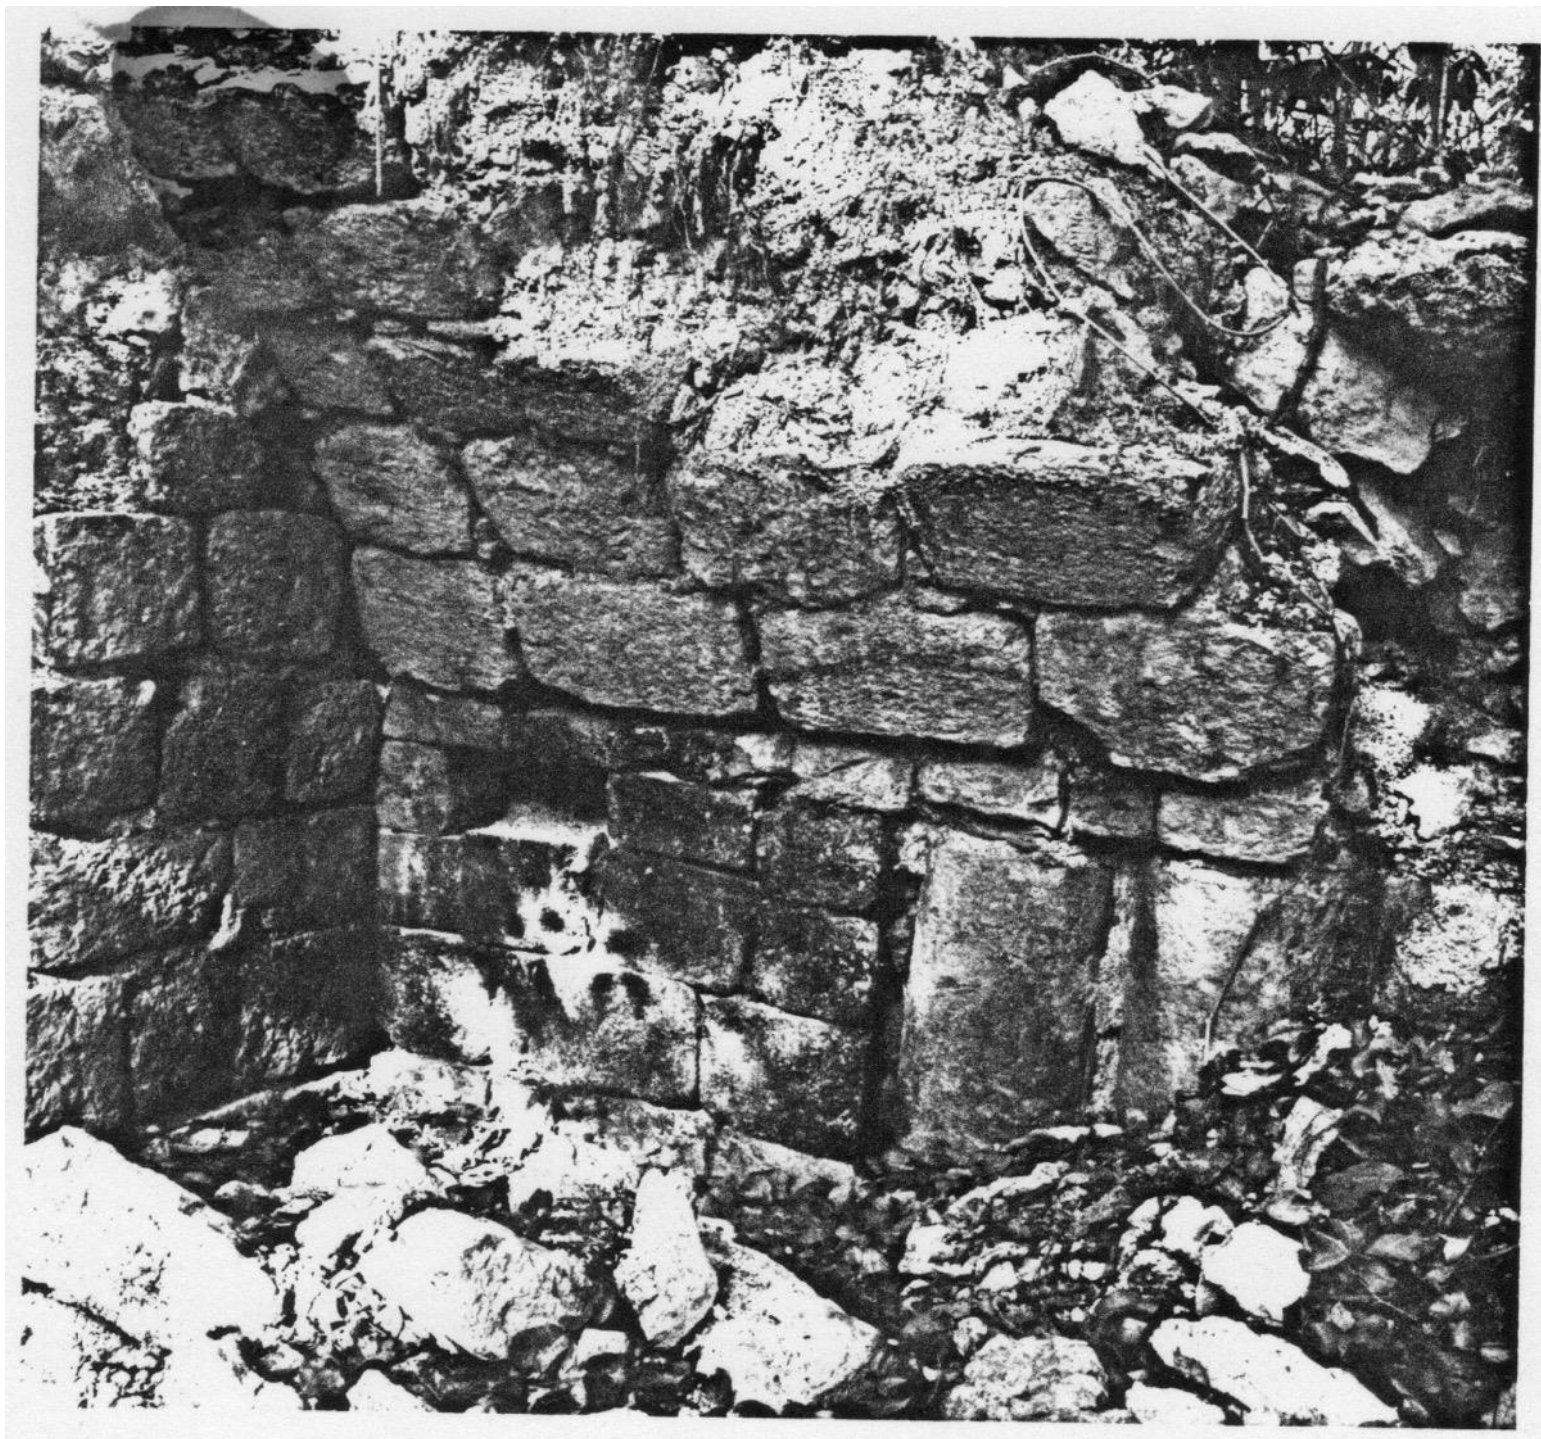
Plate 37. A rare incidence of embedded columns inside a room, in the remains of the East Range of the Cuartel. The stones directly above are of the vault soffit. The end wall (to the left) has no spring. No end wall in the Cuartel area has a Puuc spring.

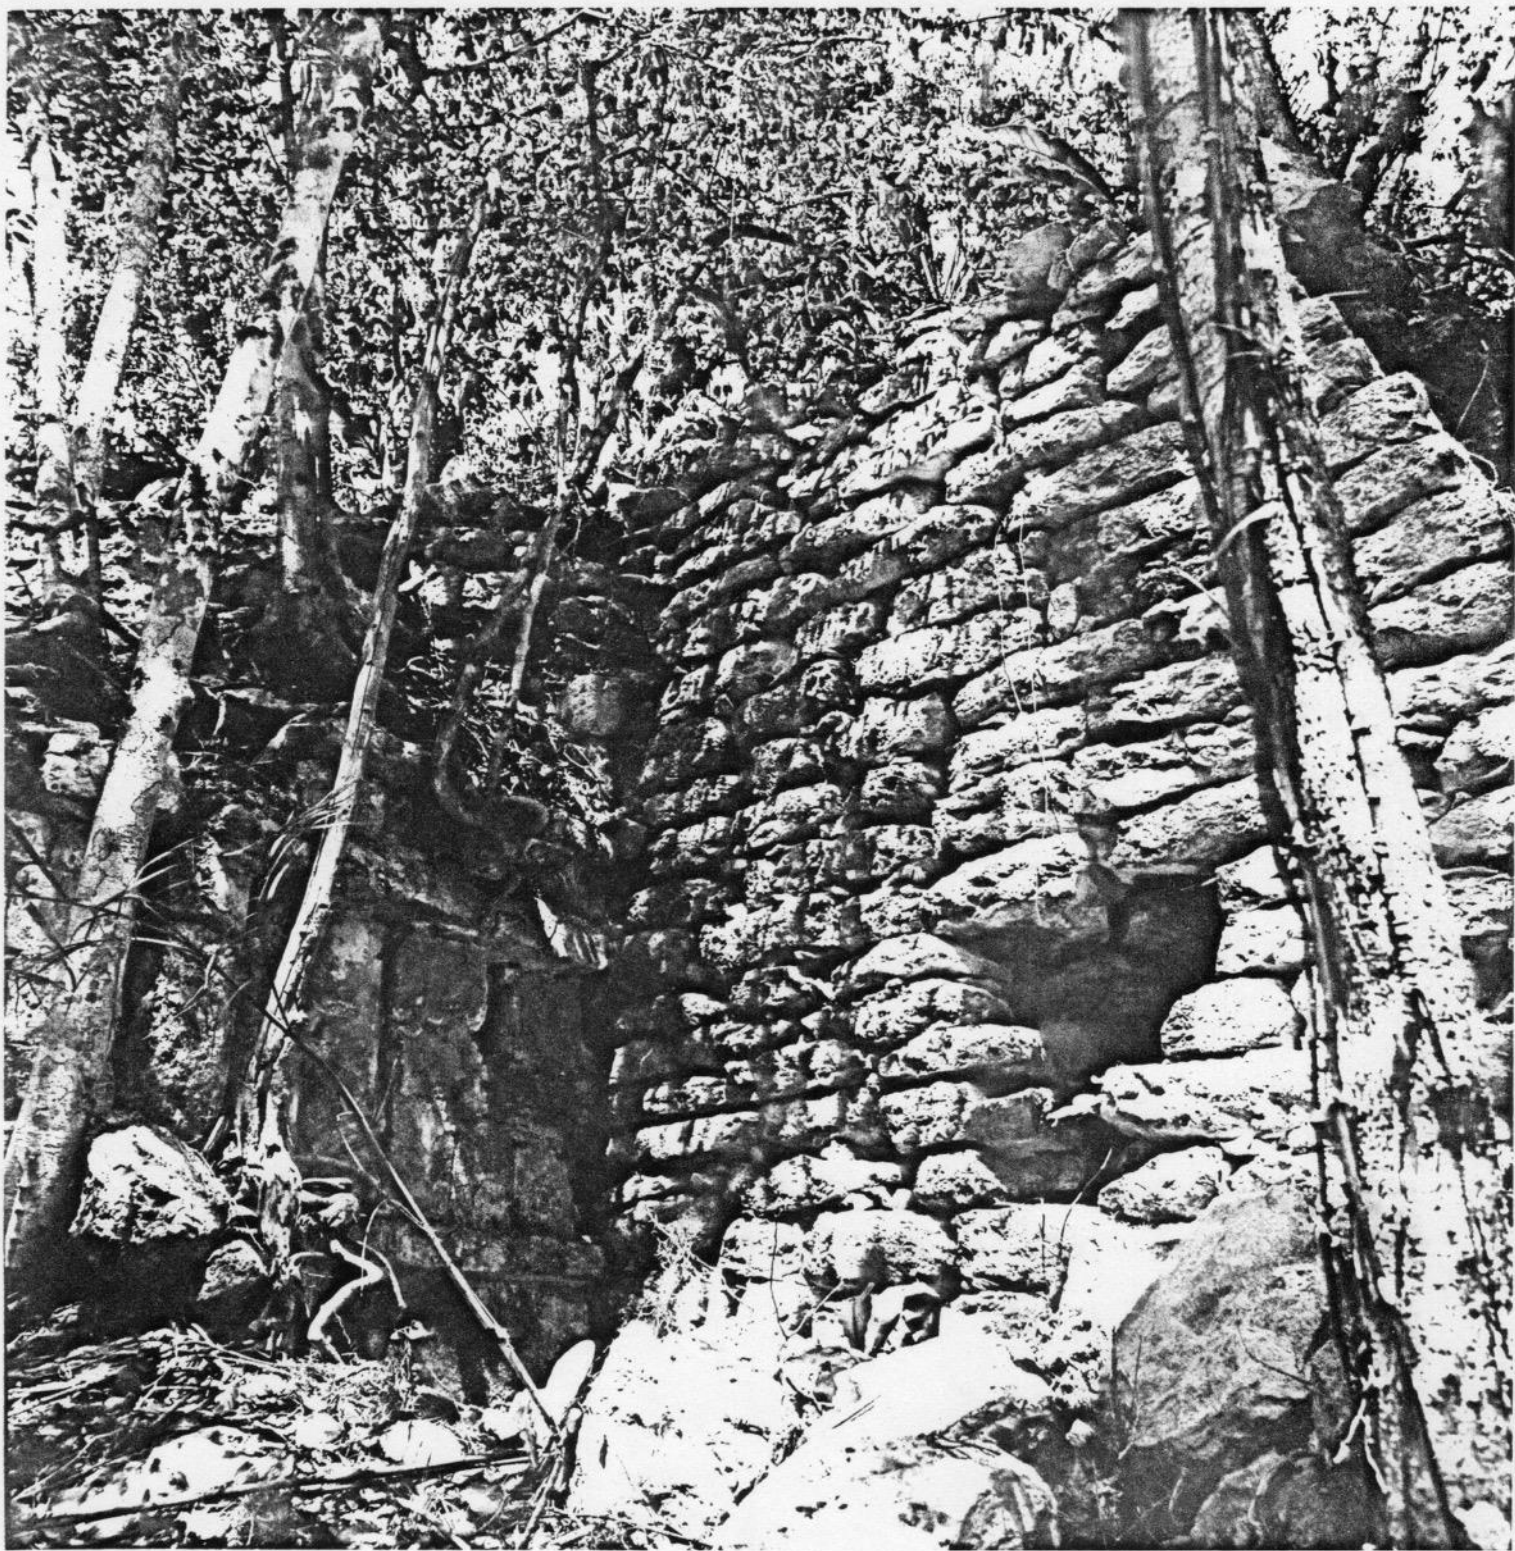
Plate 38. The large facing on the right is the side of the rear stair mass on the back of the Building with Serpent Mask. The masonry to the left is the remains of the upper zone of the back of this building.
