FIRST SEASON PHOTOGRAPHY AND  
ANALYSIS OF STANDING ARCHITECTURE

at  
SANTA ROSA XTAMPAK,  
CAMPECHE, MEXICO

Nicholas M. Hellmuth

July 1989

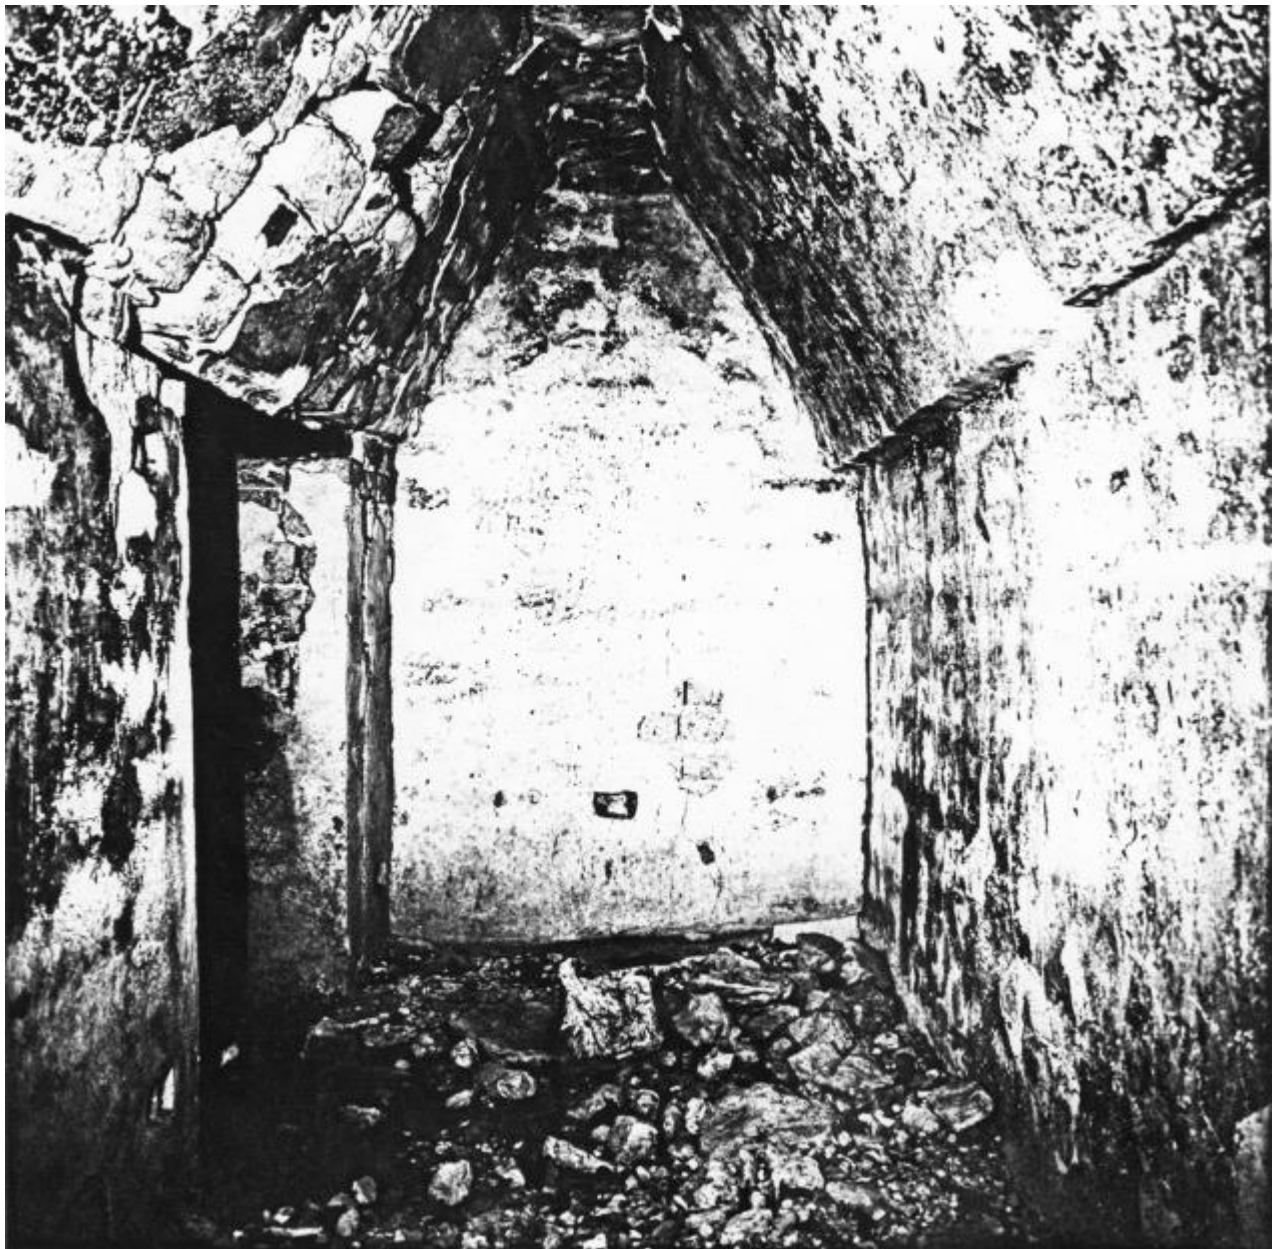
Figure 1

Figure 1. Main Palace, west side near the south end, inner room, 26, with a rare cord holder in the lower end wall. Santa Rosa Xtampak. Although the wooden lintel is still preserved the vault mass has separated from the rest of the soffit and is just waiting to collapse. Hasselblad ELX, 50mm Zeiss lens, Metz 60 CT 4 set at automatic TTL. **449951-5.**

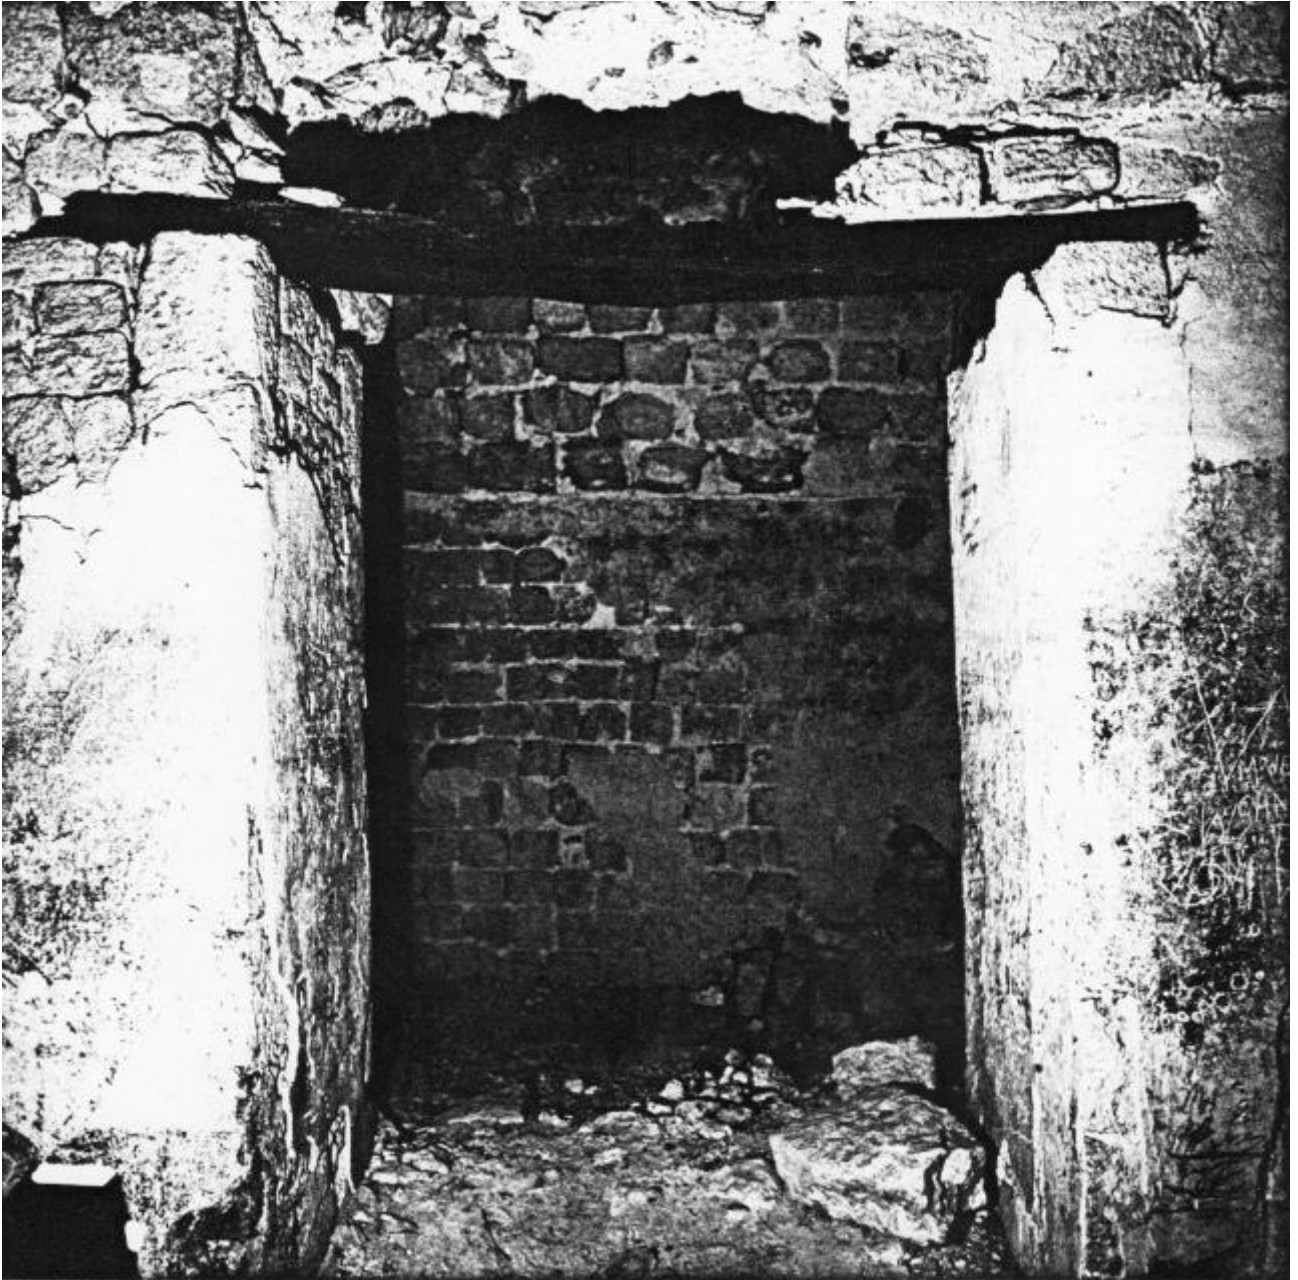
Figure 2

Figure 2. Two planks have already given way; the fragile remainder is sagging. This condition has already occasioned collapse of the vault. Wooden lintels over interior entrance into Room 14 or 17, west side, first floor, Santa Rosa Xtampak. Since the TTL meter reads in the center, it reads the far back wall, thus overexposing everything in the foreground.

The lintels still in place can provisionally be divided into four conditions: 1, cracked and bending; 2, shrunken, bending slightly but still upholding the wall; 3, shrunk yet still strong; 4, in perfect condition albeit naturally shrunk. It took a minimum of two wide lintels to span each doorway; sometimes three or more beams were used.

Folan has already declared salvaging the creaking lintels as the first order of business in rescuing the palace from collapse. Even in their dangerous condition, the wooden lintels, preserved from the 8th-9th century, are the feature of Xtampak most commented upon by visitors and those who see the color slides of the interior rooms. One front room has its lintels in such remarkable condition that you can almost see the Maya carpenter placing them over the doorway. All the more remarkable is the fact that the Xtampak lintels are the thinnest of any Maya building, less than

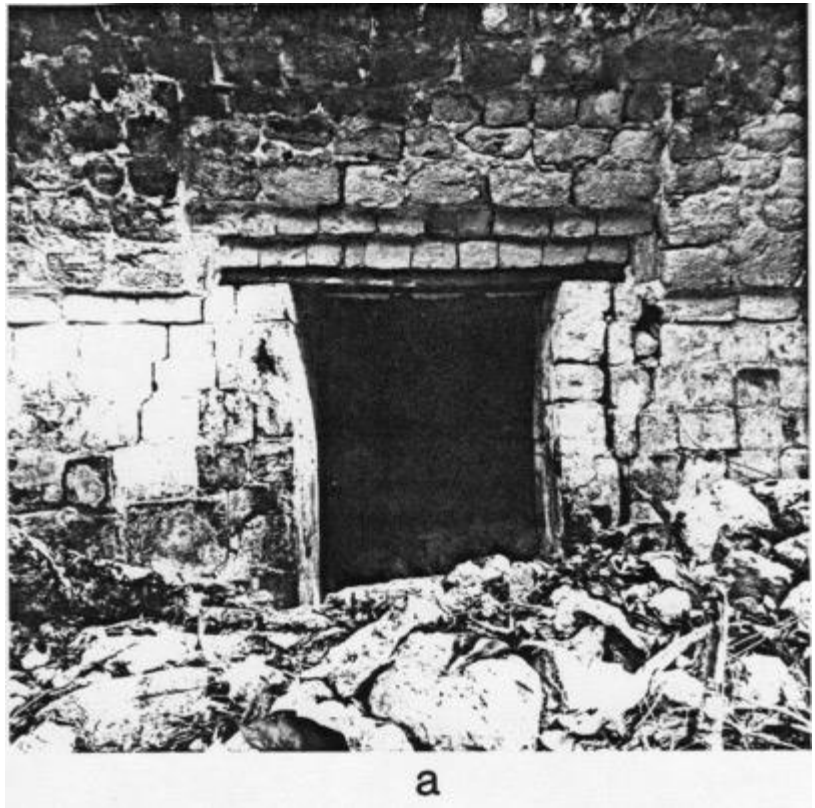
Figure 4, a. Front of Room 6 showing stepped recessed area over the lintel.

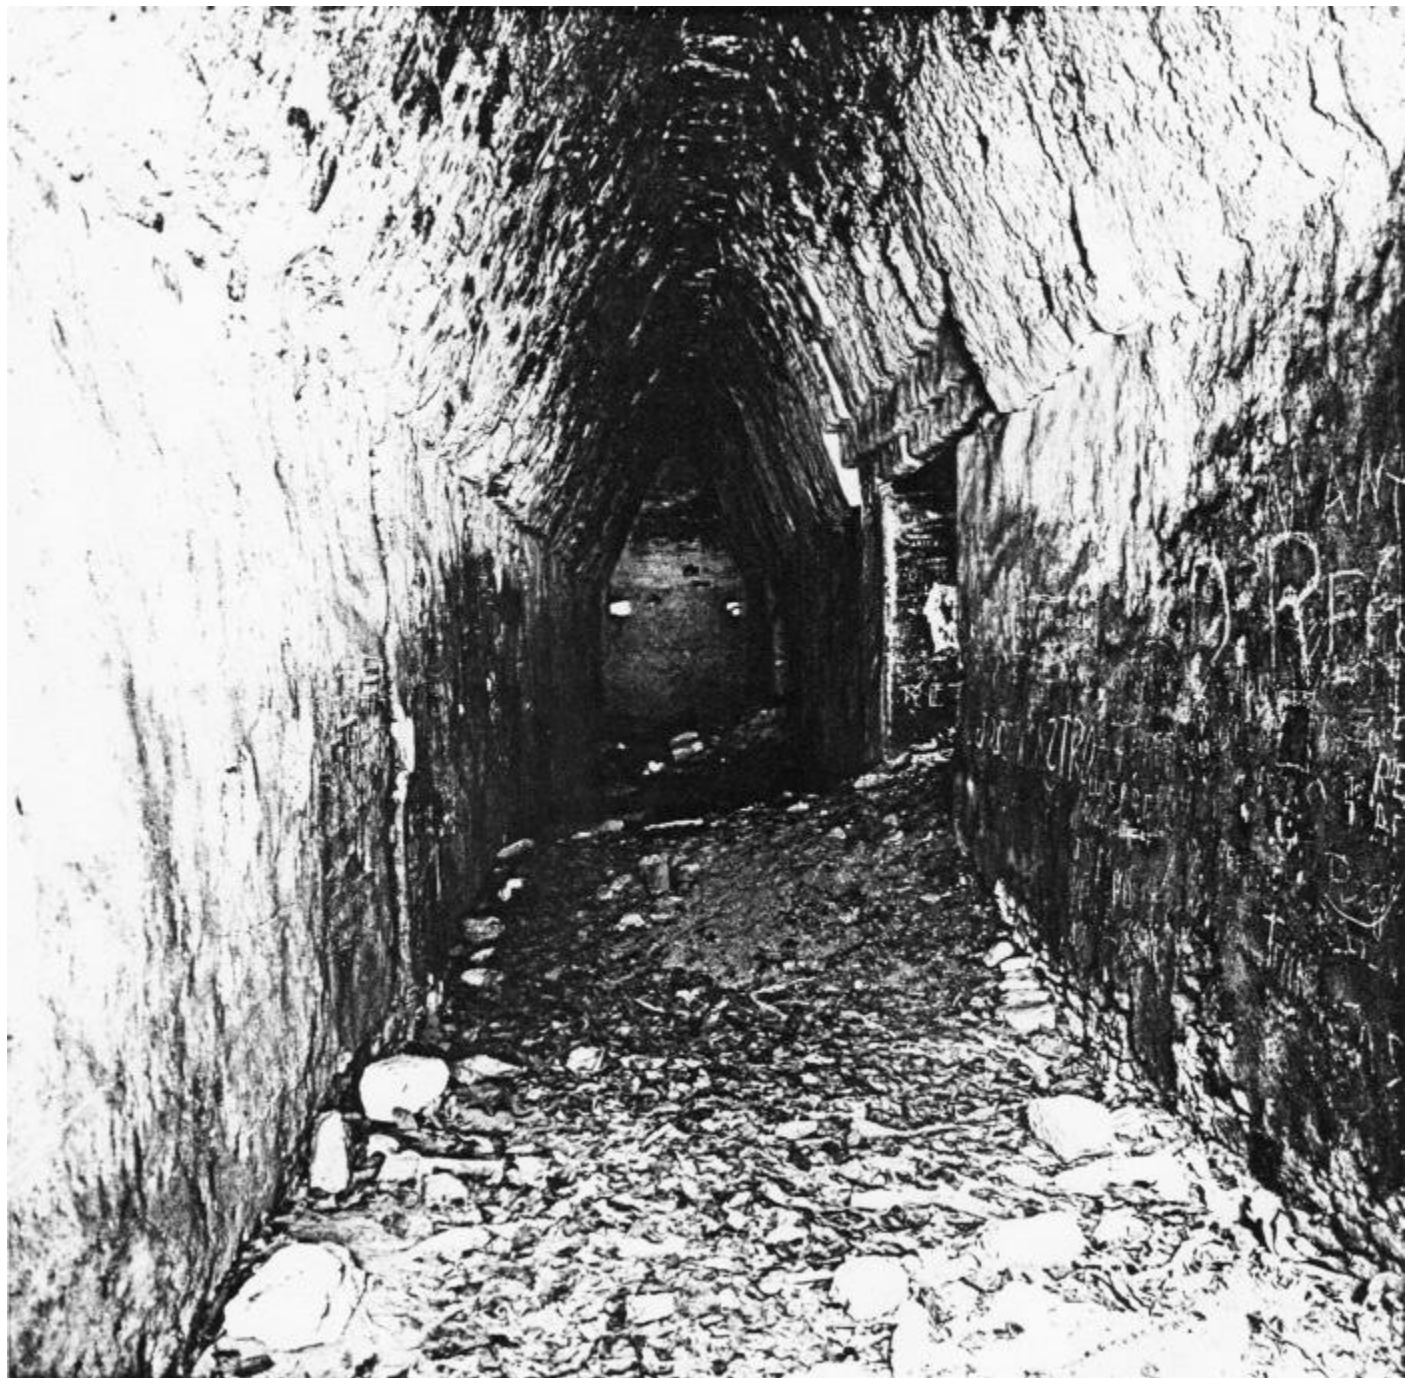
Figure 6

Figure 6. Tzikin Tzakan, two thirds of the length of this room (there is one more doorway out of view to the right). This is the longest single room yet recorded for the Peten, and possibly the longest single undivided Maya palace room outside of Palenque. According to reports this entire palace collapsed in a single moment due to excessive weight of water which soaked into the vault mass. I do not know whether this is the inner room (in which case the outer room fell long ago) or whether this is a single range structure, which I would find unlikely for such a long edifice.

Figure 6. Tzikin Tzakan, two thirds of the length of this room (there is one more doorway out of view to the right). This is the longest single room yet recorded for the Peten, and possibly the longest single undivided Maya palace room outside of Palenque. According to reports this entire palace collapsed in a single moment due to excessive weight of water which soaked into the vault mass. I do not know whether this is the inner room (in which case the outer room fell long ago) or whether this is a single range structure, which I would find unlikely for such a long edifice.

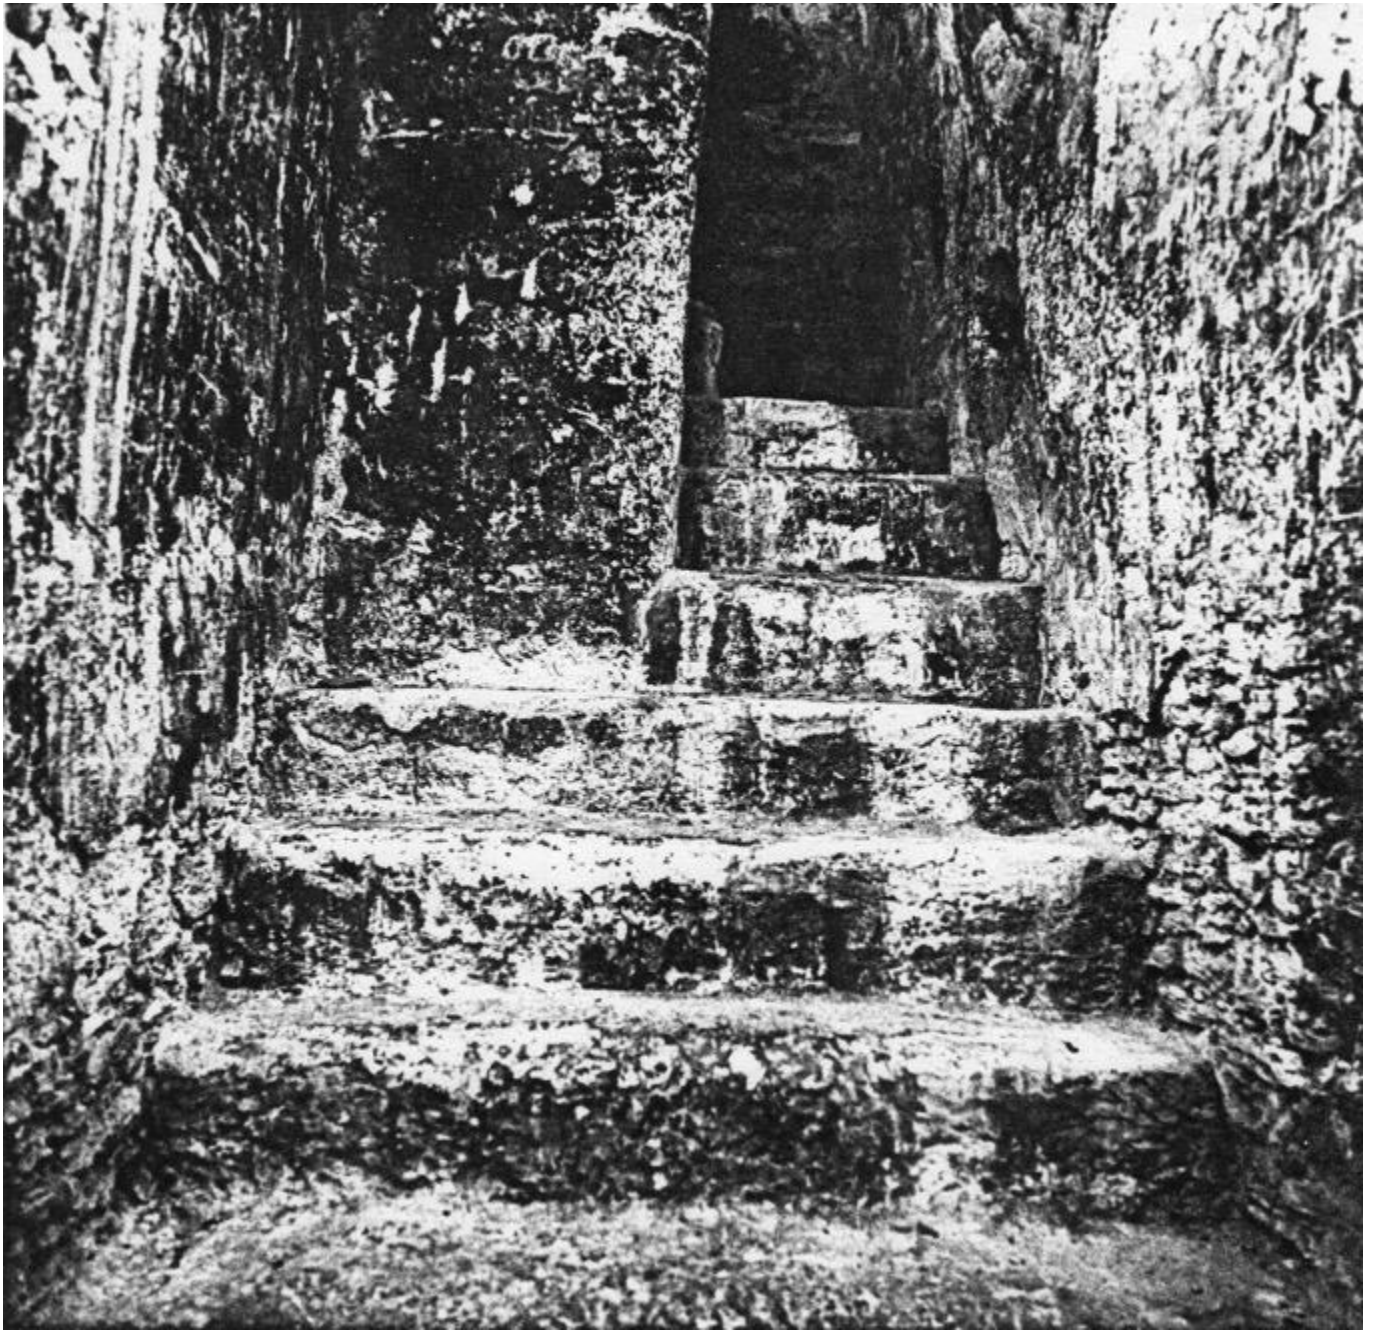
Figure 8

Figure 8. Tikal, Central Acropolis, Early Classic, structure 50-46 first floor, looking at stairway leading to the second story.

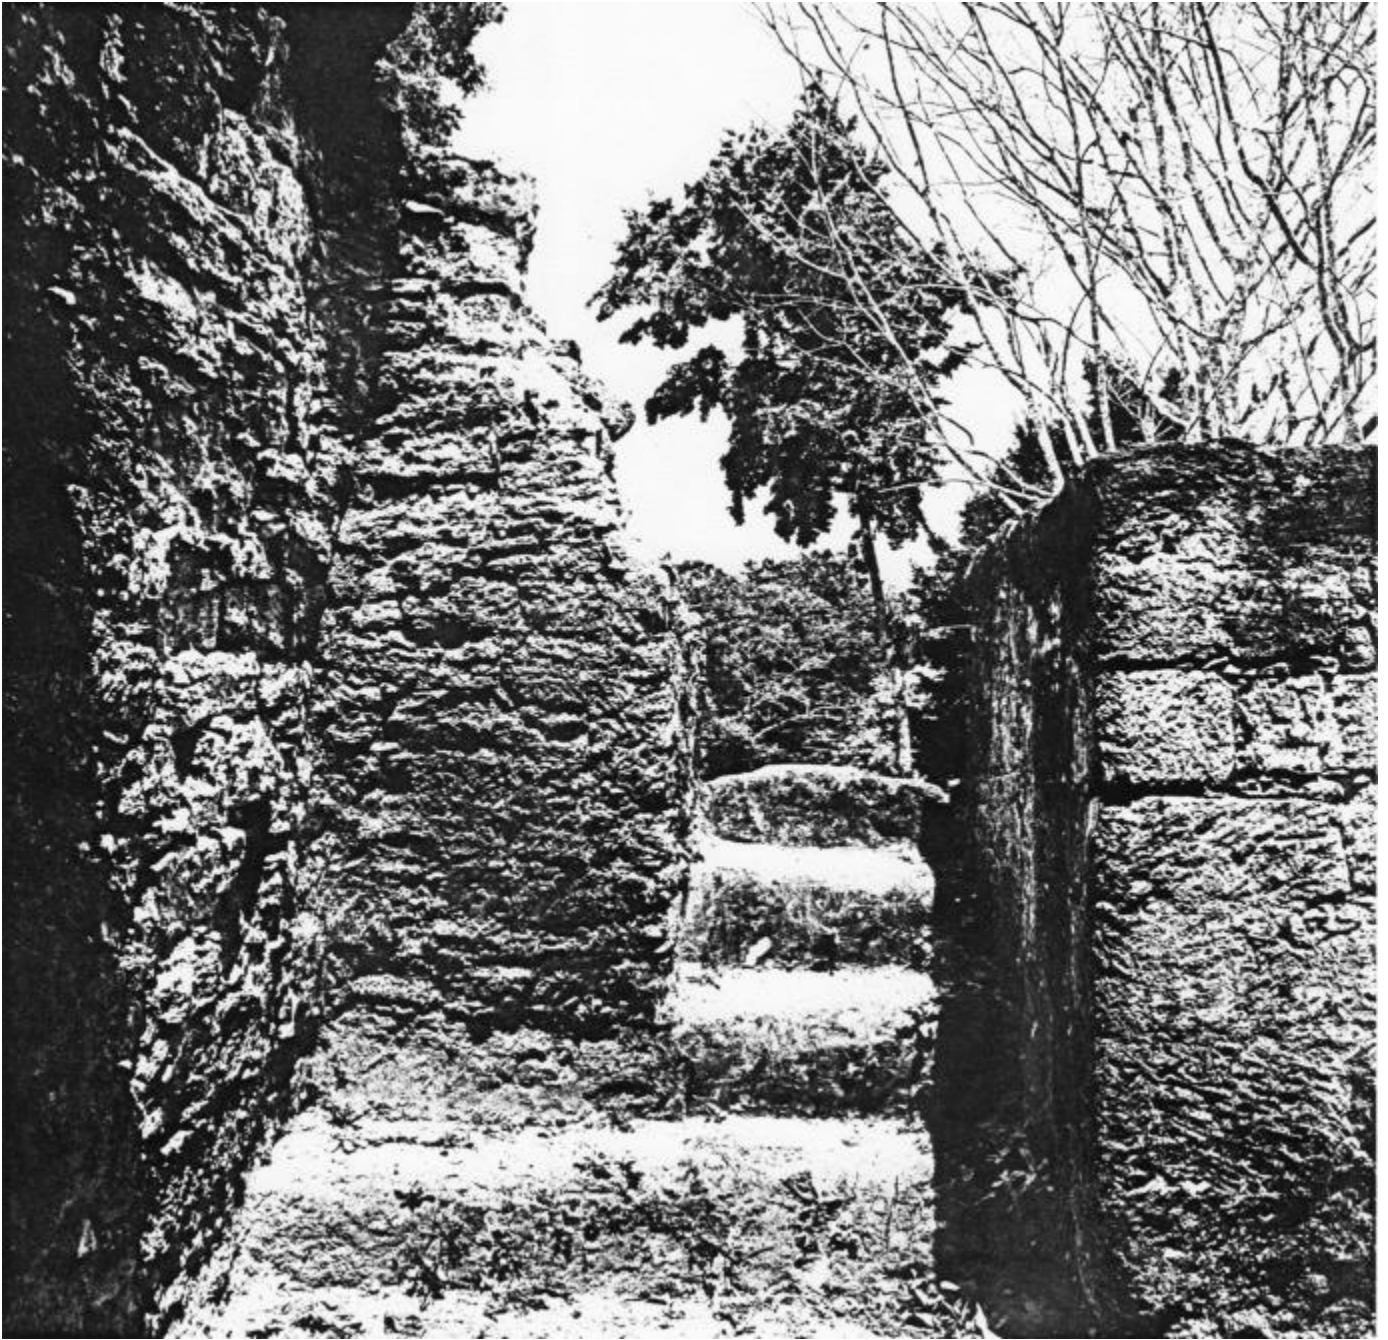
Figure 9

Figure 9. Tikal, Structure 50-54 elsewhere in the Central Acropolis, seemingly Late Classic (based on masonry size and shape), yet the beginning of stairway to second floor appears essentially the same as Str. 50-46, beginning at full room width, then changing to half width with the rest of the space taken up by a solid pier.

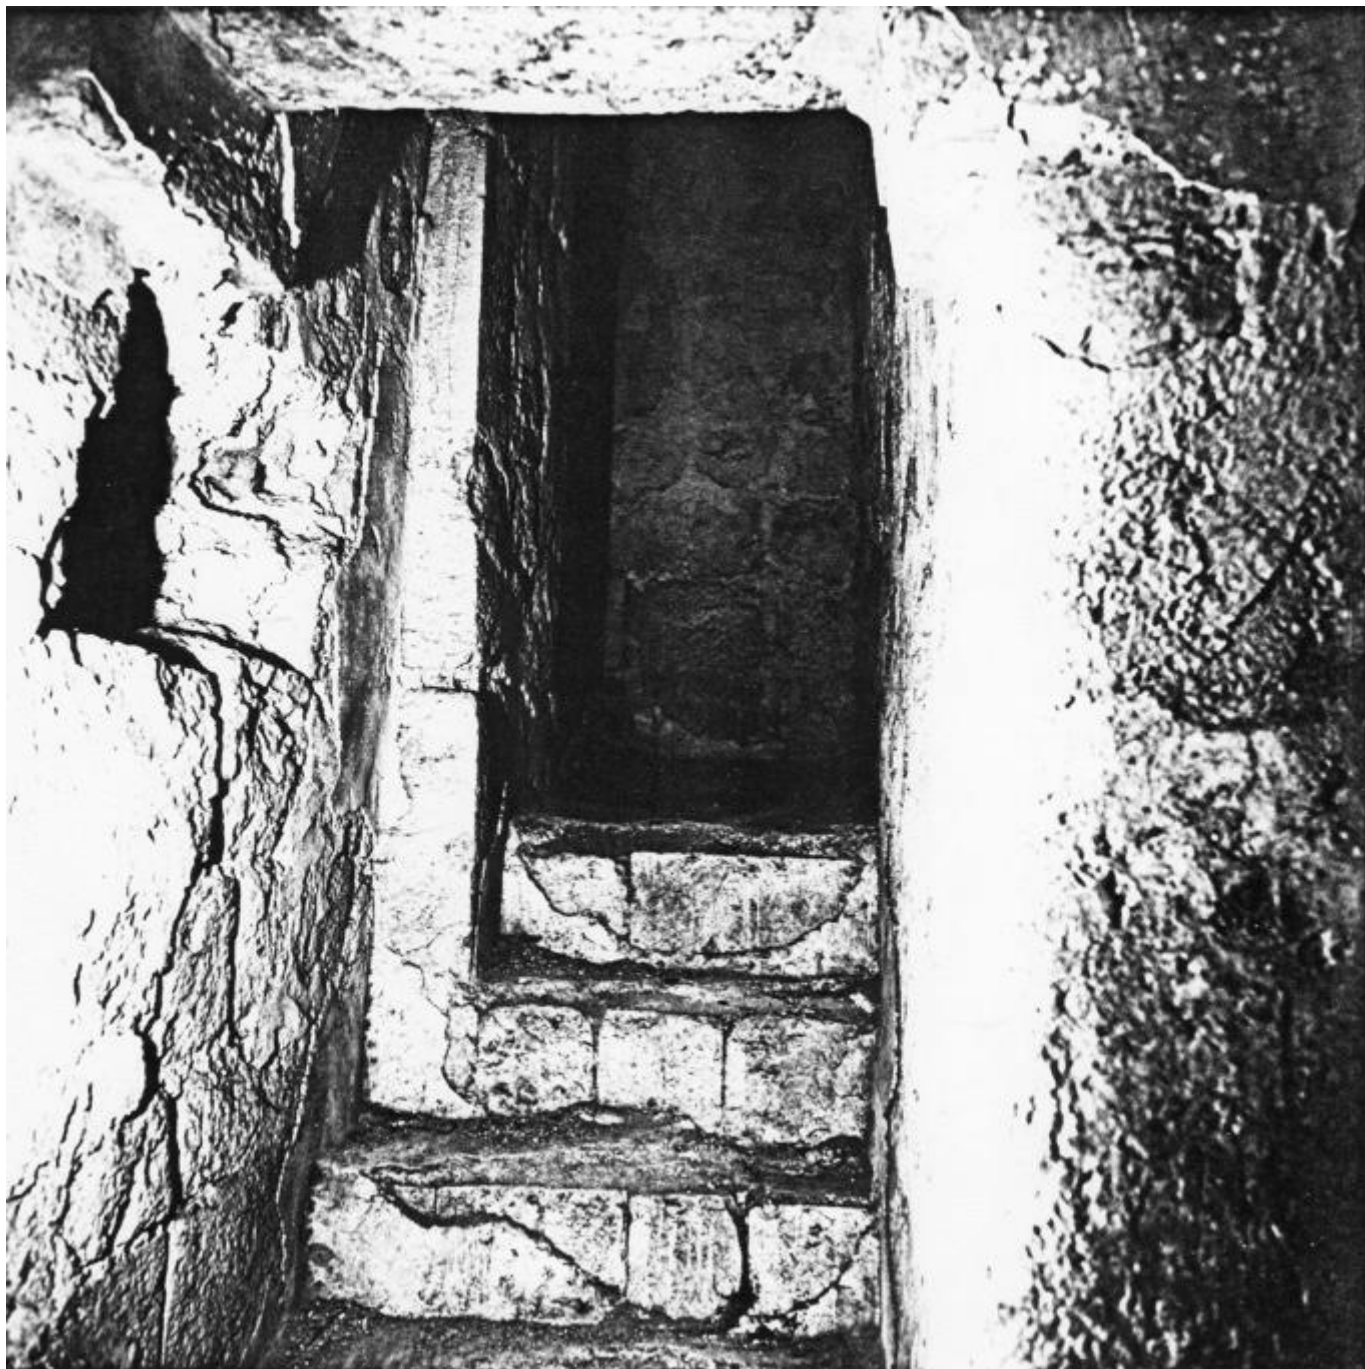
Figure 10

Figure 10. Xtampak, Main Palace, North Interior Stair, first floor. Hole in wall at left is possibly where decorated stone was ripped out by looters (possibly reused mosaic or sculpted). Maler mentions such stones. Two are still present elsewhere in the interior stairways, but not attractive enough to have enticed looters to steal them.

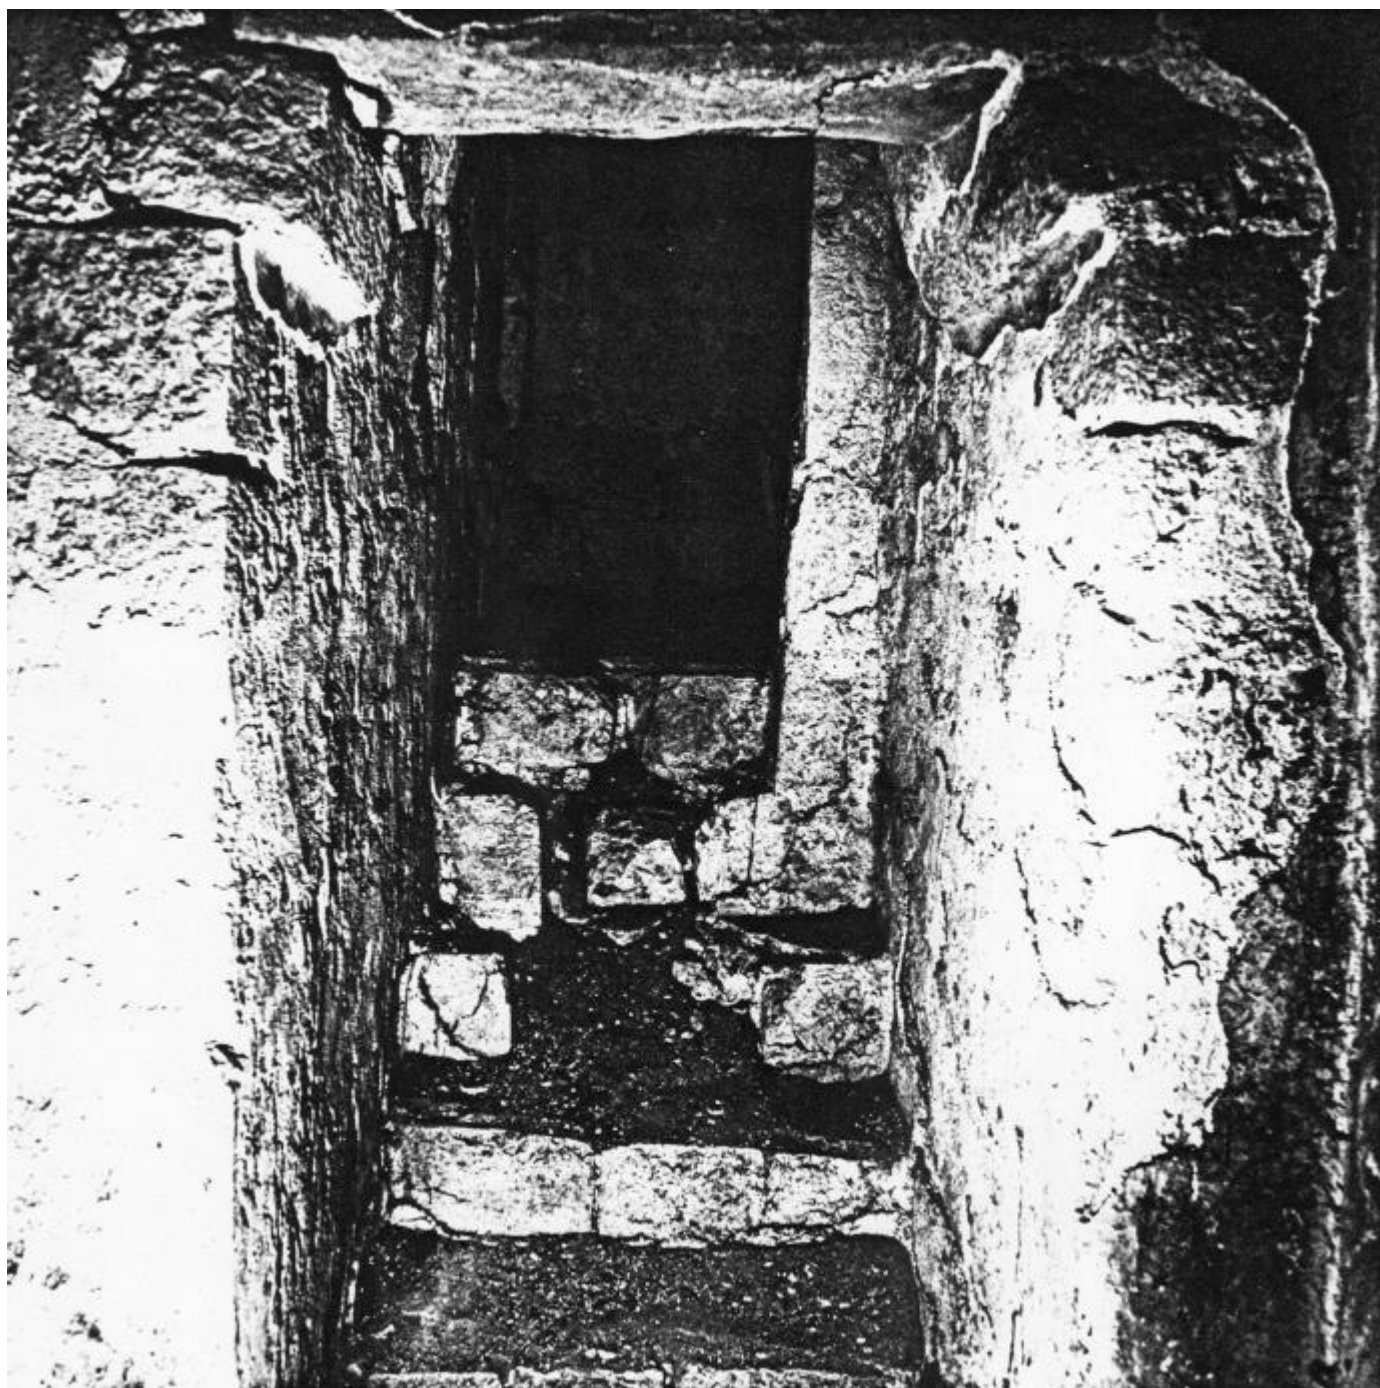
Figure 11

Figure 11. Xtampak, Main Palace, South Interior stair, first floor, showing deterioration of this stairway. Notice stepped lintel, and compare with that of North Interior stair in previous photograph. Position of photography is about mirror image of the two systems.

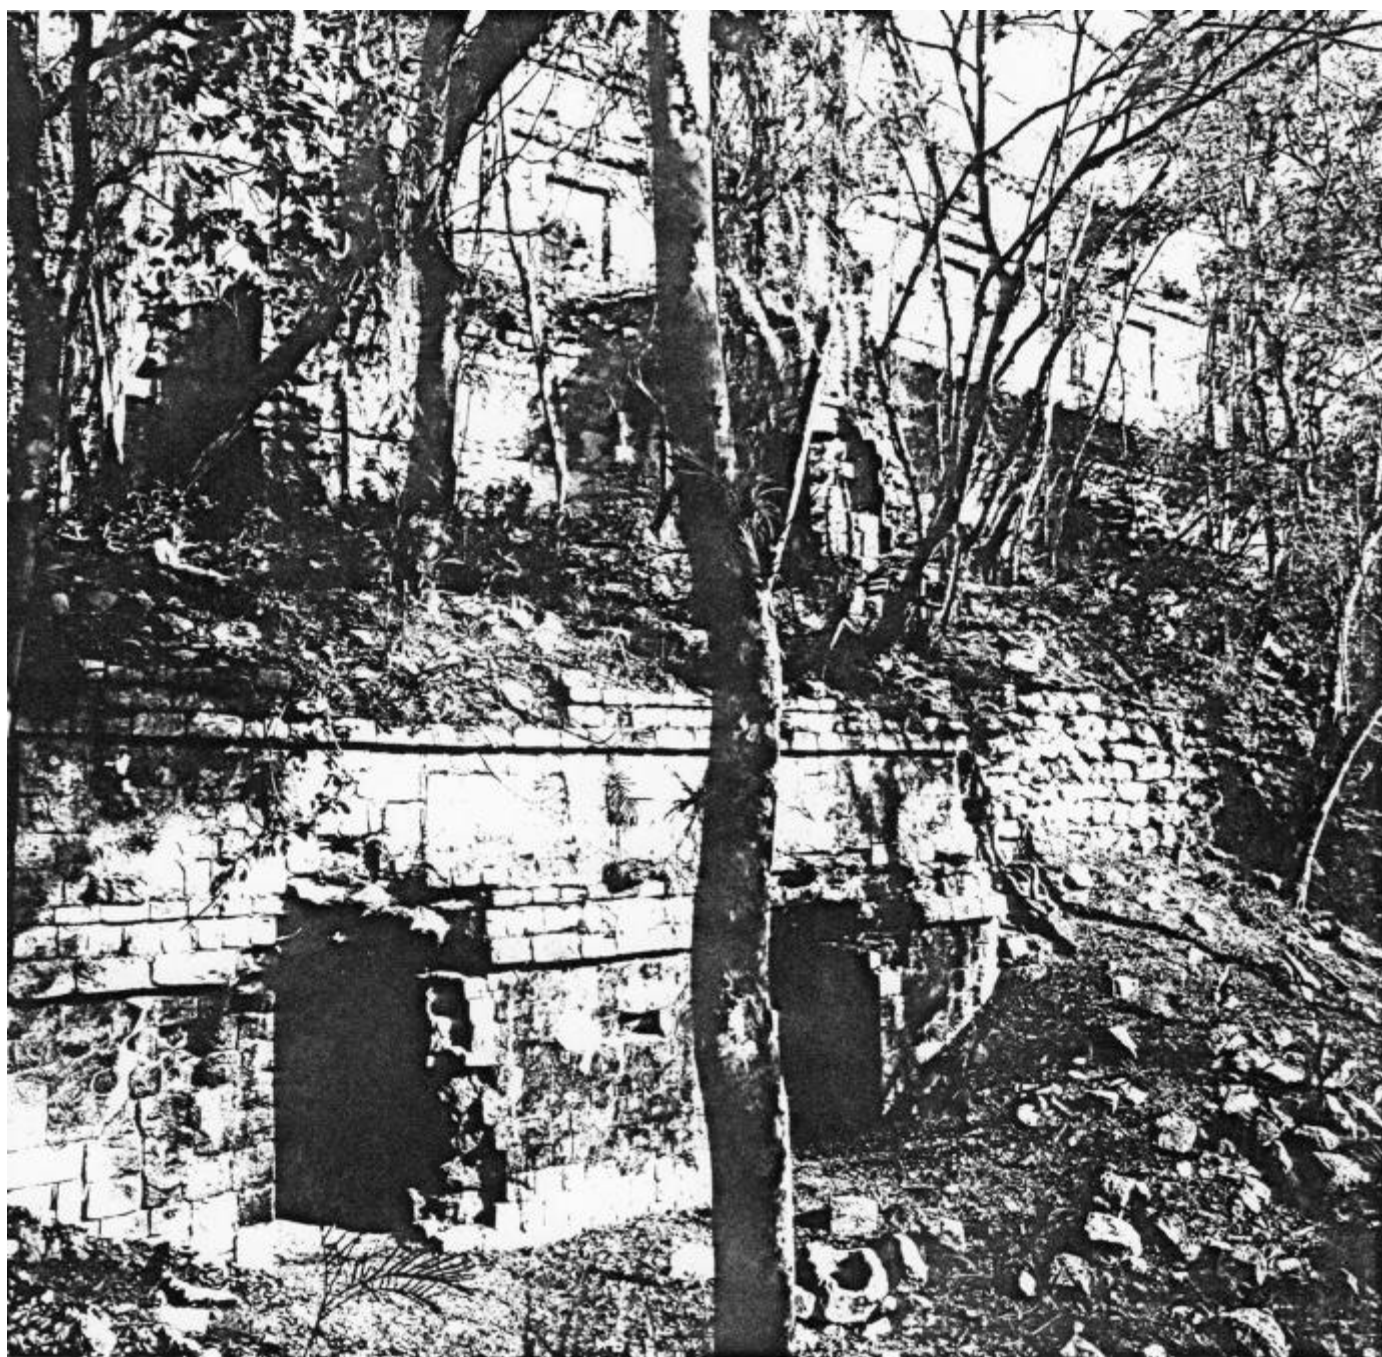
Figure 13

Figure 13. Xampak, Main Palace, back (west) showing all three stories (recessed panels show up well on the third floor). At right of the photograph is the exterior stairway, with the same kind of core wall replacing the finish masonry. If this same type of core wall always had a stairway over it, then you can estimate how many stairways existed on the sides of the Main Palace and also on the flanking towers of the front.

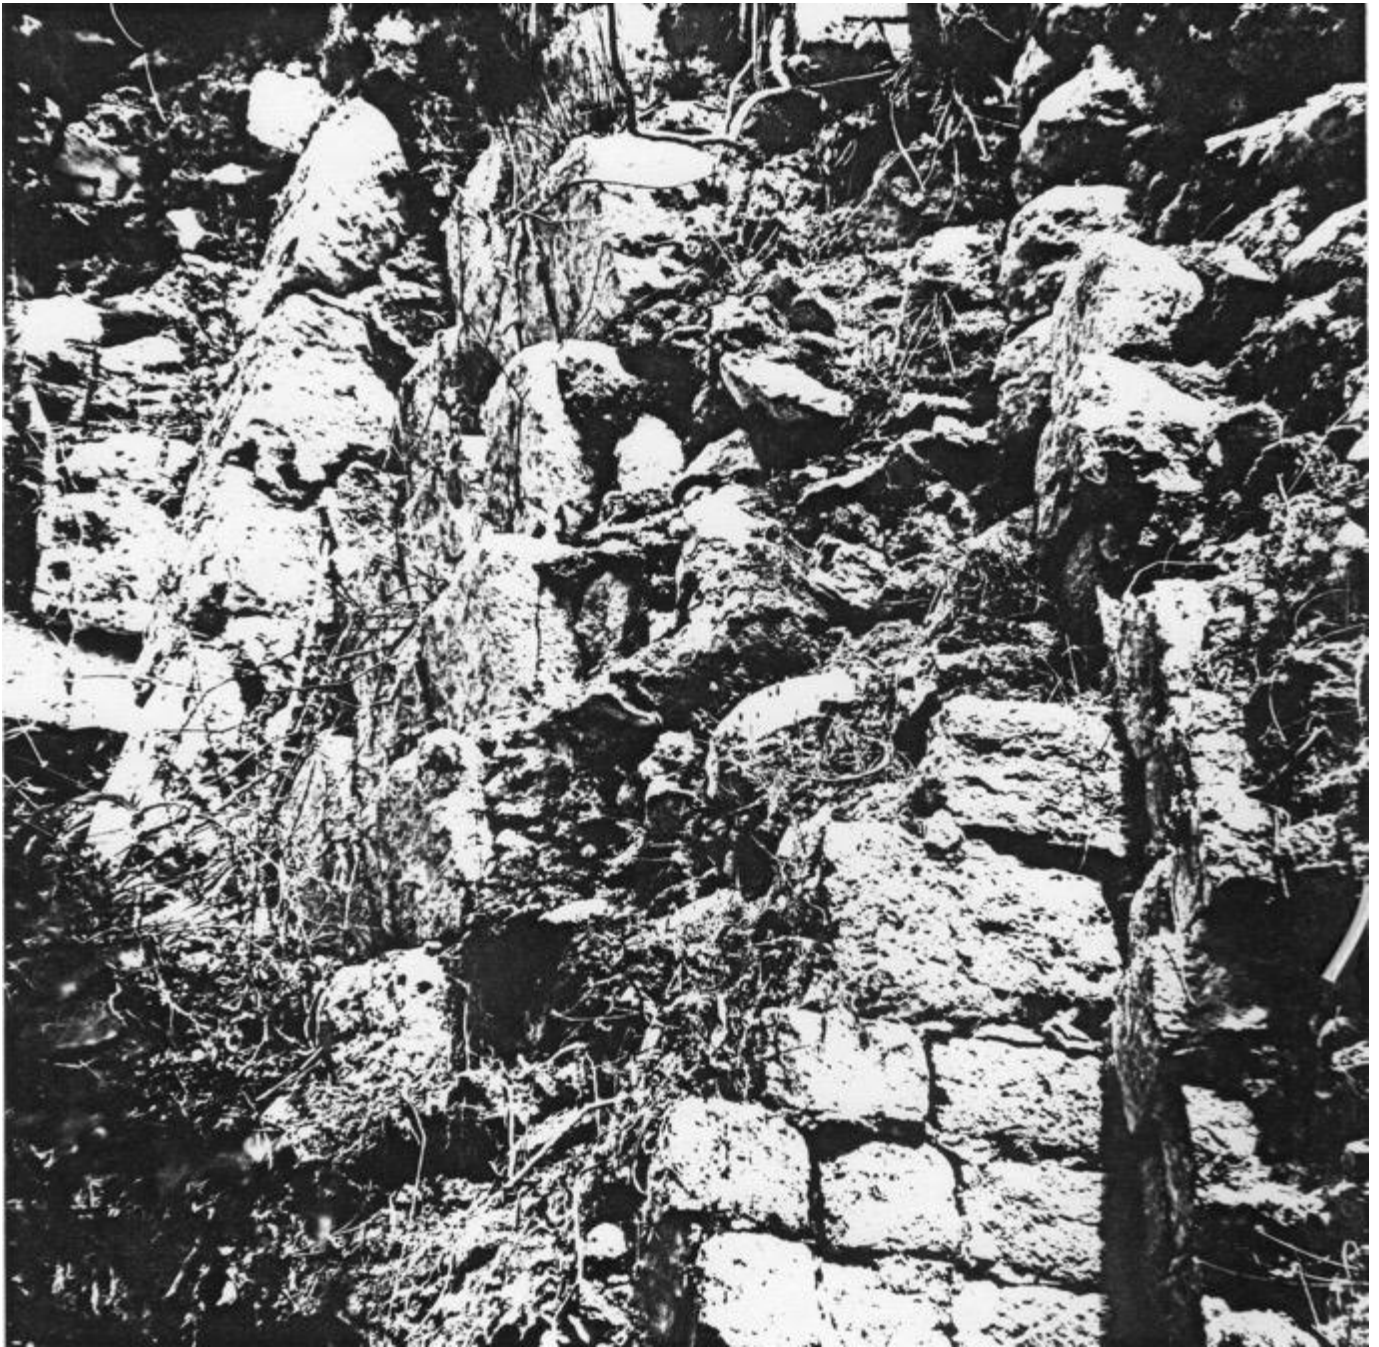
Figure 14

Figure 14. Xtampak, Main Palace, front (east), second floor, view of the remaining steps of special stairway with balustrade, first noticed and published by George Andrews (1988). The facing masonry in foreground is of the main front central stairway.

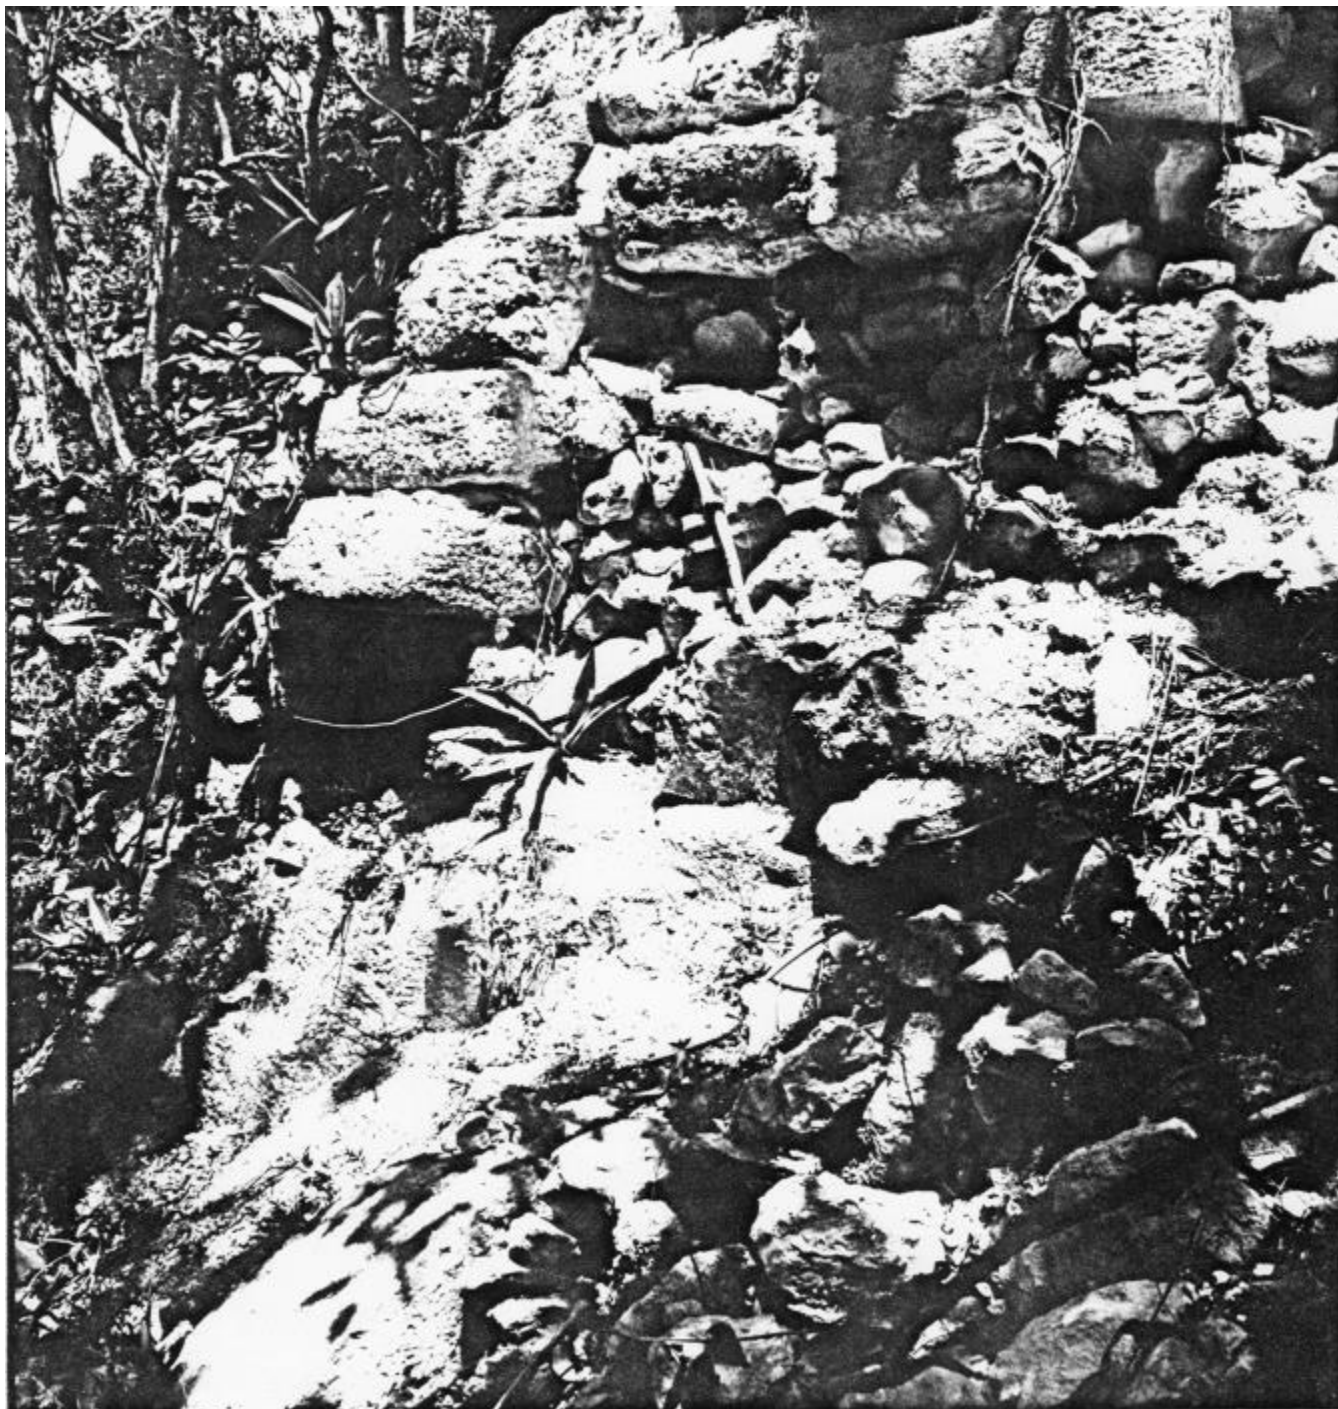
Figure 15

Figure 15. Half way up the main front central stairway, Main Palace, looking west. The top five steps are of the nicely hewn "2nd stage." Several steps of the "first stage" are in the shadow to the left, lower than those of the 2nd stage. Underneath the 2nd stage steps is loose rubble fill (fill with no mortar). Note that the 2nd stage steps start all of a sudden and have not yet been found directly covering the first stage steps. Santa Rosa Xtampak. 451608-4-Neg.14.

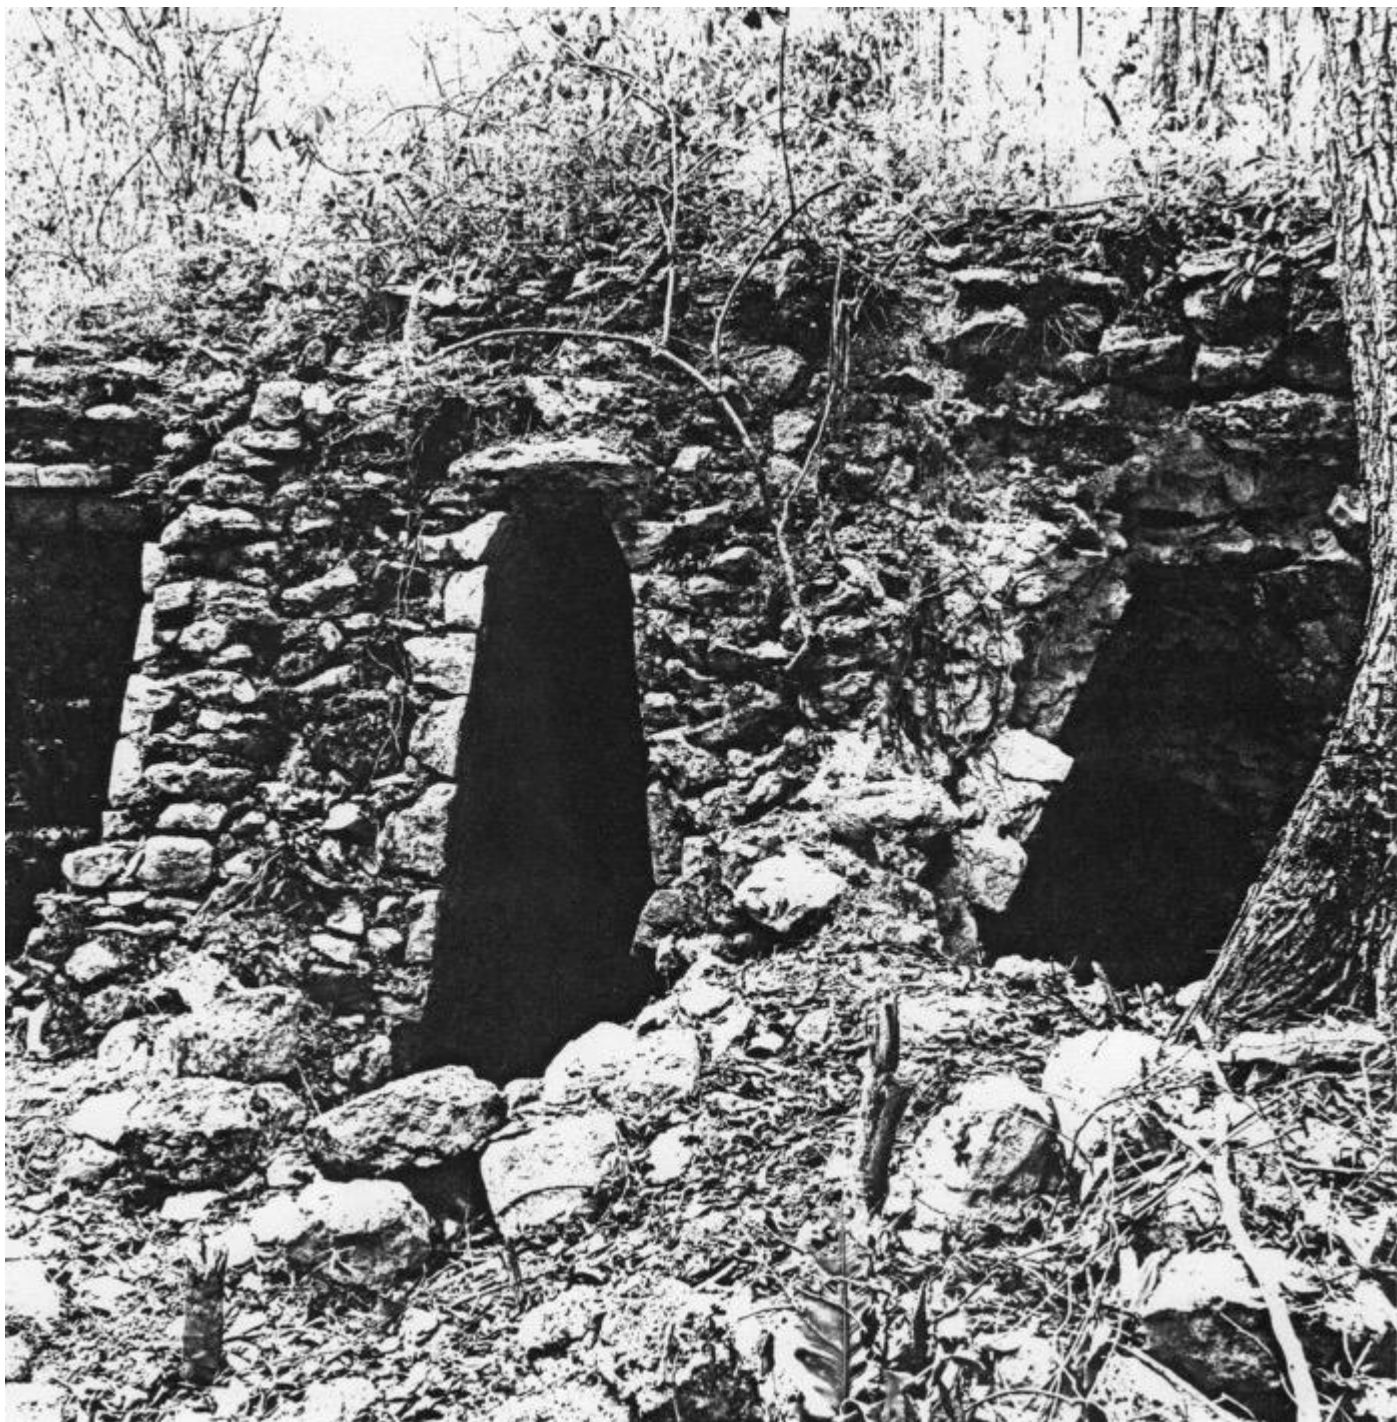
Figure 18

Figure 18. Southeast Quadrangle, southeast corner, with the Entrance Passageway in the middle, Room 3 of the East Range to the left, a room of the South Range to the right. If this passageway is secondary this does not show up in the cross-section revealed by the collapse of the front facade which exposes the core. Santa Rosa Xtampak. **451608-15-Neg.25.**
