FIRST SEASON PHOTOGRAPHY AND  
ANALYSIS OF STANDING ARCHITECTURE

at  
SANTA ROSA XTAMPAK,  
CAMPECHE, MEXICO

Nicholas M. Hellmuth

July 1989

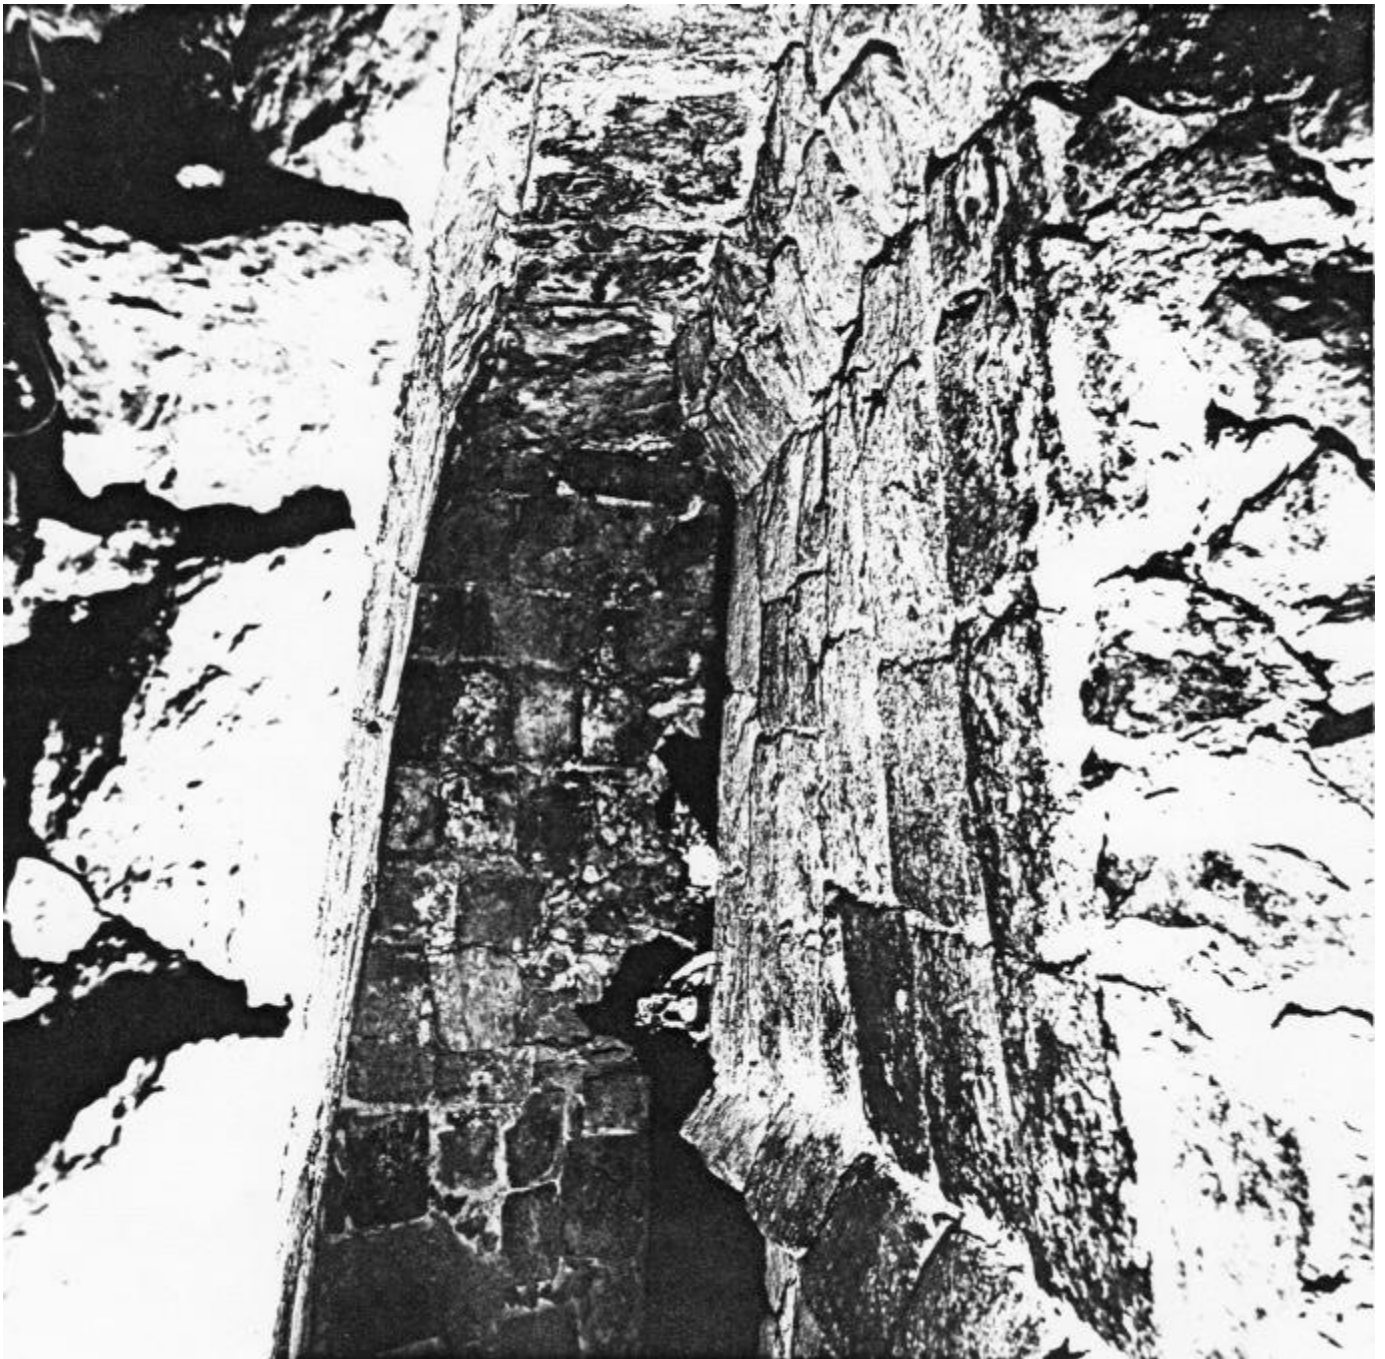
Figure 19

Figure 19. Xtampak, Southeast Quadrangle, The Entrance Passageway, looking easterly. On the right is the "incomplete" medial molding. In far background is light streaming in from the far end of the final exit. Note differing slant of both walls, and the last minute "corbel vault" consisting of only one course, with a sub-capstone framing course also serving as corbel.

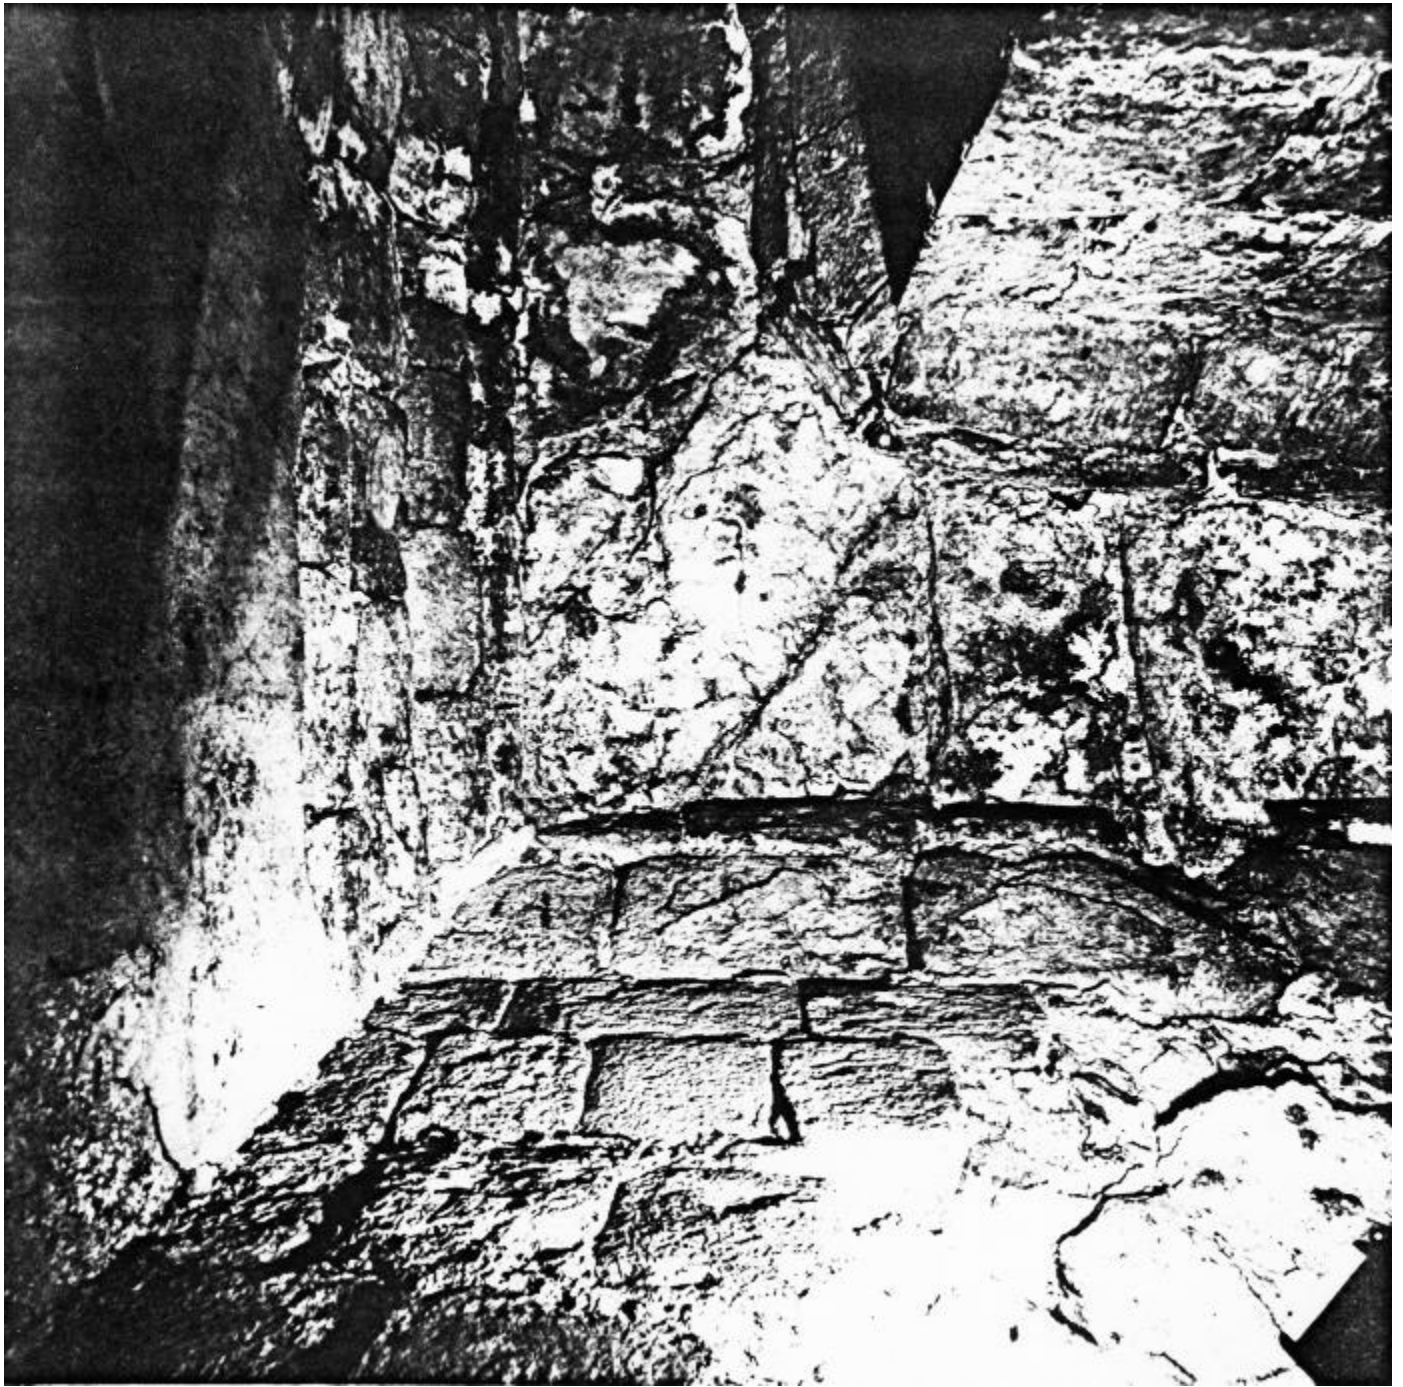
Figure 21

Figure 21. Xtampak, Southeast Quadrangle, capstones of Entrance Passageway turning corner into the narrower arm of the inner passageway. Note the widening of the capstone span at the turn, a highly unusual feature of Maya architecture, present also in the exit passageway.

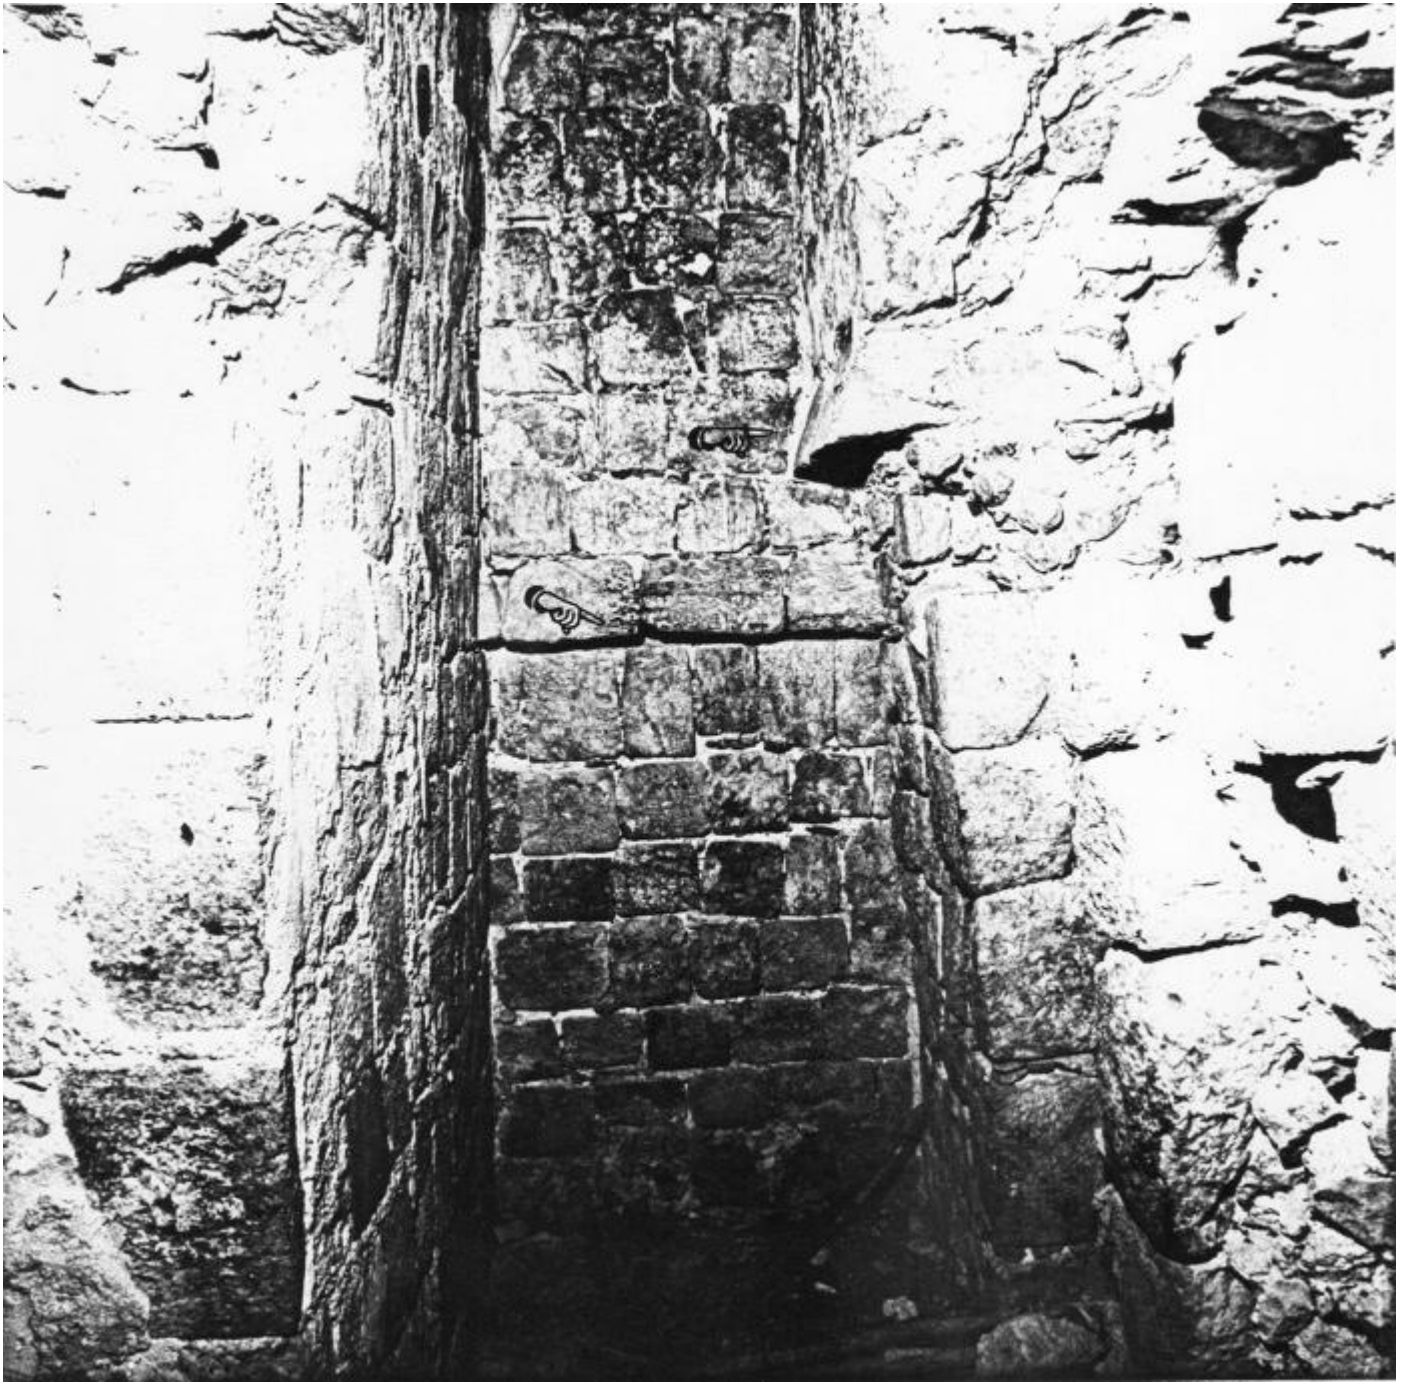
Figure 23

Figure 23. Looking south down the dead-end passageway. The end wall is of the South Range as is the wall to the right with the higher "partial" medial molding. Southeast Quadrangle, Santa Rosa Xtampak.

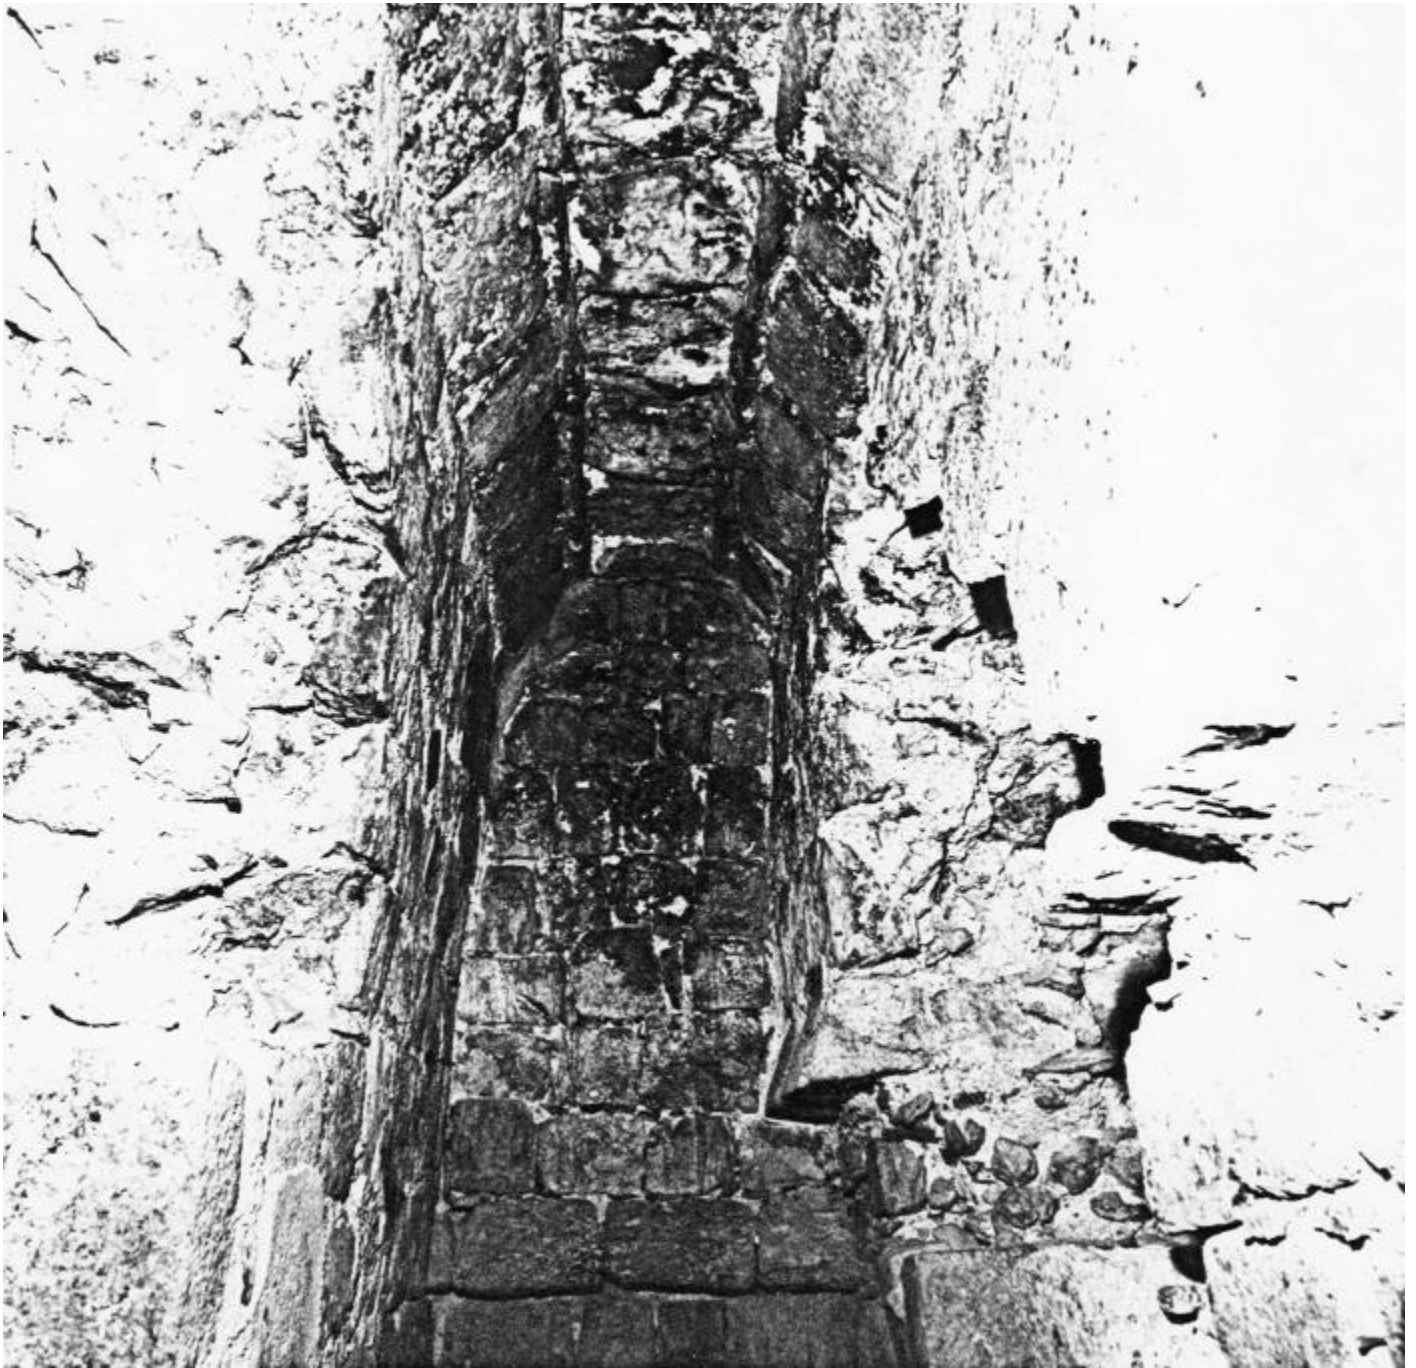
Figure 24

Figure 24. View looking up at the wobbly wall on the left and the incomplete medial molding on the right. The "vault" is only one course high, but on both sides a different height. This is slightly different than the partial vault course arrangement of the entrance passageway that leads into this. Looking south down the dead-end passageway. Southeast Quadrangle, Santa Rosa Xtampak.

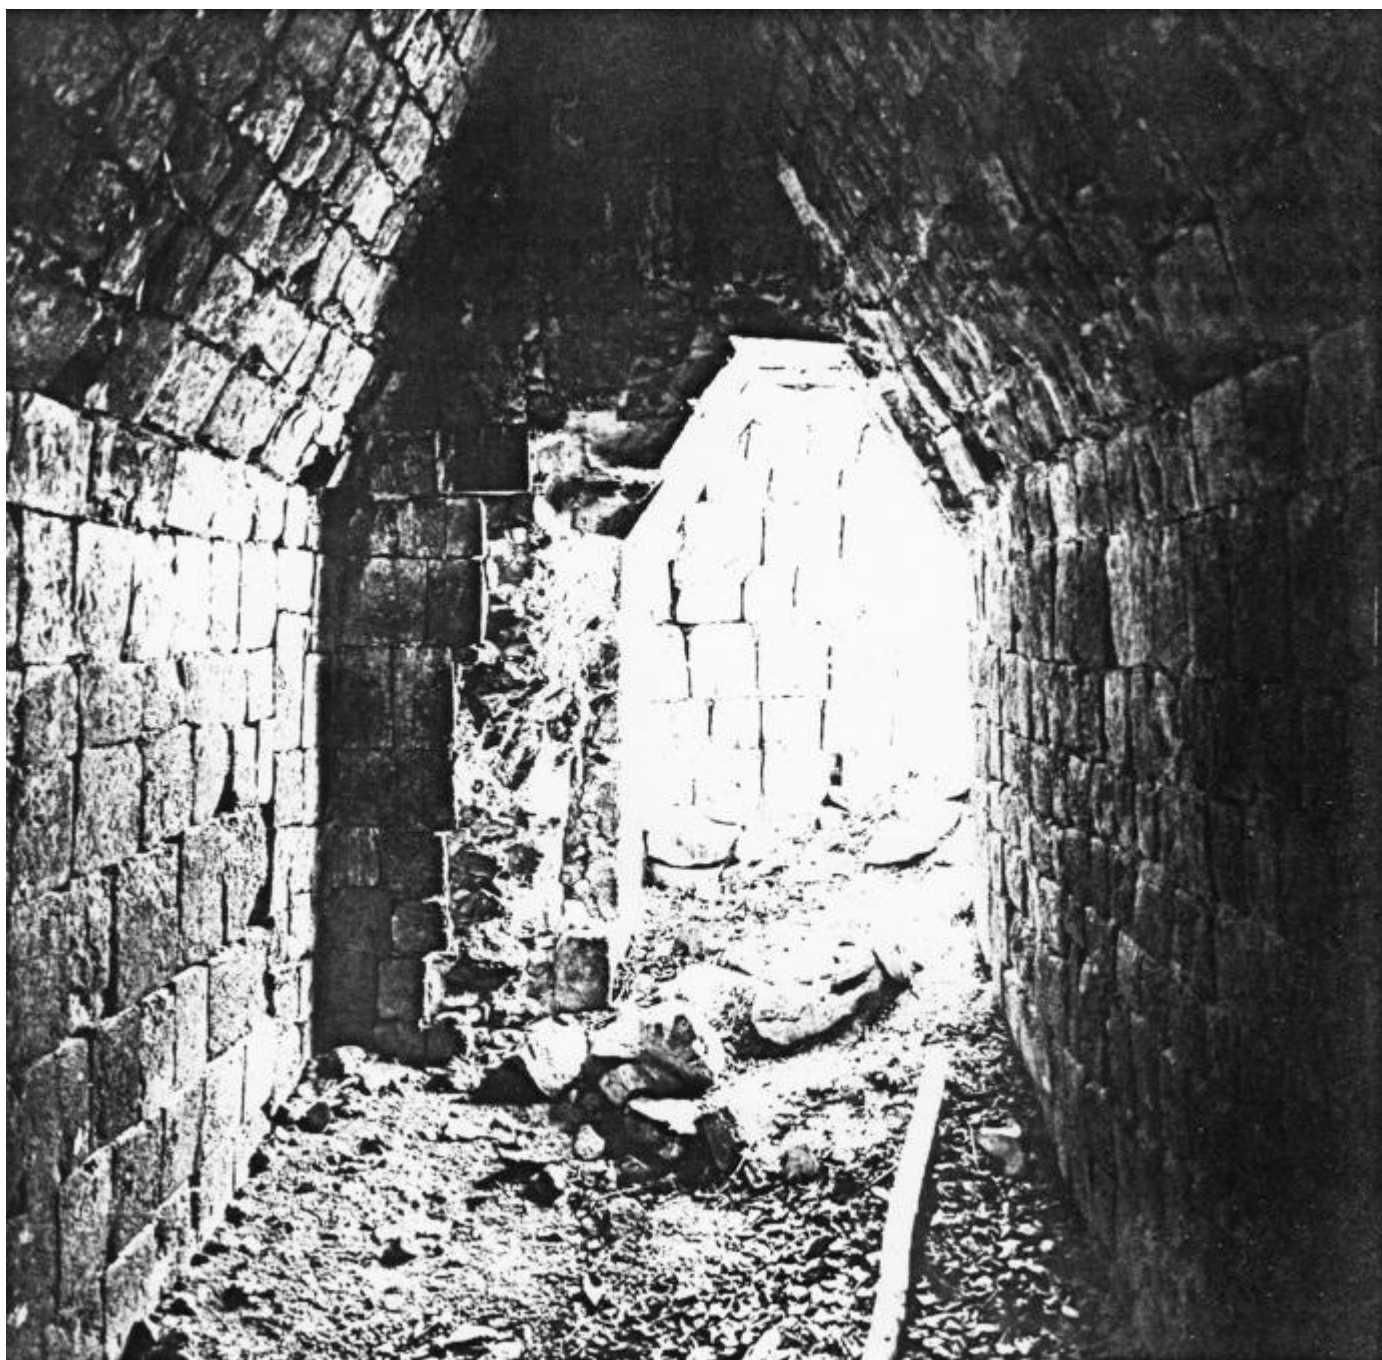
Figure 26

Figure 26. Xtampak, Southeast Quadrangle, the room at the corner. Two passageway links provide entrance; the wider passageway exists at far right. Note complete difference in size of masonry, large on north wall, normal on right wall. The difference in vault/capstone height at the end wall is highly unusual--as is the passageway system overall.

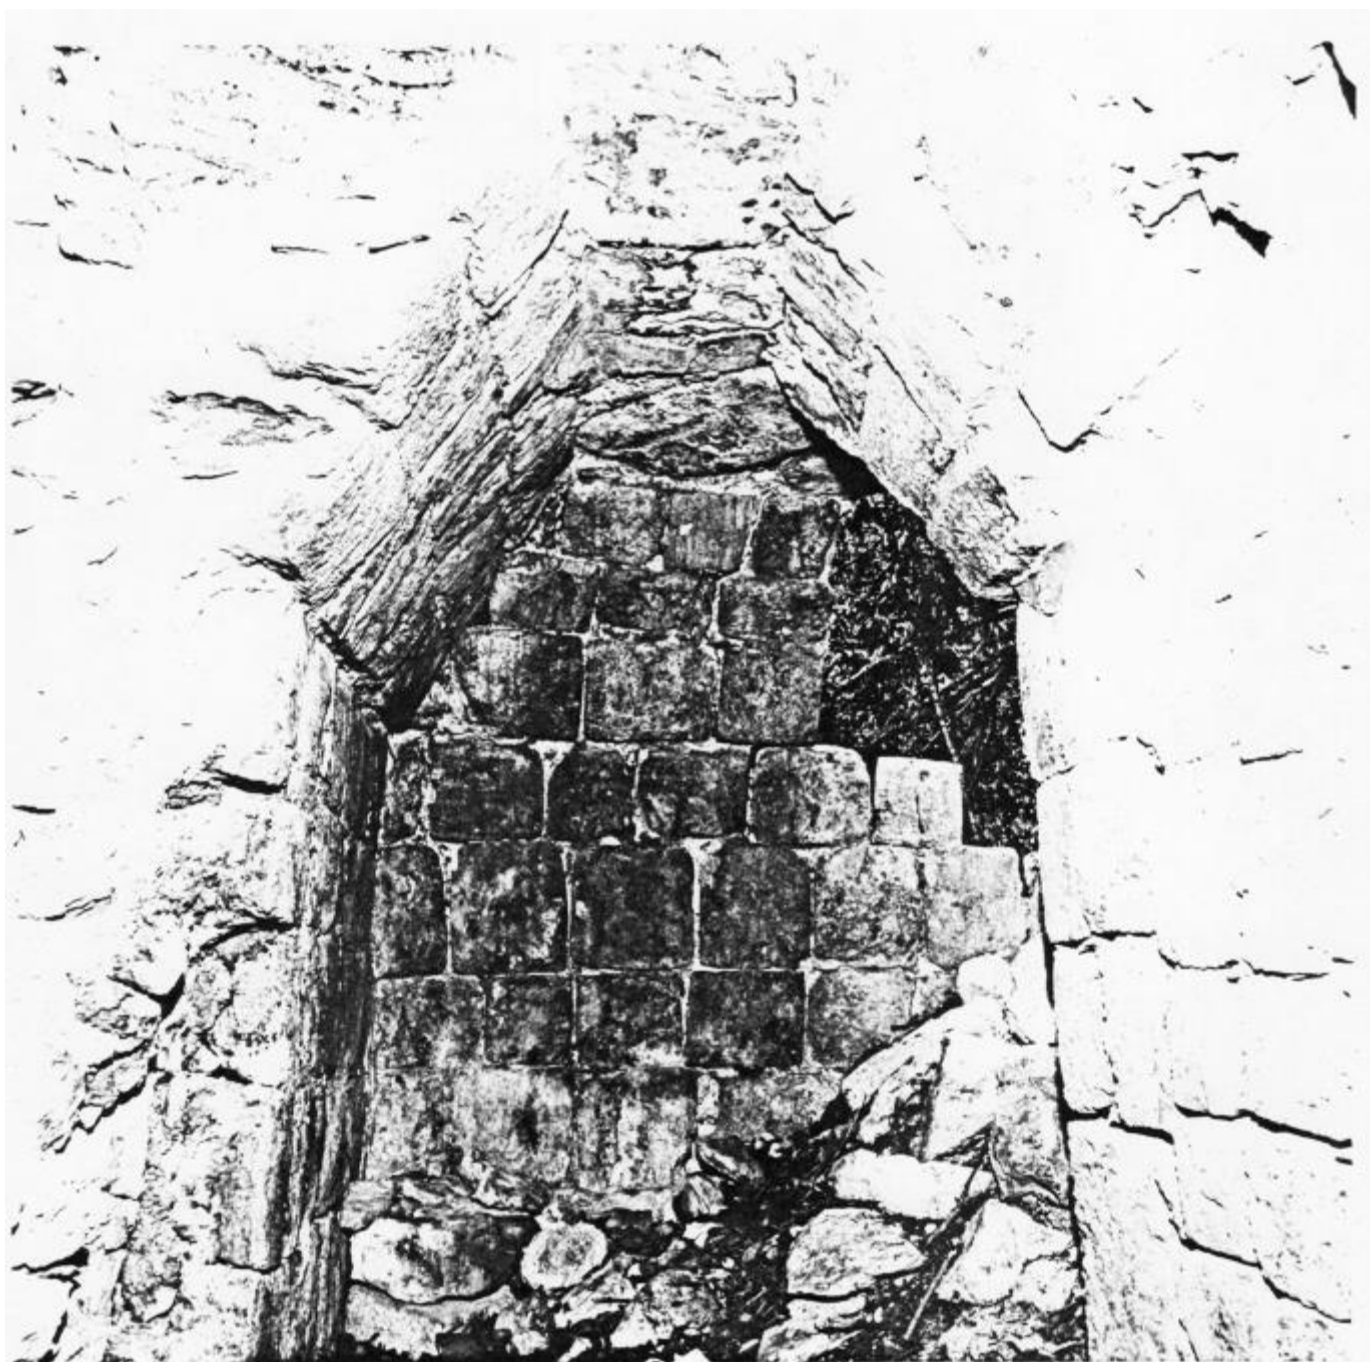
Figure 28

Figure 28. Entrance to the wider passageway going east before it turns 90 degrees and runs south. The diagonal capstone at the 90 -degree turn can be seen in the upper background. Southeast Quadrangle, Santa Rosa Xtampak.

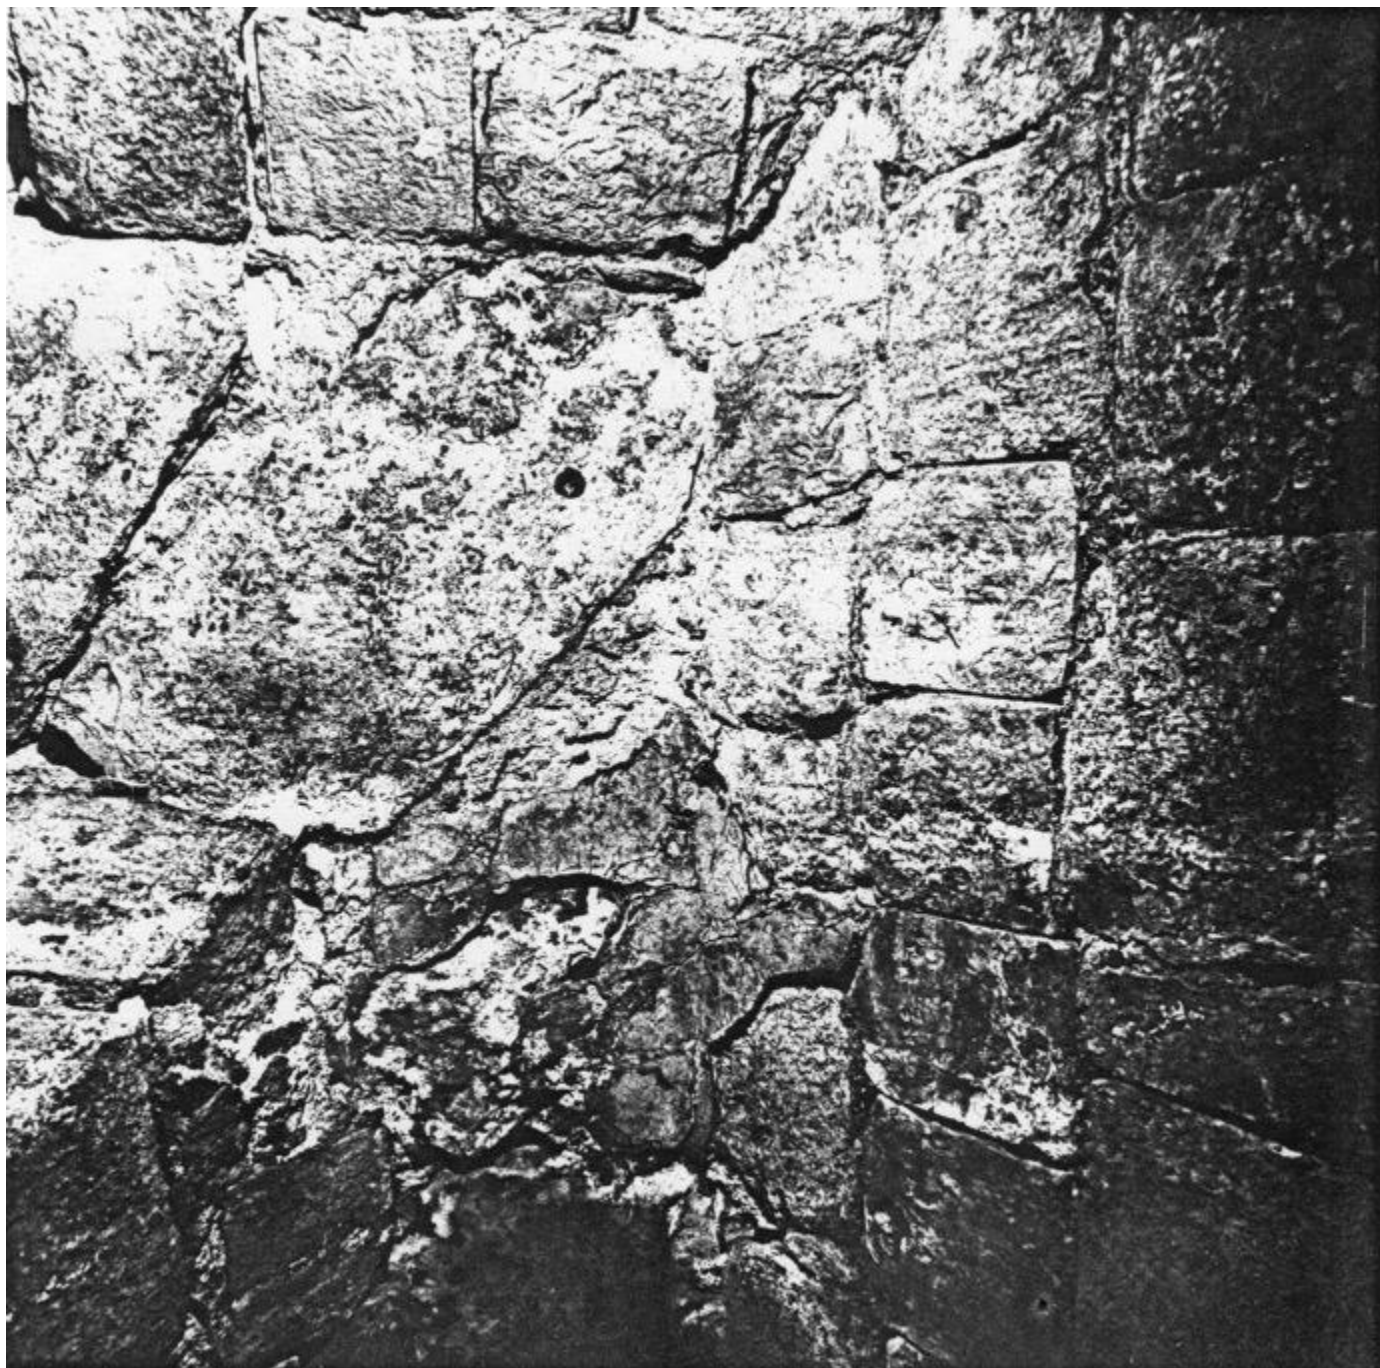
Figure 29

Figure 29. Xtampak, Southeast Quadrangle, capstones of the wider passageway that exits out the back of the quadrangle corner. Note diagonal placement at the corner, and that this "vault" lacks the framing course immediately under the capstone.

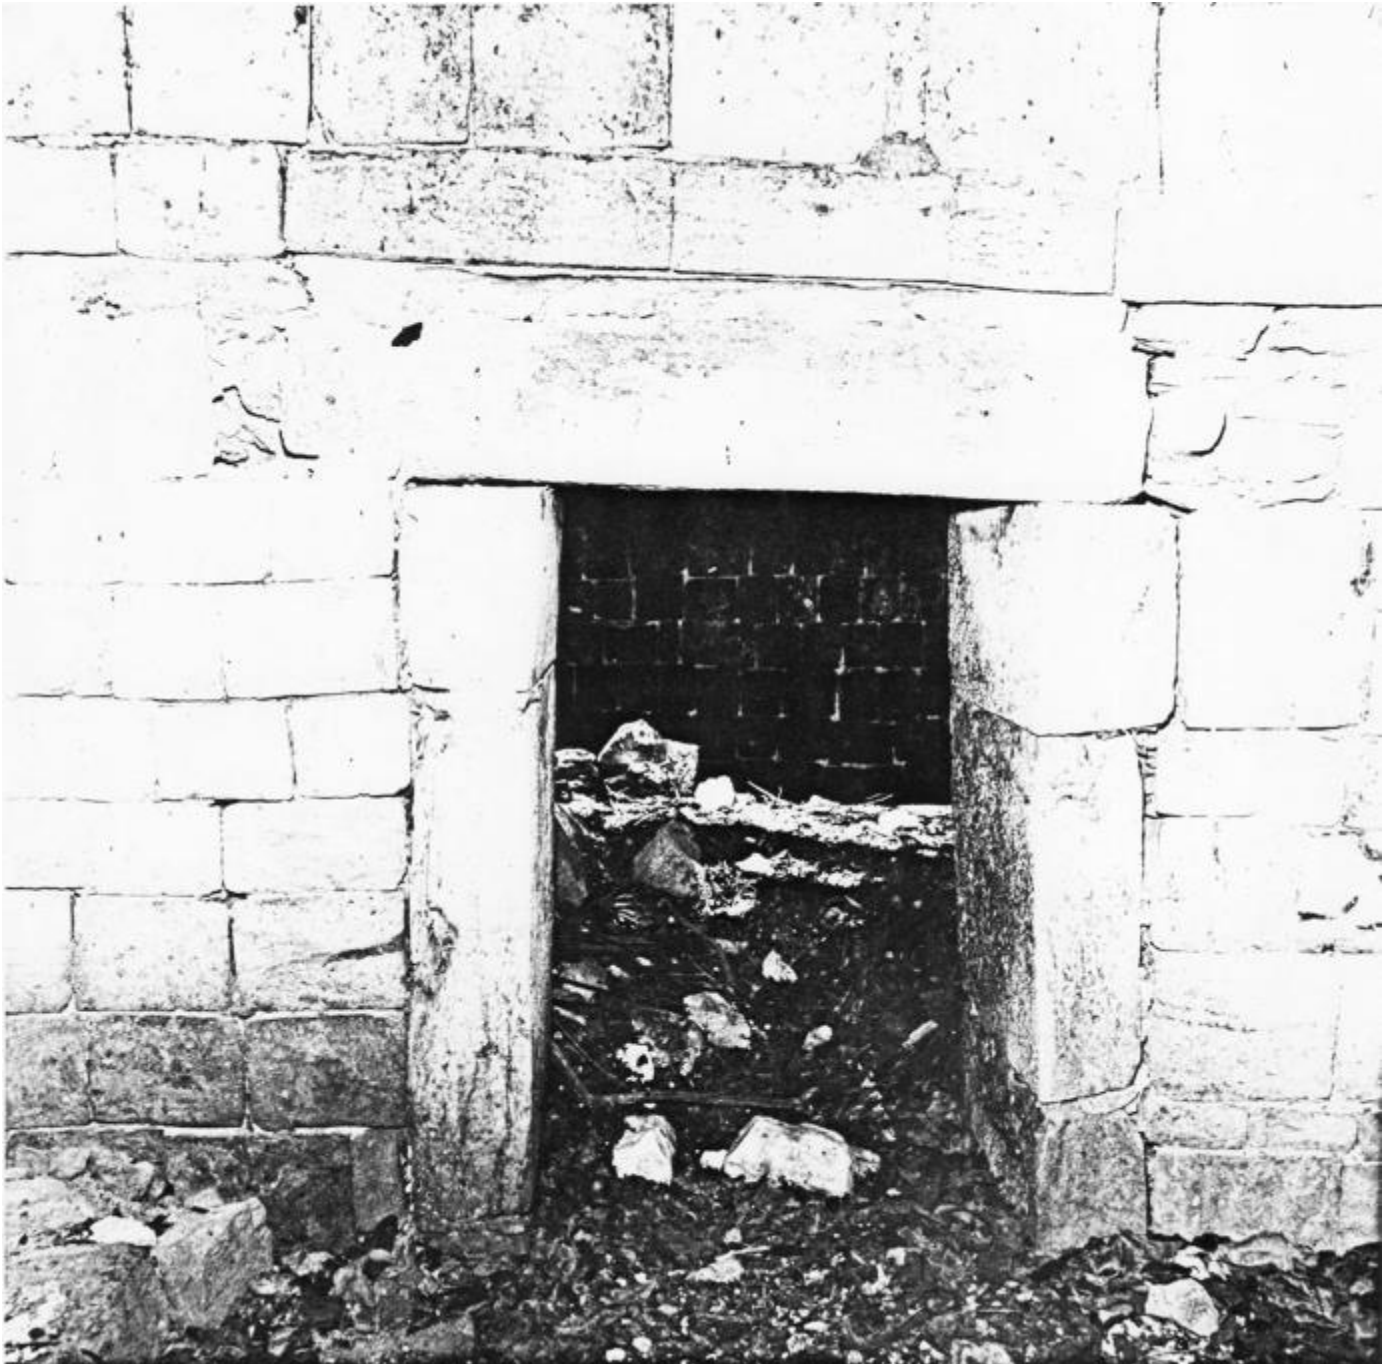
Figure 30

Figure 30. Inside the Southwest Building showing the inner doorway between two rooms. Such stone lintels are (in this part of Mexico) exclusively a Puuc architectural trait.

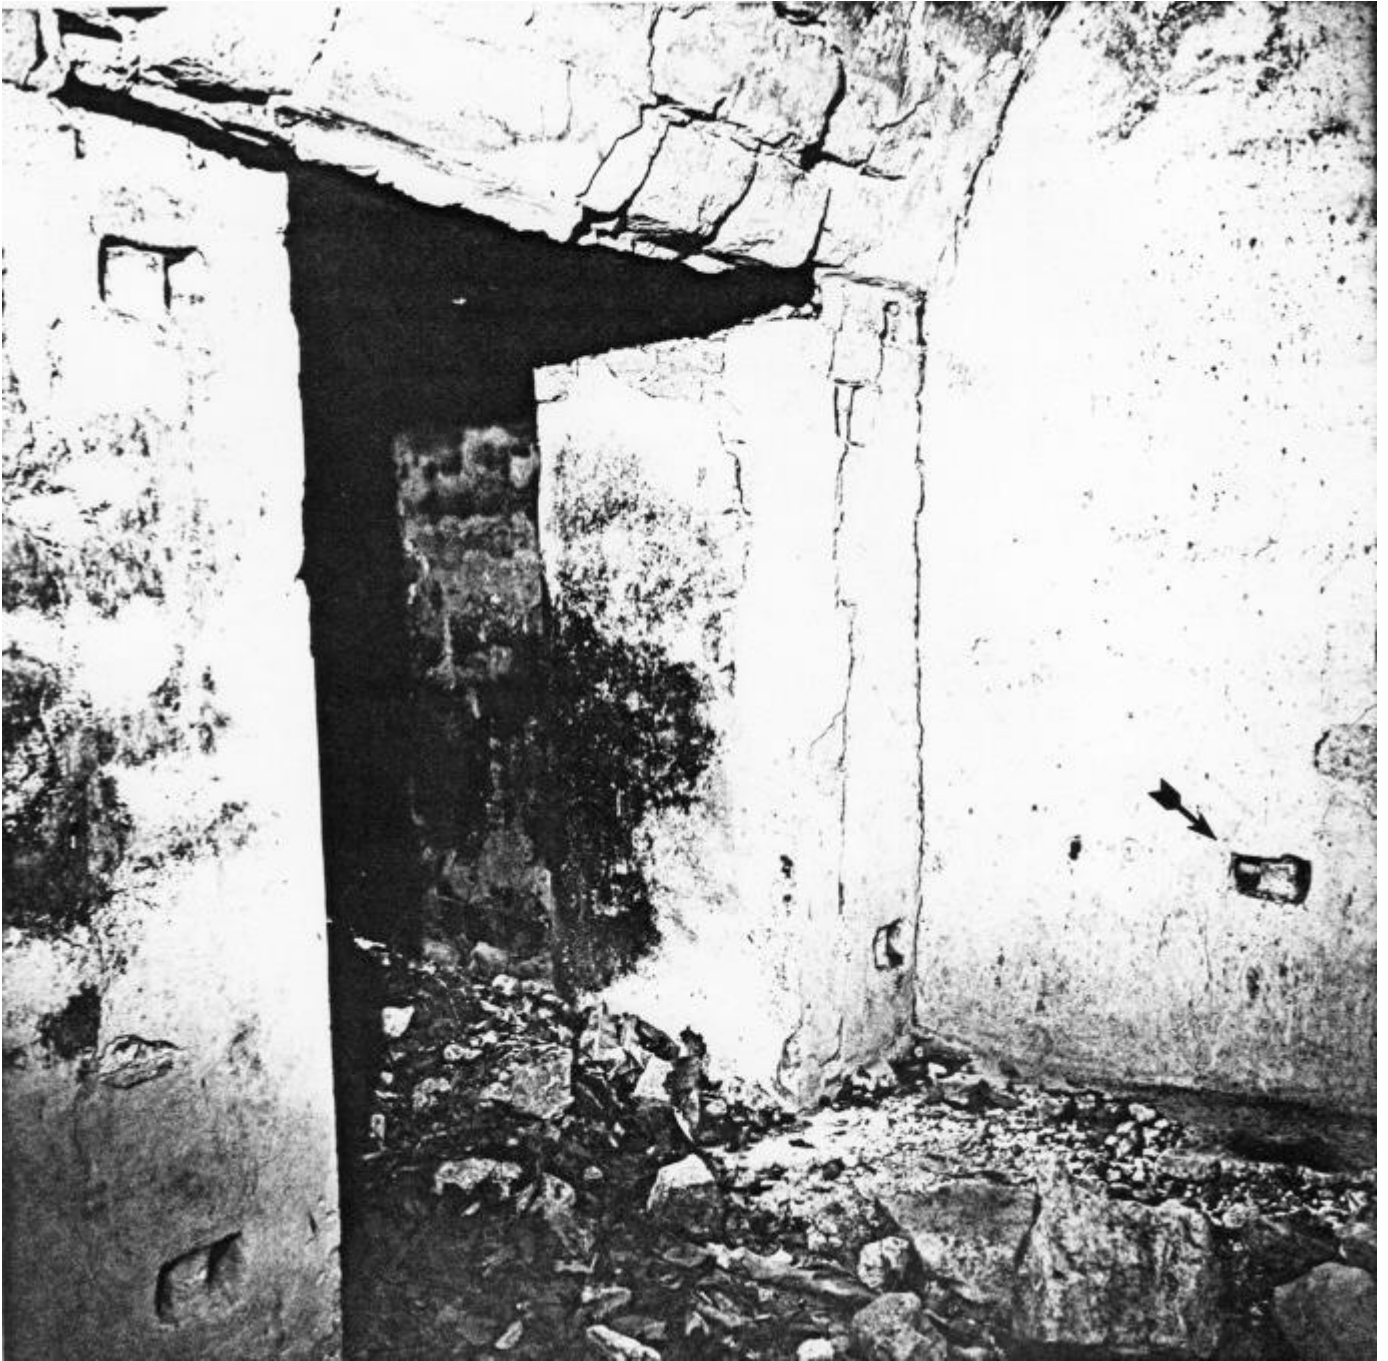
Figure 31

Figure 31. Main Palace, Room 26 looking north showing the various cord holders, including an unusual one in the end wall. These photographs are among the first every taken with artificial illumination inside a Chenes building. A goal of the Foundation for Latin American Anthropological Research is to apply its considerable photography experience and equipment to salvage a record of the architectural history of ancient Mexico.

Figure 31. Main Palace, Room 26 looking north showing the various cord holders, including an unusual one in the end wall. These photographs are among the first ever taken with artificial illumination inside a Chenes building. A goal of the Foundation for Latin American Anthropological Research is to apply its considerable photography experience and equipment to salvage a record of the architectural history of ancient Mexico.
