**Notes on "ROOM-#5-SUITE"
of the South-East Quadrangle
of the ruins at
"SANTA ROSA XTAMPAK,"
Campeche, Mexico**

Jack Sulak

August 27, 1992

With references to drawings and photographs by Jack Sulak, based on cross-section drawings and other measurements by Susanna Reisinger and Jack Sulak in August, 1989. No excavation was involved.

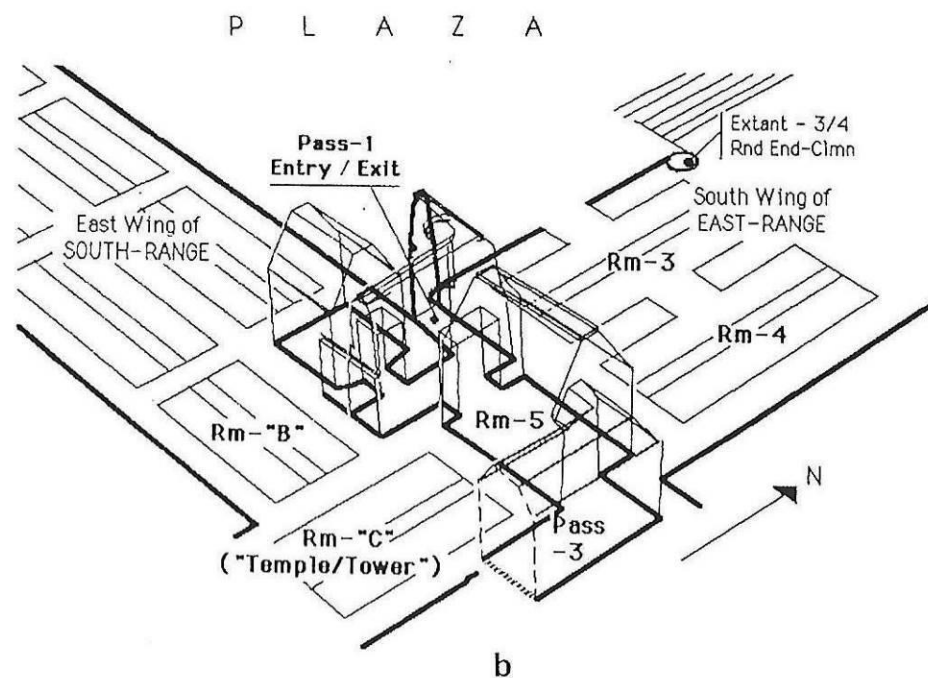
Fig. 4 - Two drawings, from opposite directions, of the south-east corner of the "South East Quadrangle" showing the relation of "Room-5-Suite" to nearby rooms (for which there is very little data).

(a) From inside plaza looking out.

(b) From outside plaza looking in.

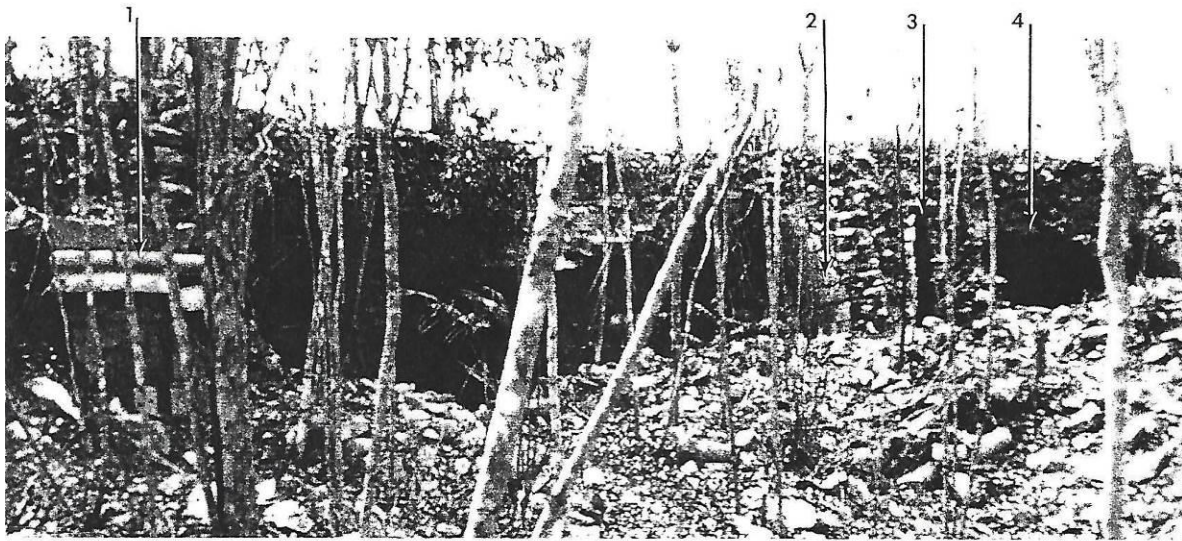
c

Fig. 4c - General view of remains at south-east corner of "South-East Quadrangle" showing: (1) three-quarter-round, corner-column, with three-part medial-molding, at north-end of Rm-3 (East-Range), (2) exposed interior, end-wall of Rm-3, (3) narrow upper part of entry/exit of Pass-1, (4) remains of collapsed Rm-"A."

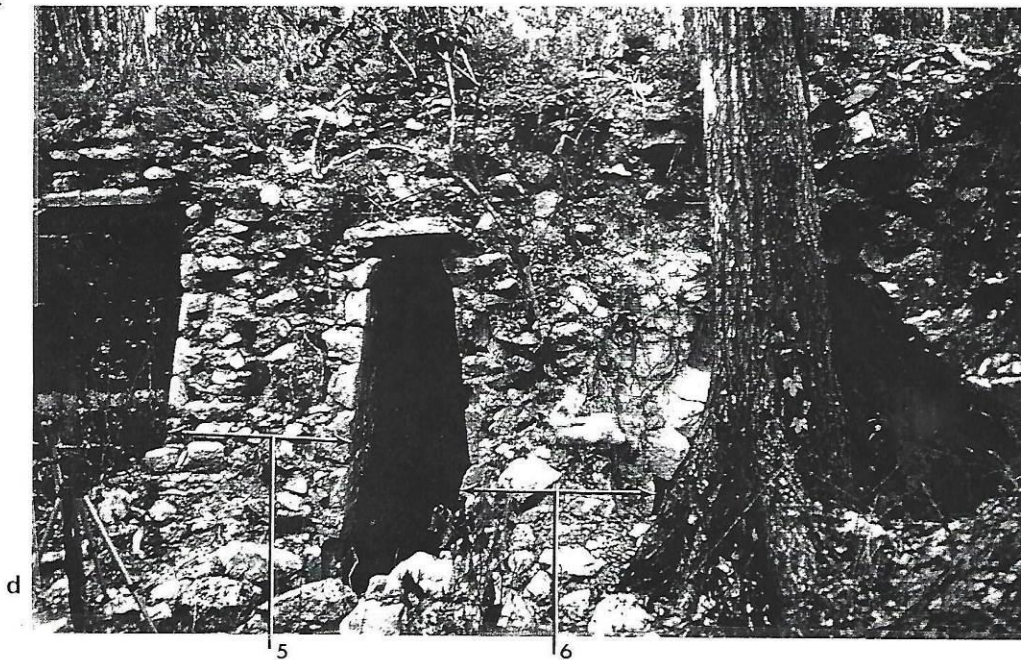
d

Fig. 4d - Closer view: (5) thickness of wall between Rm-3 and Pass-1, (6) wall thickness thickness between Pass-1 and Rm-"A." (right arrow touches highest wall-course immediately below offset vault-spring course.

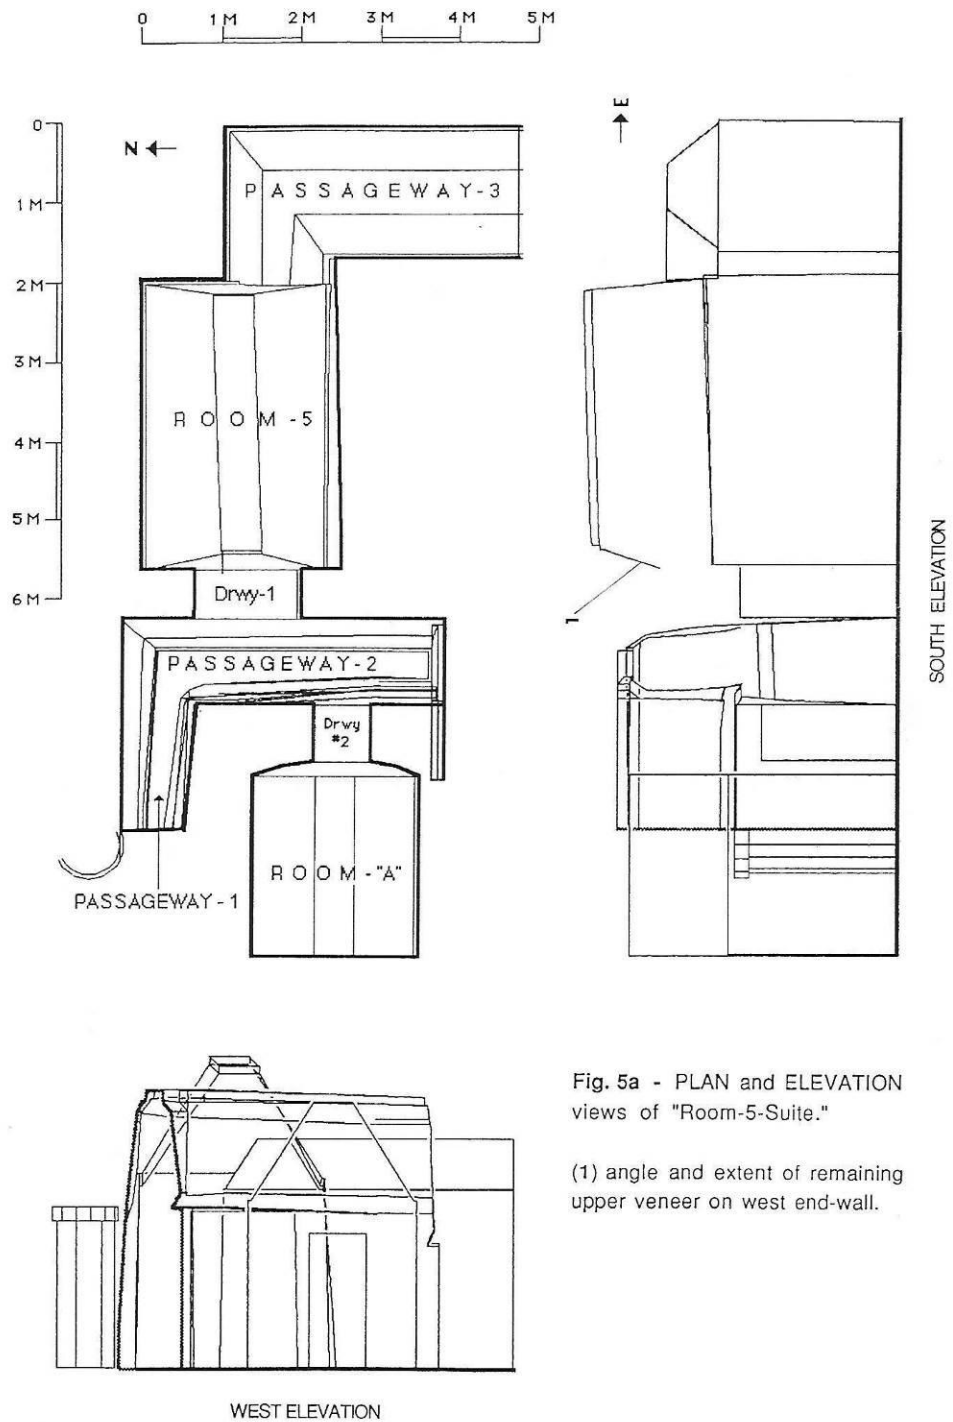
Fig. 5a - PLAN and ELEVATION views of "Room-5-Suite."

(1) angle and extent of remaining upper veneer on west end-wall.

Although the lower wall at the west-end does not tip inward, the wall above (vault end) does. Most of this upper wall is gone, because of the collapse of the Drwy-#1 lintel but there are enough veneer stones at the top to show a strong slant, which if continued would come down within the wall (Fig. 5a-1). It's possible that after the collapse of the lintel, the wall shifted west, but the north-west corner has a noticeable curve built in (Fig. 9), so it may have been built that way or have settled

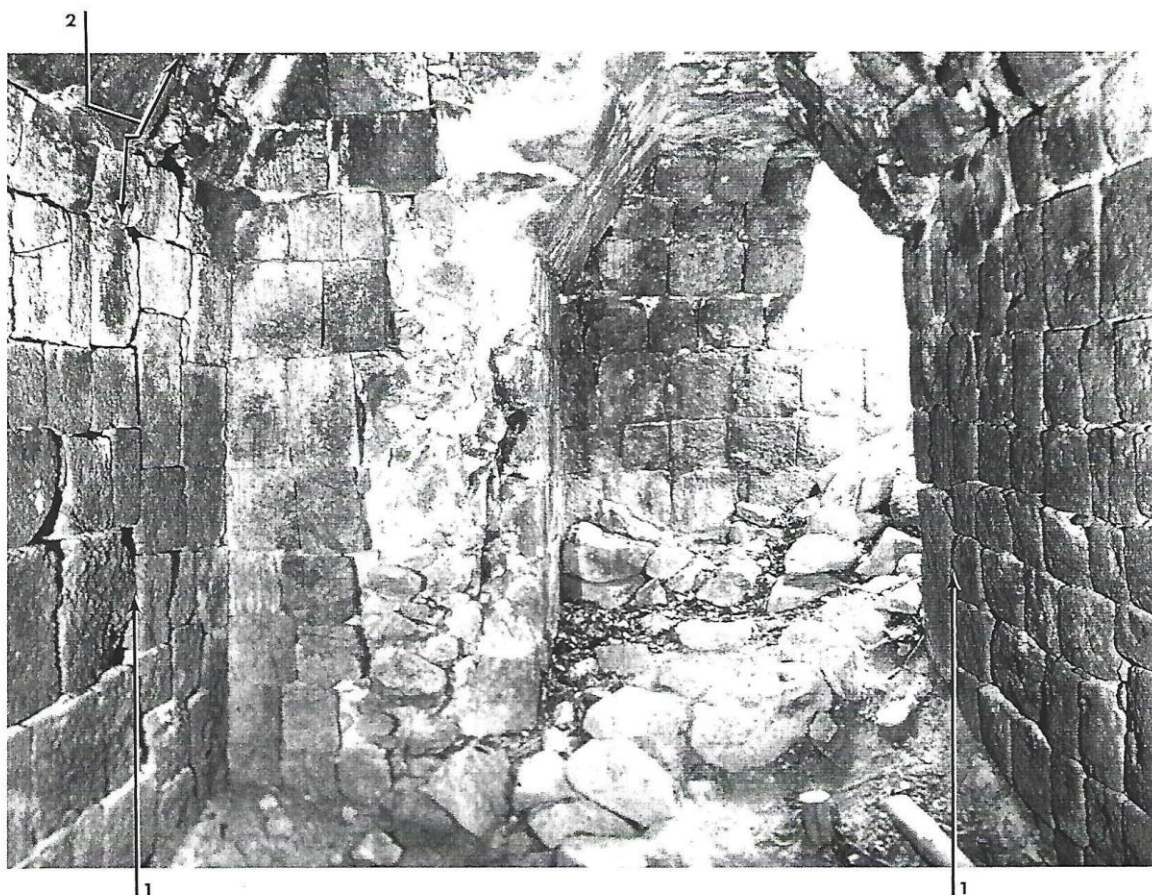
Fig. 7a - ROOM-#5, east-end and entrance to Pass#3 (with collapsed corner), showing
 (1) discontinuities in wall courses, on both side-walls. (2) Top-most wall course and offset
 vault-spring course, of north-wall, continue around corner to east end-wall.

On the **north-wall** of Rm-#5, the veneer stones run in parallel courses till about 48cm (19") from the east-end, where there is a rough vertical line in the masonry.(Fig. 7a,b) Beyond this line there's a different set of parallel-coursed-stones, which continue to the corner and around, on to the east end-wall.

The top-most wall-course looks original, continuing around to the end-wall, and so also does the first course of the vault (the offset-course) (Fig. 7a). The **south-wall** extends about 33cm beyond where the endwall would have intersected with it. But at just about that point also, a roughly vertical line, breaks the parallel courses (Fig. 7c).

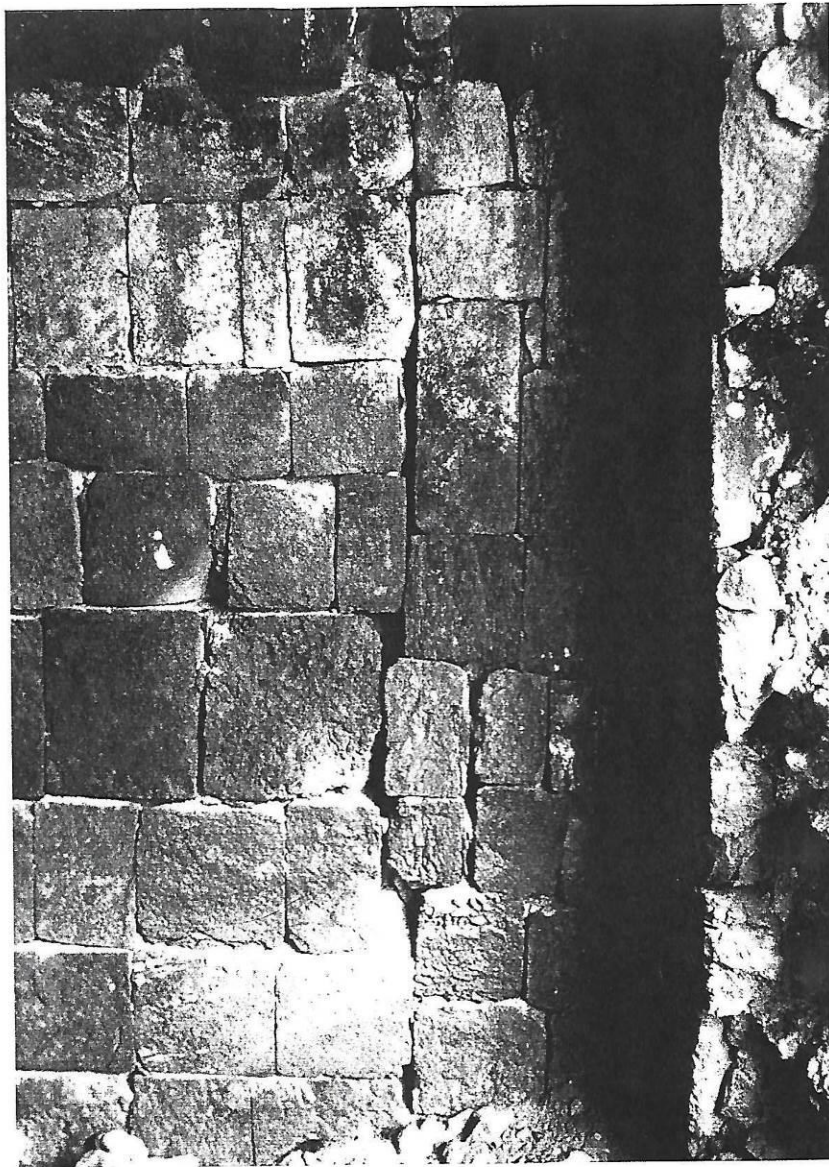
Fig. 7b - ROOM-#5, east-end of north-wall, showing roughly vertical line (starting just below a pair of "cross-beam" sockets) - original wall courses, on left, altered ones on right.

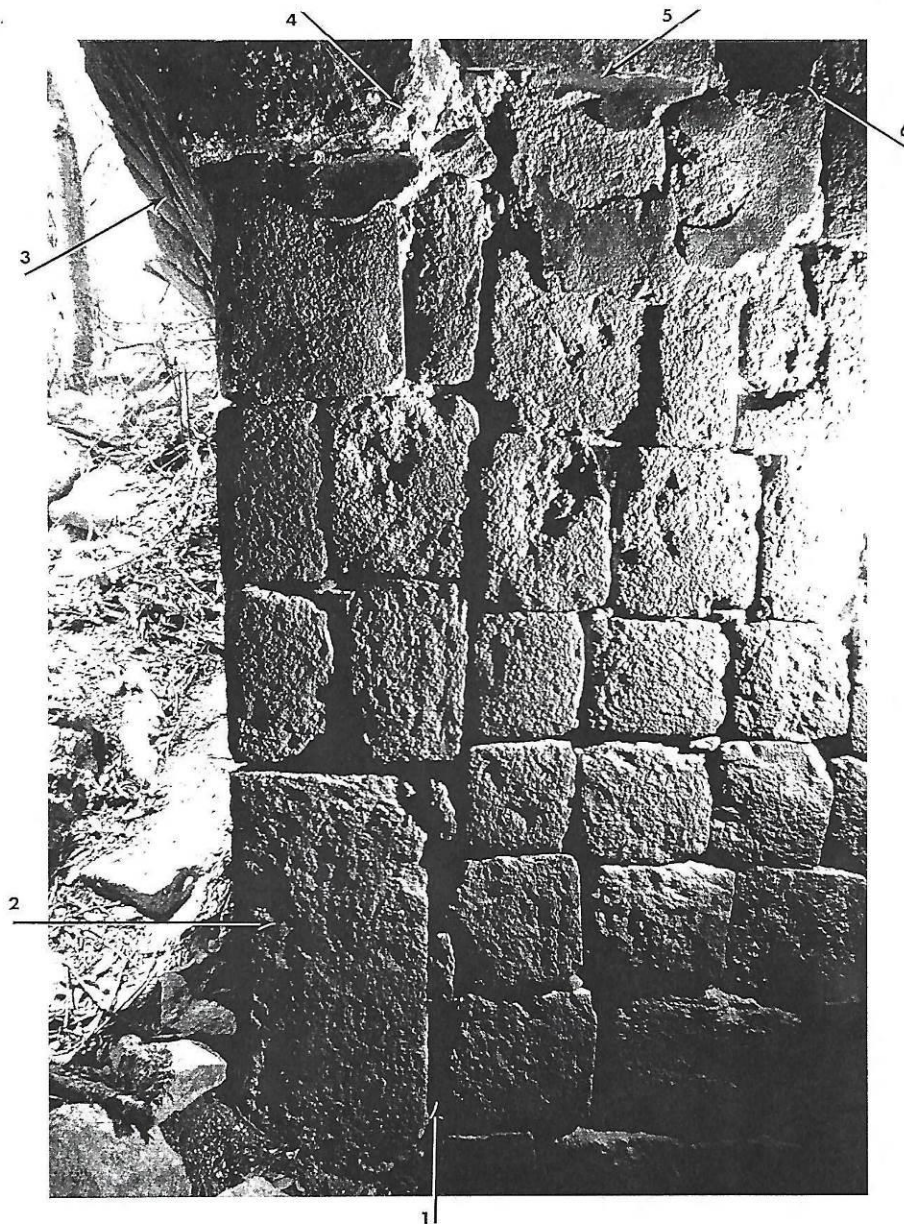
Fig. 7c - ROOM-#5, east end of South-Wall, showing vertical line in masonry (1) at what would be the approximate intersecting point with the east end-wall, (2) large jamb-stone at corner, (3) remains of the west vault of Pass-#3, (4) unusual "join" of Pass-#3 vault-spring as it jogs up, to meet the (higher) Rm-#5 vault-spring (see also Fig. 10b), (5) offset vault-spring of the south-wall of Rm#5, (6) left-most, of a pair of cross-beam sockets.

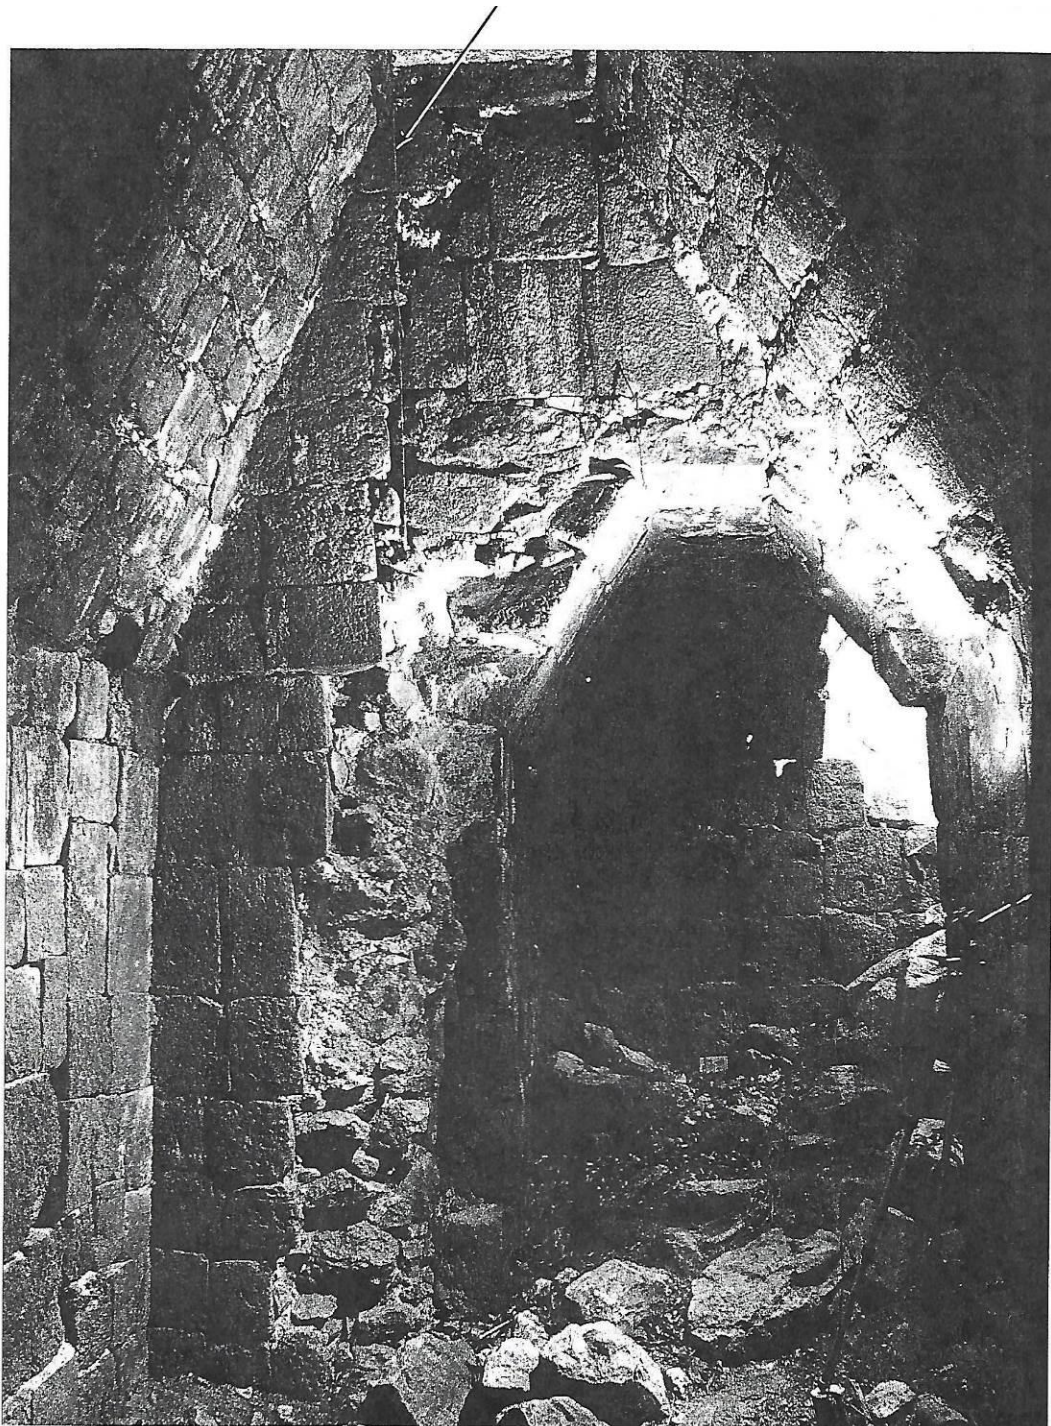
Fig. 8 - ROOM-#5, view of east end-wall showing upper wall with original stones to left (roughly) of the white plumb-line (arrow).

On the upper part of the end-wall, on the extreme left-side, the veneer looks original (Fig. 8). On the right (south) side, at the top, the stones are orderly, but larger. Lower down, nearer to the opening of the vault of Pass-#3, it becomes disorganized, with mortar filling-in large gaps. The vaults themselves, at the east end, show no unusual signs of disturbance on either side.

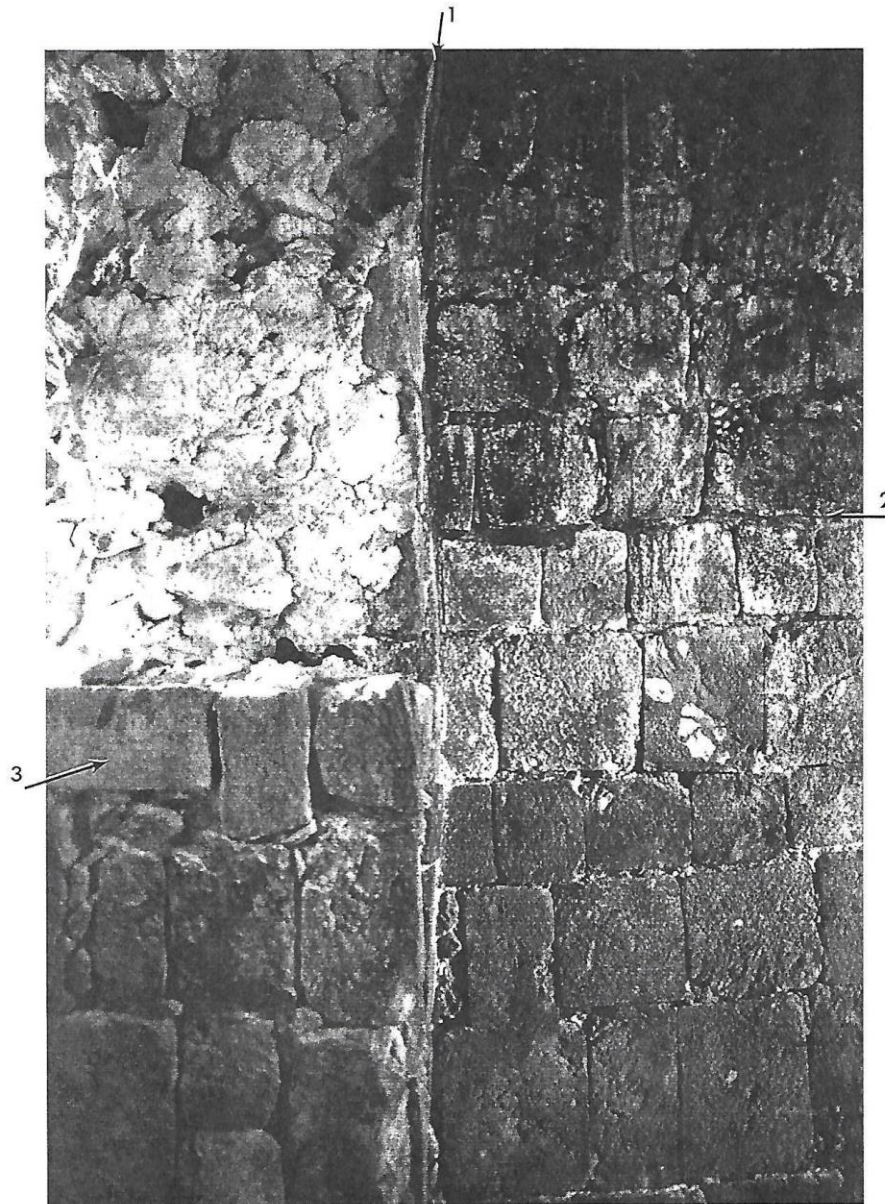
Fig. 9 - ROOM-#5, looking directly "edge-on," at the west end-wall, (1) which curves in and out as it rises - no offset vault-spring (for angle of upper part, see Fig.5a-1), (2) vault-spring of the north-wall, (3) north jamb of Drwy-#1.

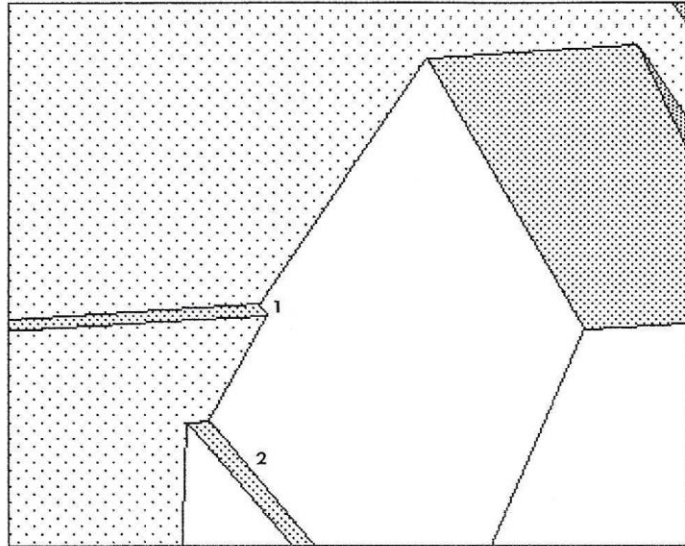
Fig. 10a - Looking at east-end of Rm-#5, at unusual "join" of offset vault-springs - (1) Rm-#5 end-wall, vault spring, (2) Pass-#3 vault-spring.

The convex corner where the east end-wall of Rm-#5 and the north wall of Pass-#3 would have joined is collapsed, but the drawings (Fig. 10a) show both vault-springs continuing to their natural ending, which makes for an odd, unaesthetic "join" (Pass-#3 offset-vault-spring is 14cm (6") lower than that of Rm-#5). The Maya may have had a more clever masonry or plaster solution.

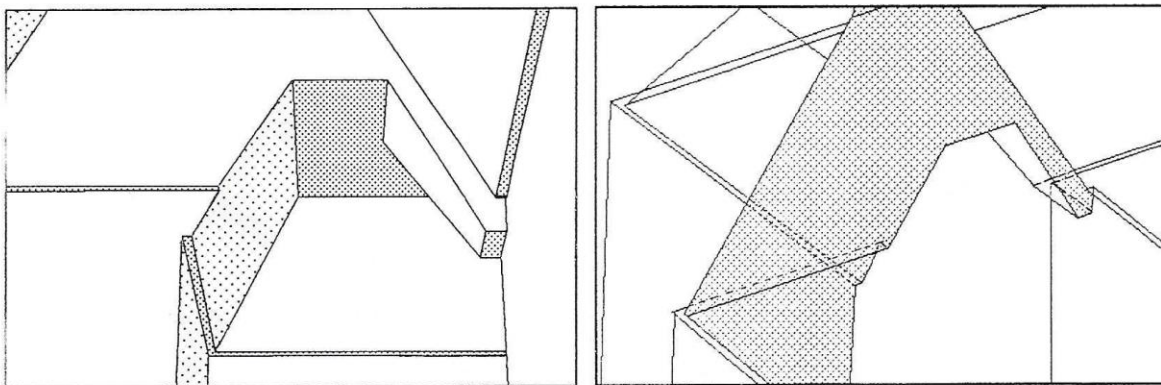
Fig. 10b - The offset vault-spring on the south wall of Pass-#3, also has an unusual "joining," to its common wall with Rm-#5.

The other, south side of the Pass-#3 opening, where its vault meets the "common" wall, also has an unusual, but more comfortable, "join" (Fig. 10b).

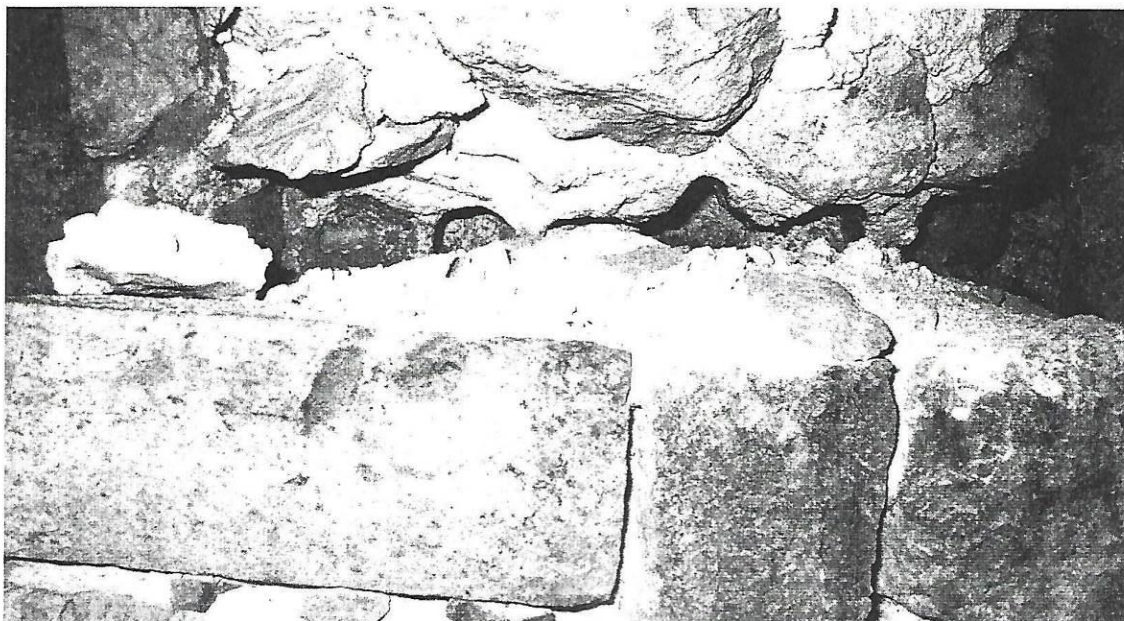
Fig. 11a - Looking directly at the north jamb of Drwy-#1 showing some of the "molds" of a lintel made of "poles."

Impressions in the mortar at the north end of Drwy-#1 show that the lintel was made of poles (or tree limbs). There are five definite molds with diameters of 6 to 8 cm (2-1/2" to 3") but there probably were seven or eight of them. The "mold" shapes are very round, suggesting that they were not "Log Wood," which has a distinctive, sinuous "muscle-like" form.⁵ If this is true, it would be my first awareness of the use of simple "poles" as lintels, but it may have been common for interior doorways of lesser buildings.⁶

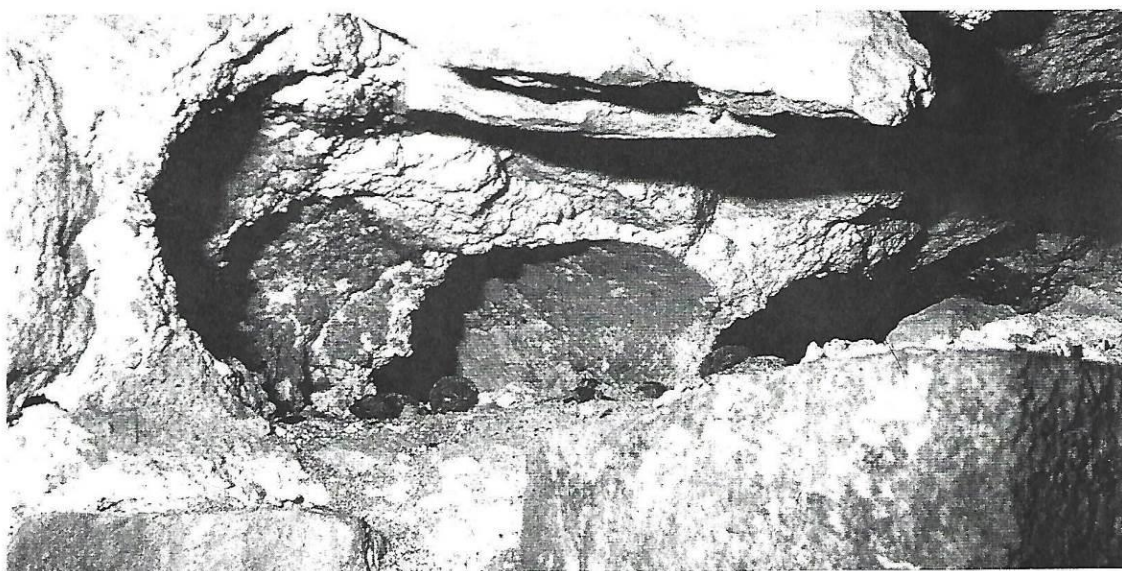
Fig. 11b - Close-up of left-most "molds" of Drwy-#1 lintel.

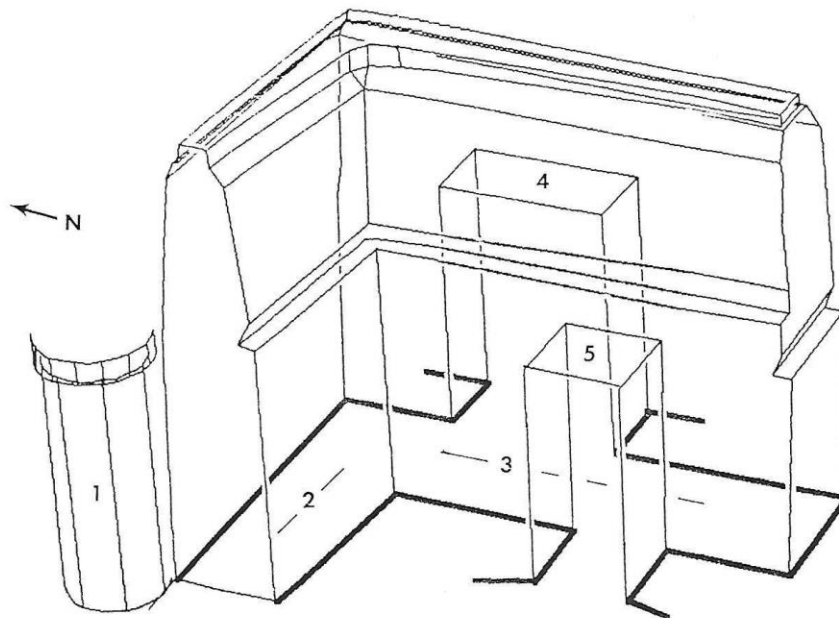
Fig. 12a - General view eastward of Pass-#1 and Pass-#2 (the first Right-Angle-Vault) including the three-quarter-round end-column, at the open end of Pass-#1 (buried up to just where its collar would have begun). (1) three-quarter-round end-column, (2) Pass-#1, (3) Pass-#2, (4) Drwy-#1, (5) Drwy-#2.

This is the east/west arm of the first right-angle-vault. It has decorative-stone-insets at the capstones (same as Rm-#5) but only one course of vault-stones, which are "boot-shaped" (Fig. 12, 13).

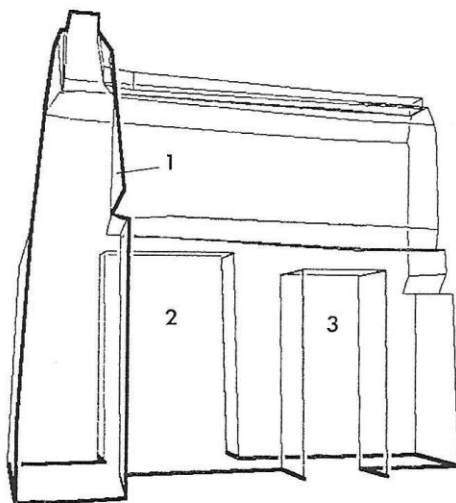
Fig. 12b - Looking eastward, directly into Pass-#1 (at approximately eye-level) showing ability to see into Rm-#5 from plaza. You can also see the change in the upper south-wall (1) as it shifts from angled to vertical (and "outset"). (2) Drwy-#1, (3) Drwy-#2.

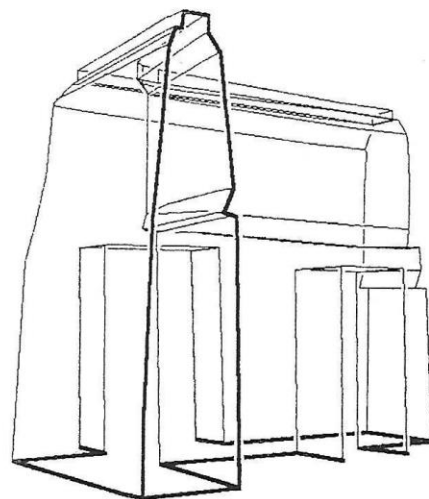
Fig. 12c - View, at a sharper angle, into Pass-#1 and still able to see into Rm-#5, through Drwy-#1.

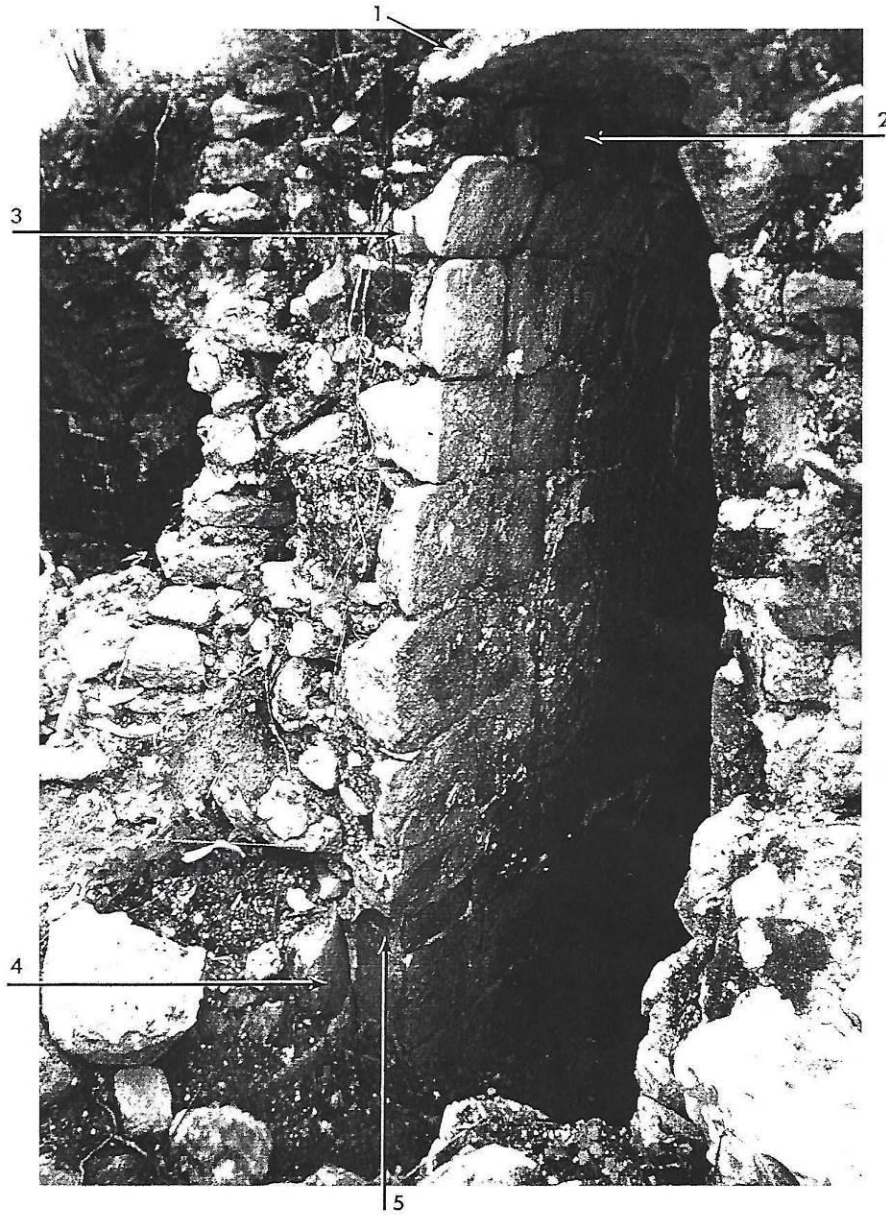
Fig. 13 - The entry/exit of Pass-#1. Rubble fills entrance to above original head level, (1) capstone, (2) decorative-inset at capstones, (3) "boot-stone" of single vault-course, (4) rounded side of remains of buried, three-quarter-round end-column, (5) remains of plaster "groove" with rounded top, showing where the upper "collar" of the column would have begun (above ones head).

At the plaza-end of the north-wall of Pass-#1 (which is also the south end of Rm-#3 of the East-Range) are the remains of a three-quarter round end-column (Fig. 13). There is an end-column at the opposite (north) end of Rm-#3 (Fig. 14) which is complete with "collar" and three-part medial-molding. The medial-molding is composed of a reverse battered upper member, a rounded mid member and a battered lower member. The lower member is angled outward much more sharply than the upper. These end-columns are similar to ones in the "Cuartel,"⁹ on the North and West-Ranges (Fig. 15) although the "Cuartel" end columns are smaller in diameter and the medial-moldings are different.

Turned-up plaster on the remains of the Pass-#1 column, shows where the decorative "collar" at the top of the column, would have begun (Fig. 13).

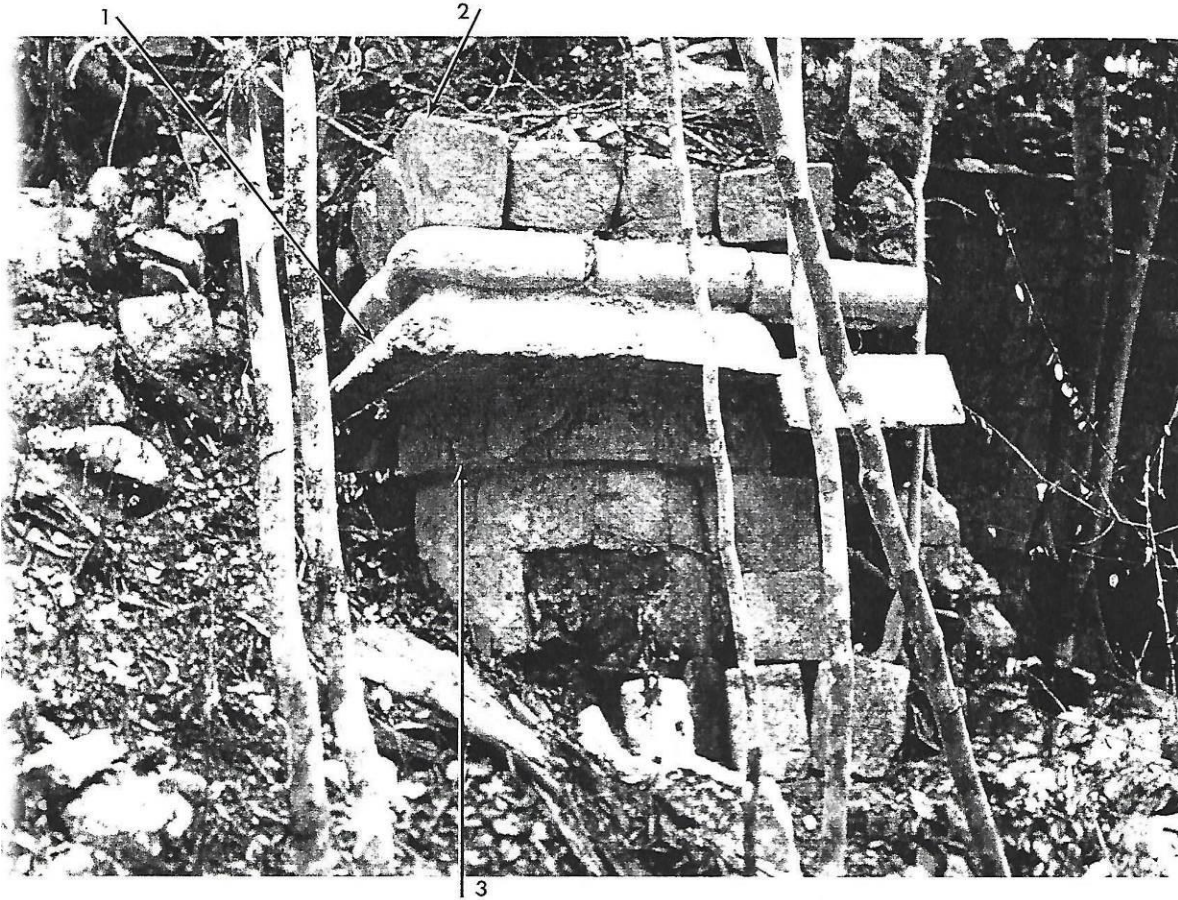
Fig. 14 - Large three-quarter-round end-column at north-end of Rm-#3 (south-wing of East-Range). Area to left is a predicted stairway - if so the corner of the building projects significantly out in front of the stairway. (1) unusual three-part medial-molding - lowest member is very sharply angled outward, also (2) upper corner piece angles upward, (3) collar at top of column.

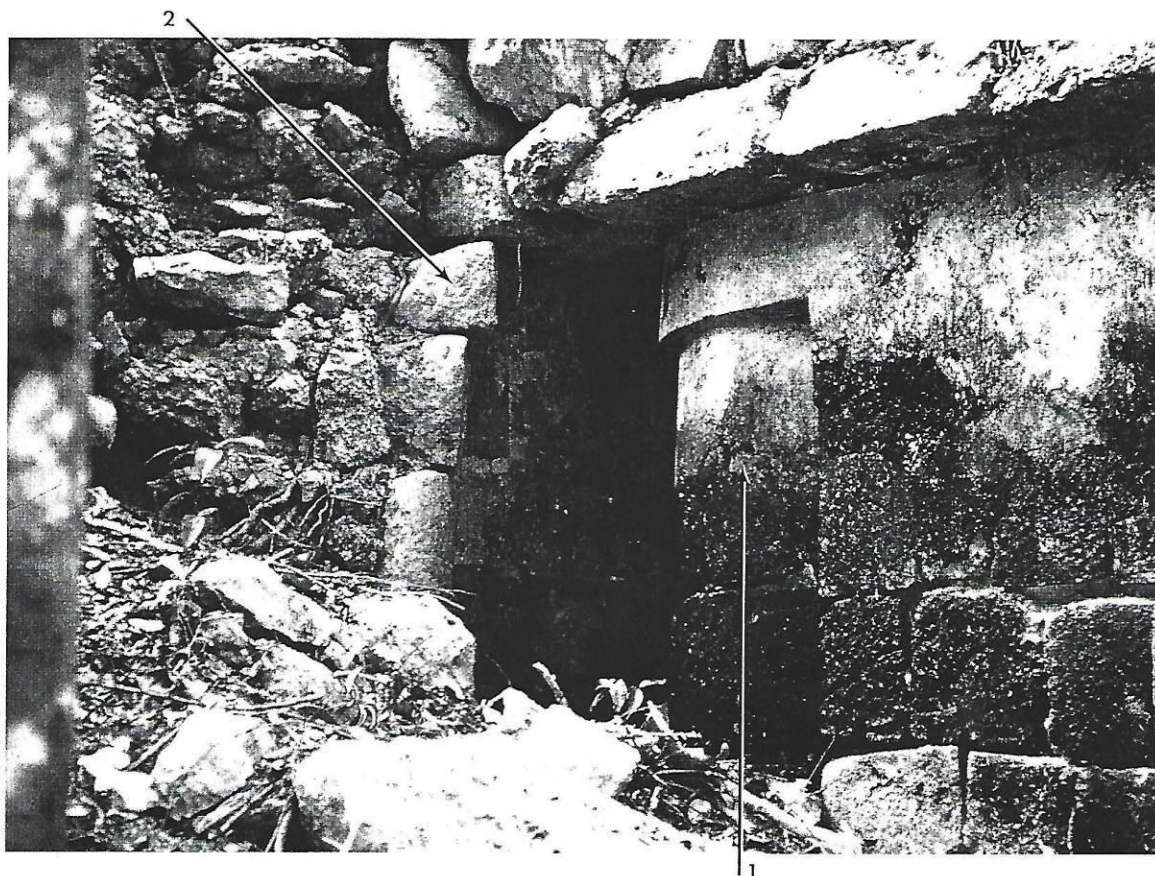
Fig. 15 - North-Range of the "Cuartel" (east-end) (1) three-quarter-round end-column, similar to Rm-#3, of the East-Range (of the South-East Quadrangle) but the shaft is narrower (more like Pass-#1) and the medial-molding is different. Notice the "cross-section" of a similar column (2) at the beginning of the East-Range.

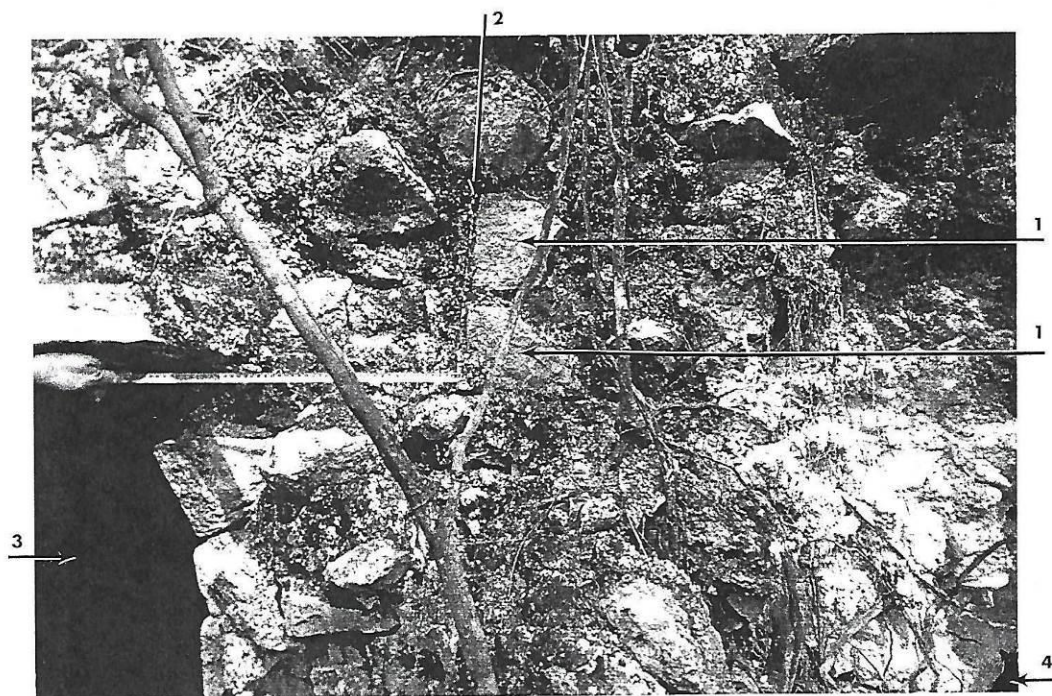
a

Fig. 16a - Two contiguous veneer-stones within wall, between Pass-#1 and Rm-#A, with intact plaster covering both "faces," (1) two veneer-stones, (2) plaster surface, (3) Pass-#1 opening, (4) Rm-#A opening.

N. Hellmuth pointed out two contiguous, apparent veneer-stones in the "cross-section," resulting from the collapse of the common wall between Pass-#1 and Rm-#A. Intact plaster covers the angled "front"

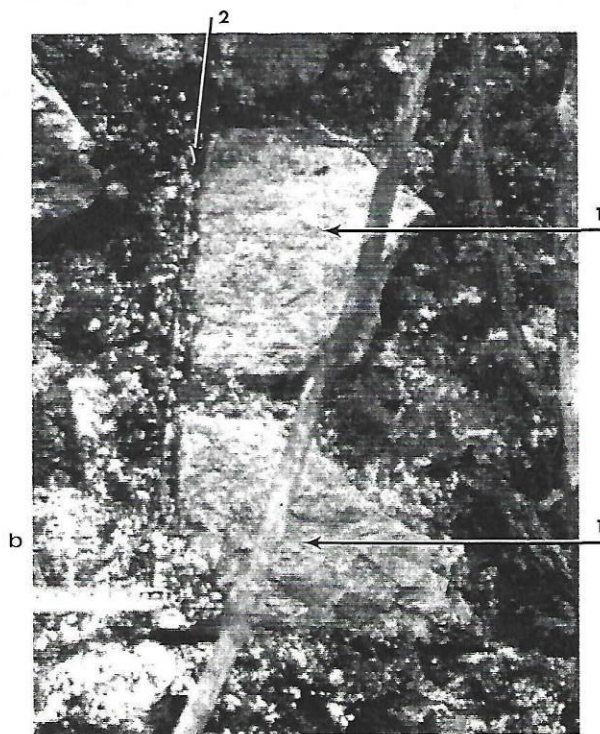
b

Fig. 16b - Close-up of two veneer-stones.

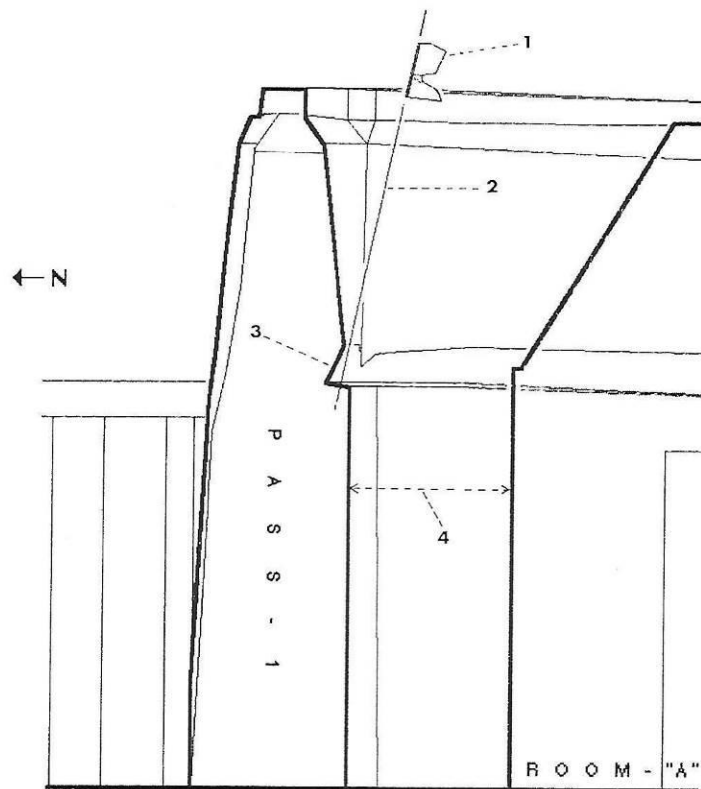
Fig. 17 - West-elevation (partial) showing position of "two contiguous veneer-stones" in wall, separating Pass-#1 and Rm-"A." (1) two contiguous veneer-stones, (2) projected line of surface of veneer-stones, suggesting battered, exterior upper-wall-zone and/or a possible relation to the medial-molding (3) at the entrance of Pass-#1, (4) cross-section of wall between Pass-#1 and Rm-"A."

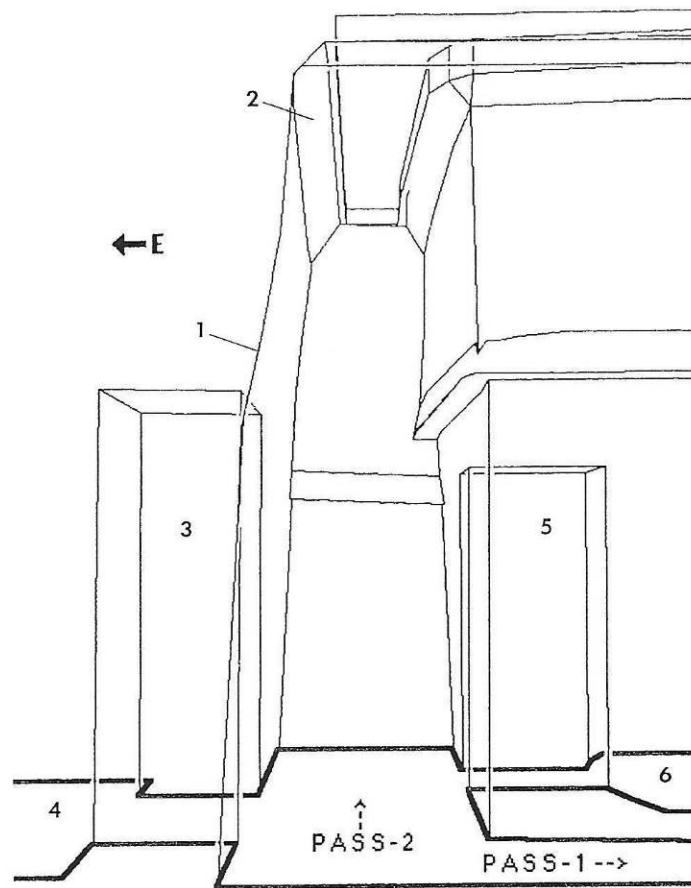
Fig. 18 - PASS-#2, looking southward down its length. On the left can be seen the "tipped-in" angle of the north-east,"concave" corner (1) of Pass-#1 and #2. The veneer angles outward from around Drwy-#1 (visible also in photo Fig. 22). All the veneer above (and much on both sides) is missing, except for the single vault-course (2) at the very top, (3) Drwy-#1, (4) Rm-#5, (5) Drwy-#2, (6) Rm-"A."

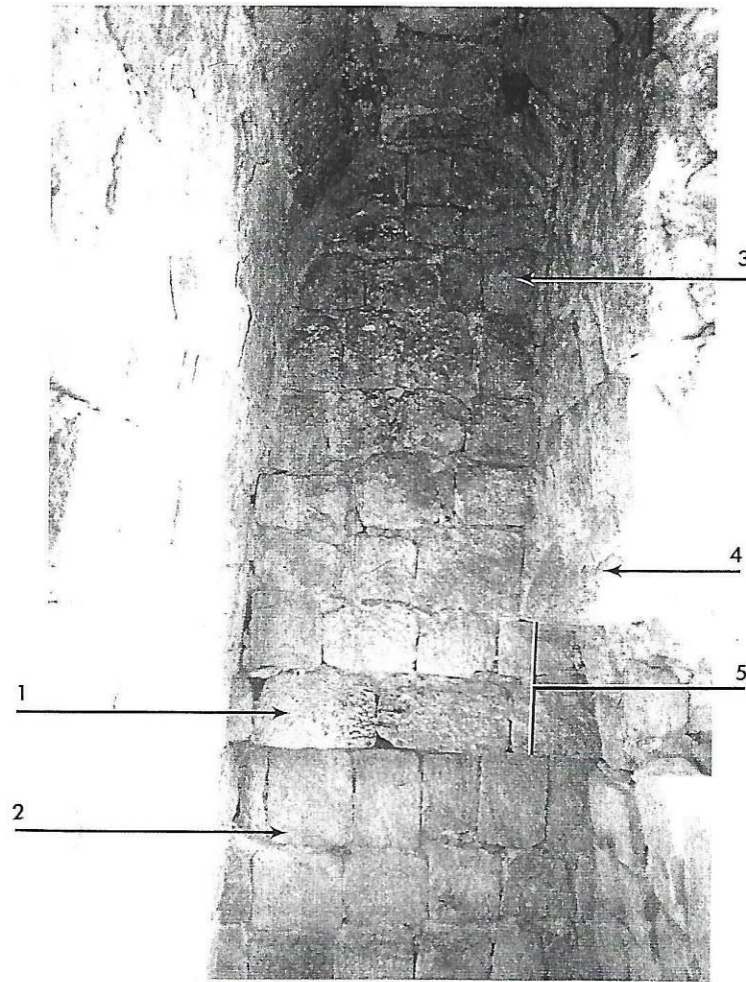
Fig. 19 - South end-wall of Pass-#2, (1) medial-molding (and 2) lower end-wall, are of previous construction, (3) upper veneer has been fitted between present walls, (4) remains of west-wall medial-molding at south-end of Pass-#2, (5) gap between two medial-moldings.

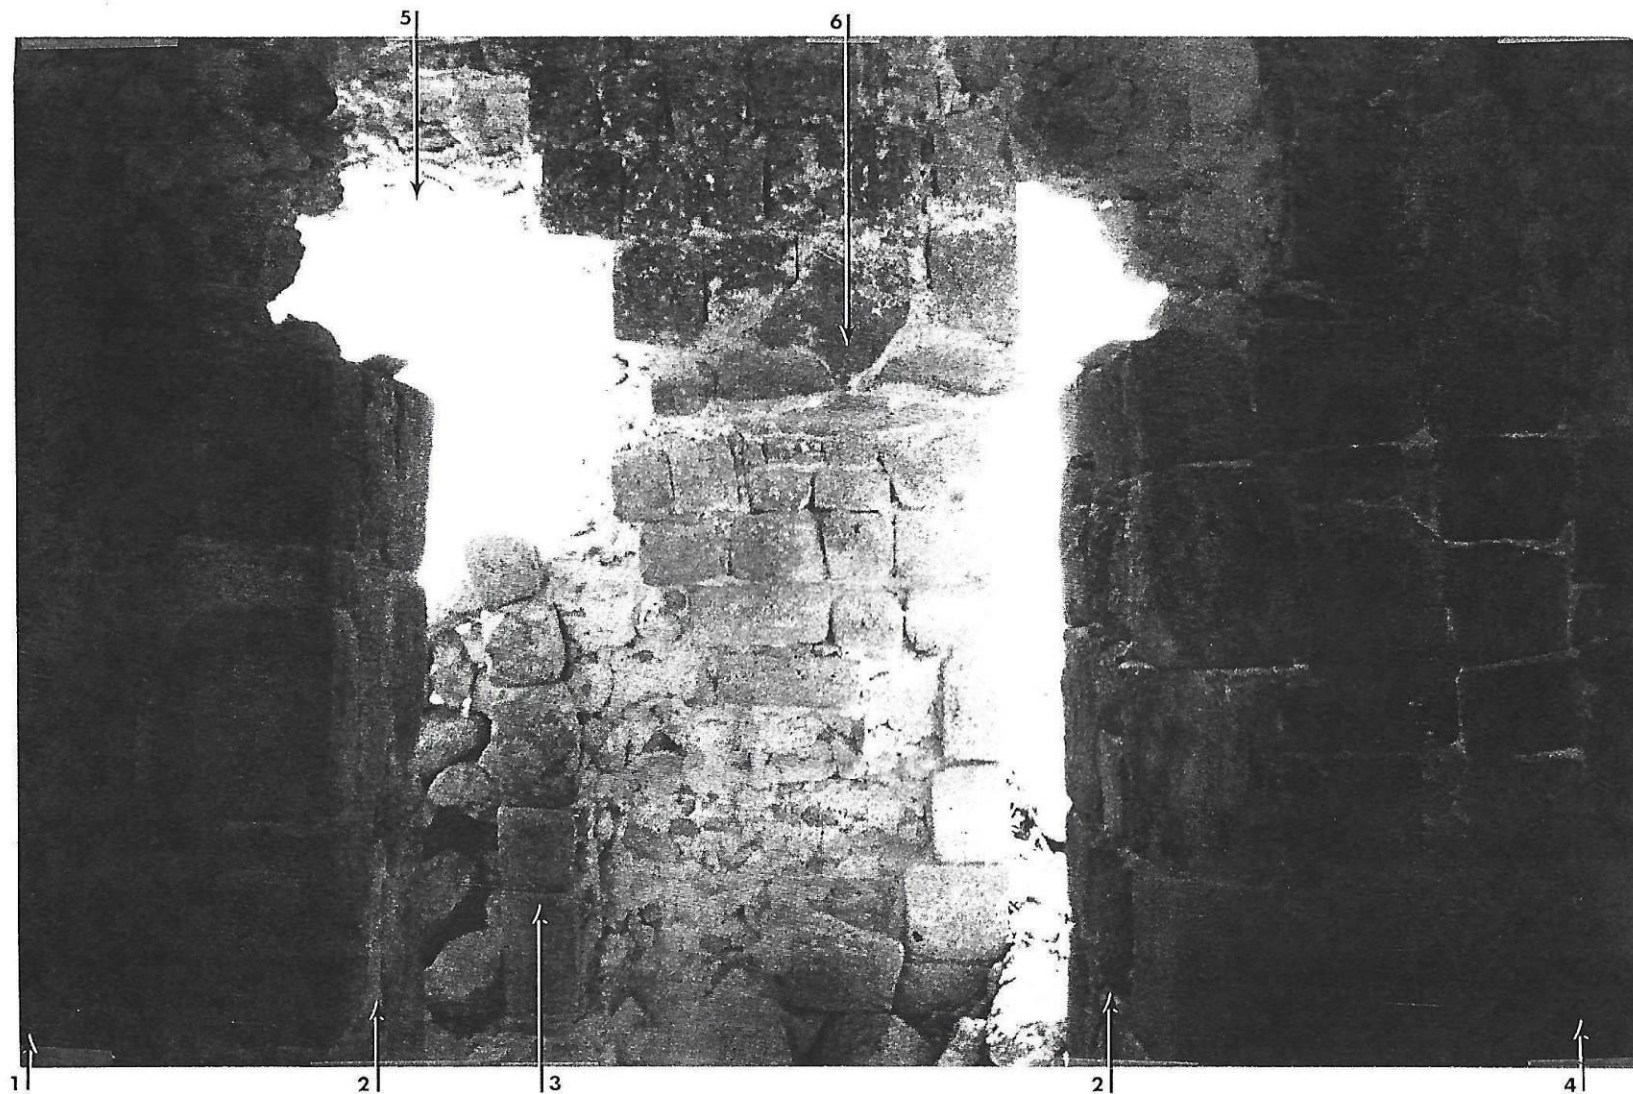
Fig. 21 - Looking west from inside Rm-#5, through Drwy-#1, into Pass-#2, then through Pass-1 to the outside (plaza), (1) south/west corner of Rm-#5, (2) jambs of Drwy-#1, (3) north-jamb of Drwy-#2 (with upper corner stones collapsing), (4) north/west corner of Rm-#5, (5) collapse above Drwy-#2, (6) only place where plaster covers medial-molding.

that way shortly after construction. The opposite side of this wall, in Pass-#2 (above Drwy-#1) is also extended west (pushed-out [?] see Fig-21).

Drwy-#1 is 10cm (4") to the south of center - a little over half the width of the wall (132cm to 248cm). This off-centeredness is easily visible (Fig. 21).
