**Notes on "ROOM-#5-SUITE"
of the South-East Quadrangle
of the ruins at
"SANTA ROSA XTAMPAK,"
Campeche, Mexico**

Jack Sulak

August 27, 1992

With references to drawings and photographs by Jack Sulak, based on cross-section drawings and other measurements by Susanna Reisinger and Jack Sulak in August, 1989. No excavation was involved.

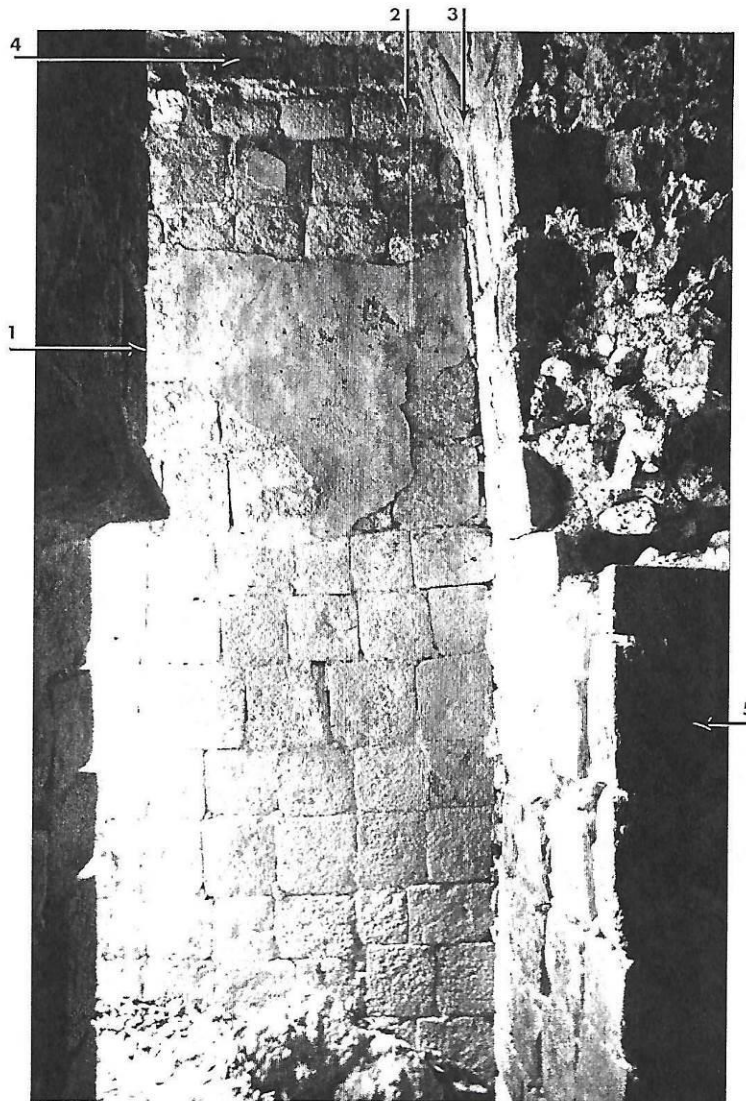
Fig. 22 - Looking north from inside Pass-#2, toward Pass-#1, (1) outset of upper-wall, (2) single course of vault-stones of Pass-#1, (3) single course of vault-stones of Pass-#2 (noticeably longer), (4) decorative-inset at capstones, (5) north jamb of Drwy-#1 and collapsed area above.

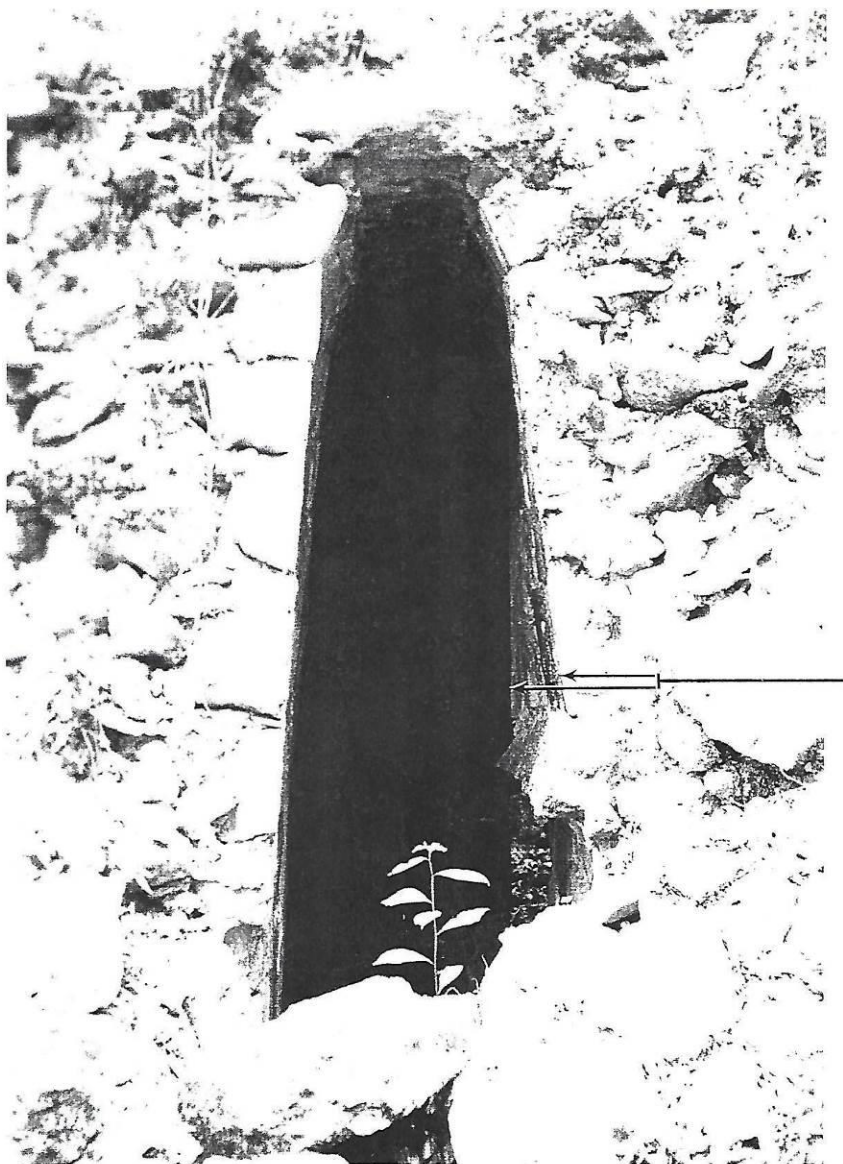
Fig. 23 - Looking east from plaza into Pass-#1, showing upper part of south-wall, changing from "angled" to vertical (arrows) and becoming "outset" from lower wall.

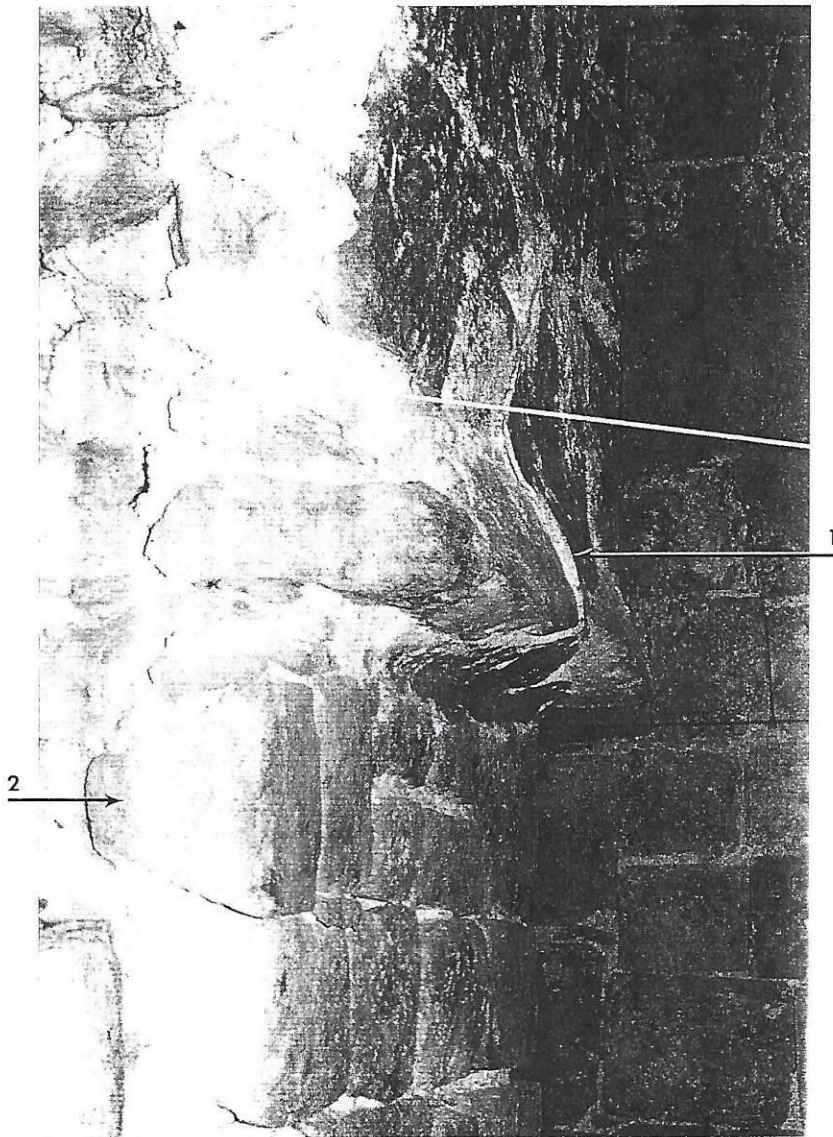
Fig. 24 - Looking north in Pass-#2 (same view as Fig. 22) showing (1) plaster covering the medial molding, (2) deeply wedged veneer-stone. white "level-line" is shown in foreground.

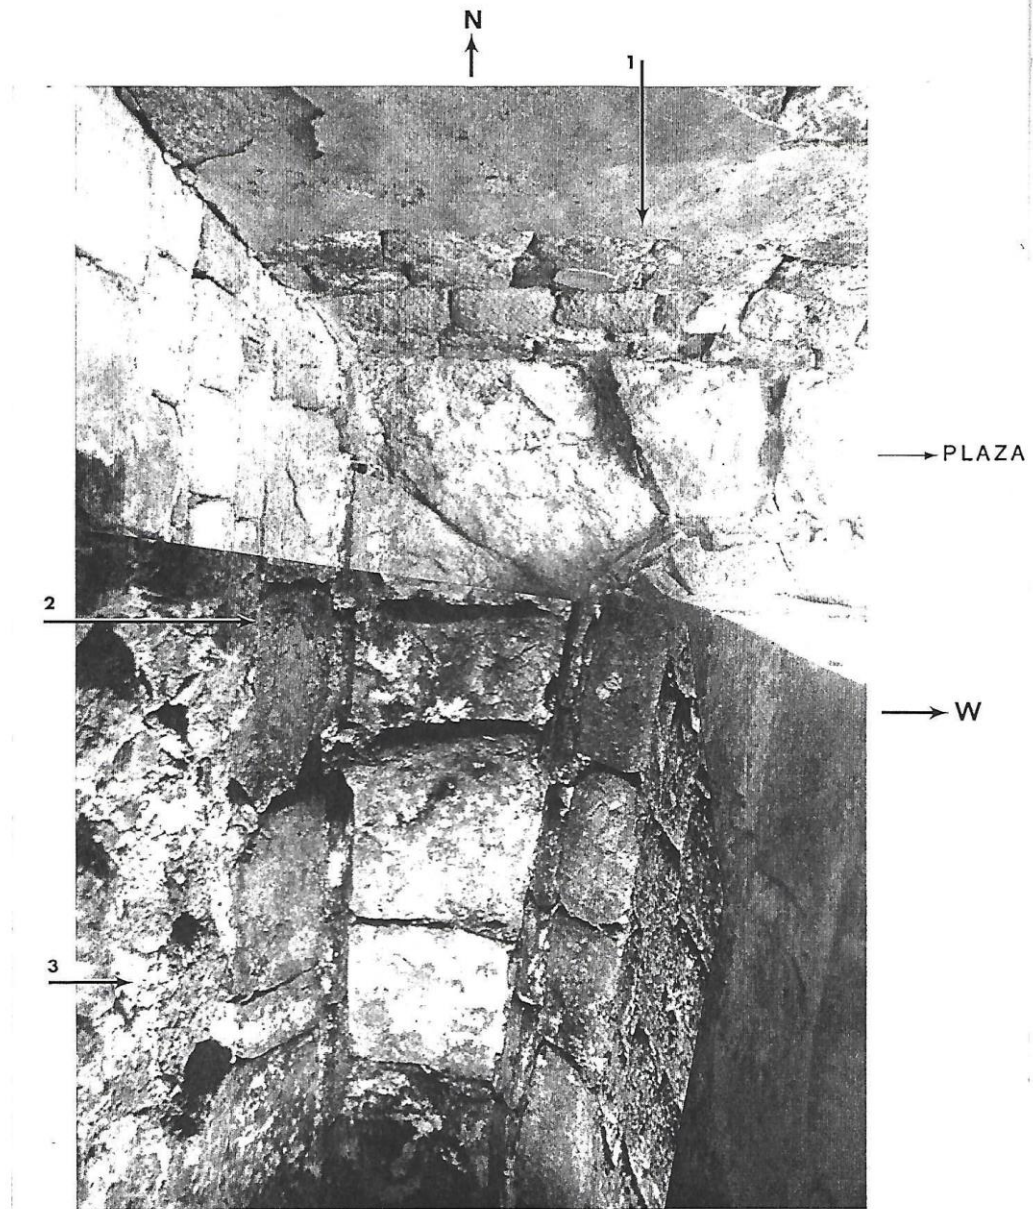
Fig. 25 - RIGHT-ANGLE-TURN of PASS-#1 and #2, seen from below (composed of two photos)
 - three stones angle to make turn, (1) Pass-#1, (2) Pass-#2, (3) collapse above Drwy#1,
 (4) single courses of vault-stones on both sides of Pass-#2 are longer (vertically) than Pass#1.

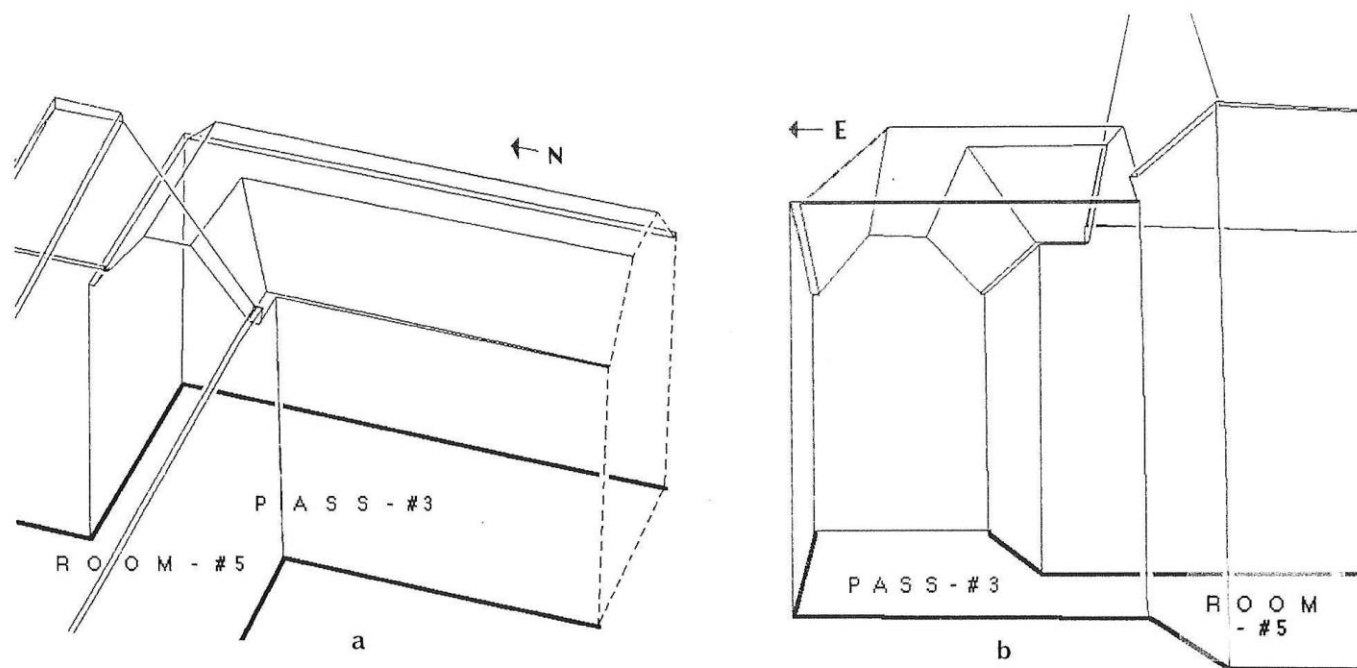
Fig. 26 - PASSAGEWAY-#3, two views. The west-wall (at the offset-vault-spring level) is the longest visible wall (239cm - 7'10"), the dashed line is at this length.

(a) Looking north-east.

(b) Looking south, down its length.

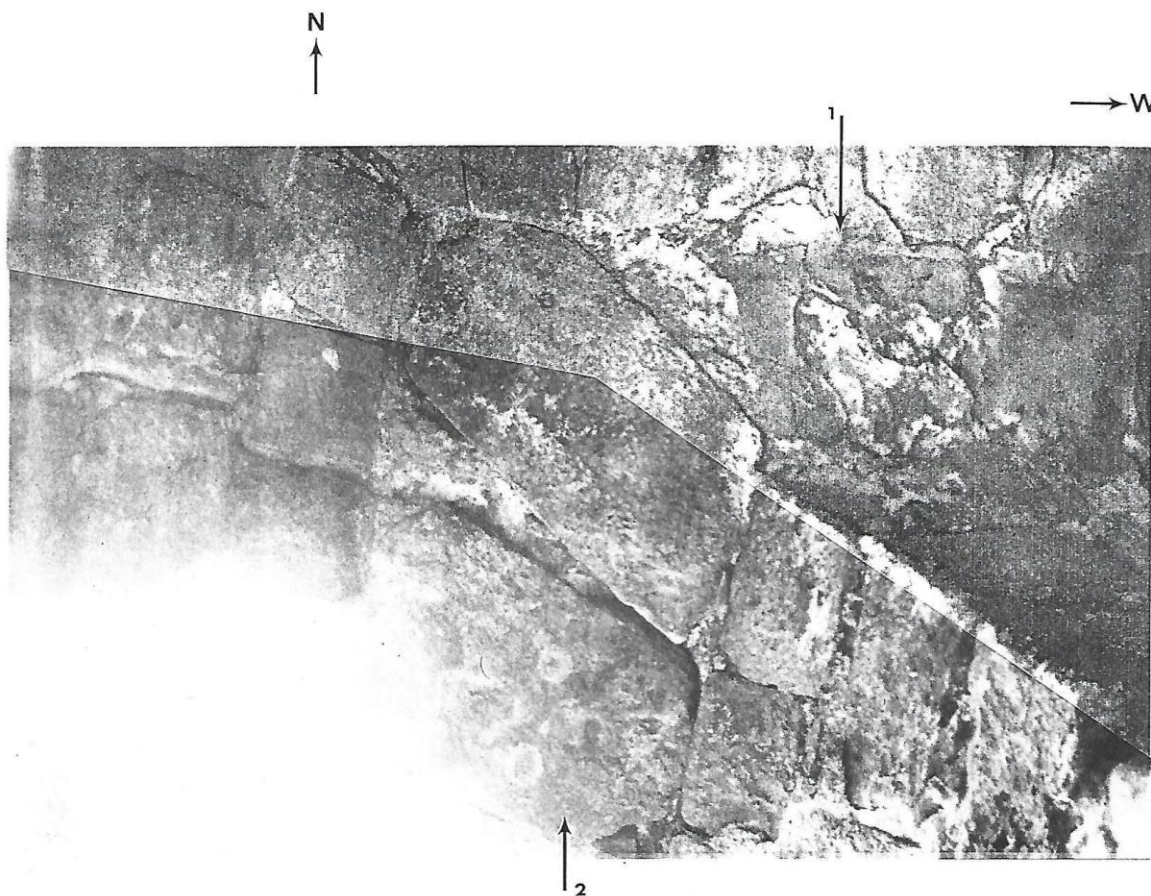
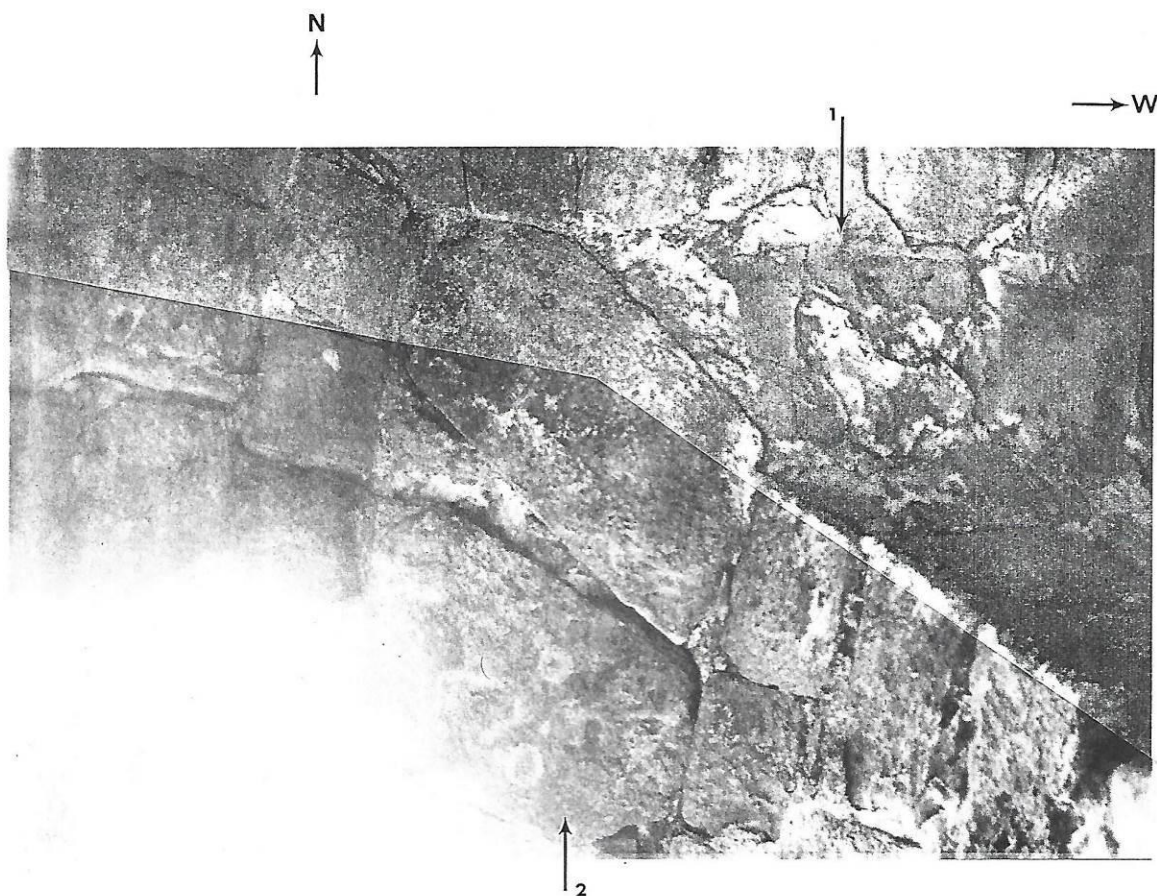
Fig. 27 - RIGHT-ANGLE-TURN of PASS-#3 (seen from below). Enough plaster remains on the short east/west, arm to make the precise shape of the vault-stones uncertain. (1) east/west arm connected to Rm-#5, (2) north/south arm.

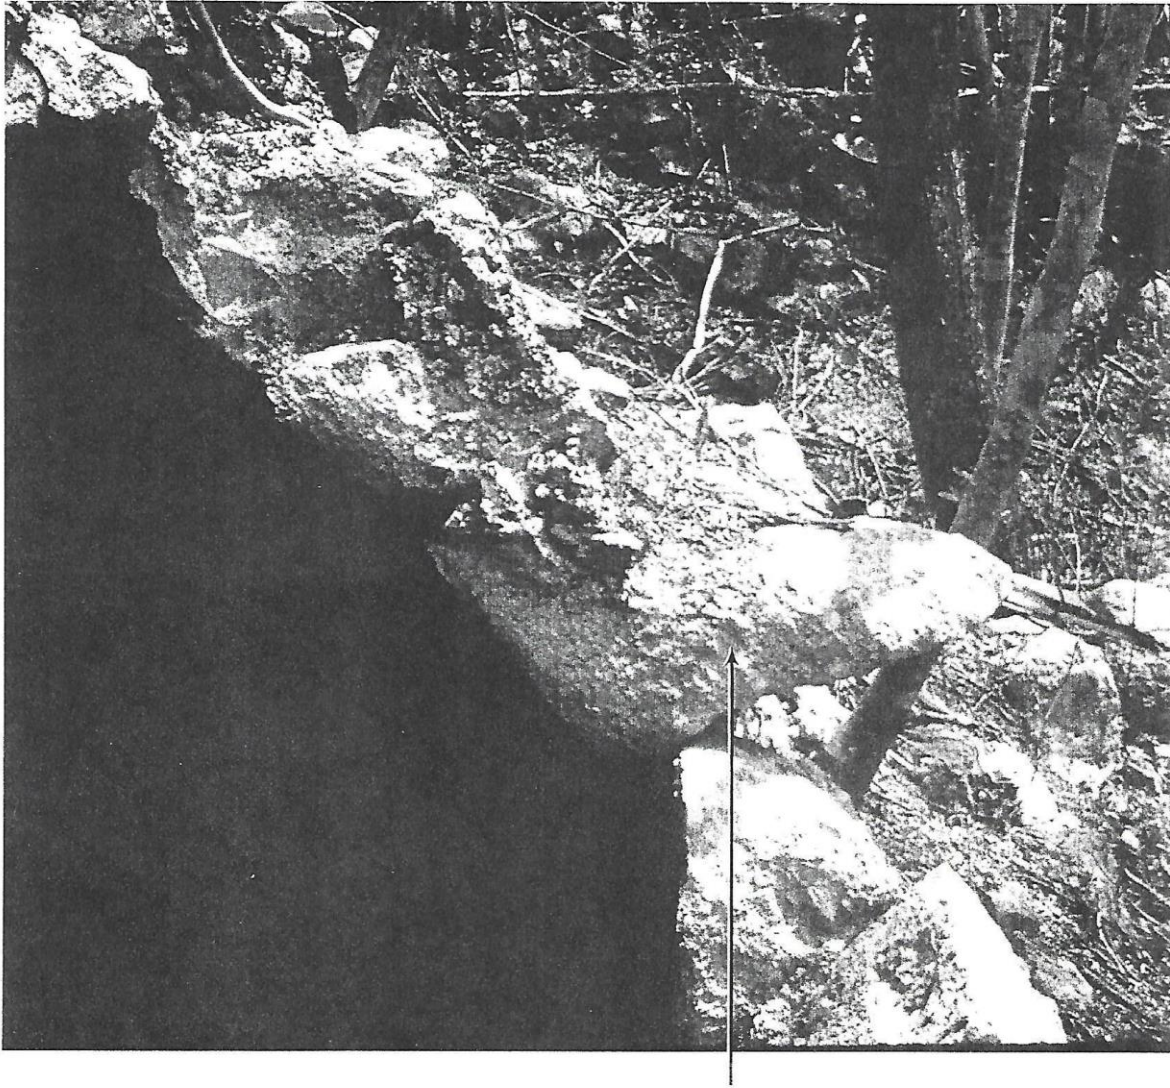
Fig. 28 - PASS-#3, looking north ("edge-on") at the east-vault, showing side-view of exposed "boot-shaped" vault-stone (arrow) part of the offset vault-spring course.

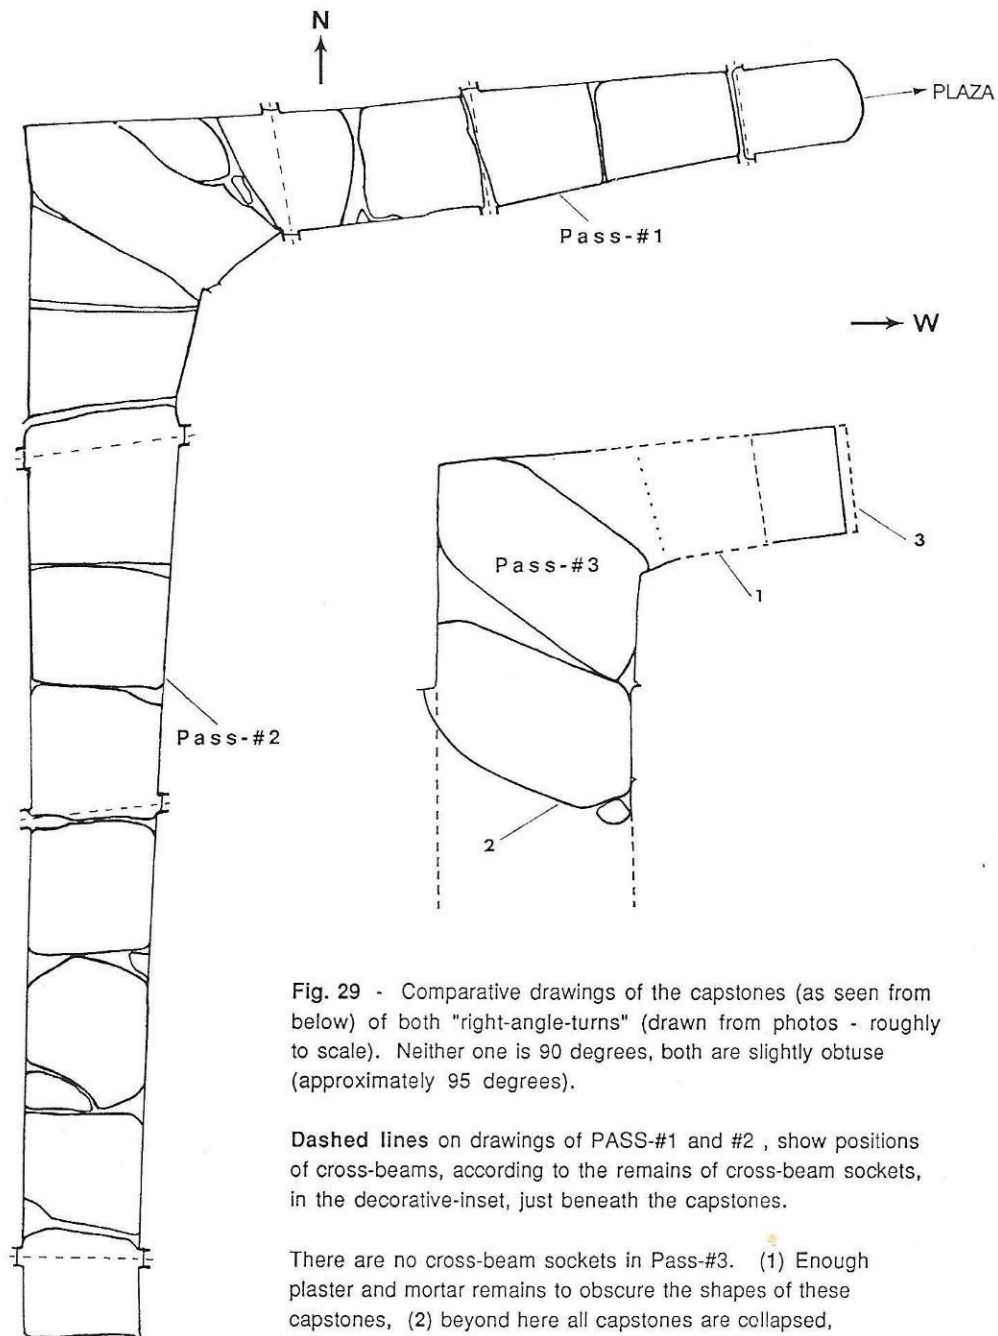
Fig. 29 - Comparative drawings of the capstones (as seen from below) of both "right-angle-turns" (drawn from photos - roughly to scale). Neither one is 90 degrees, both are slightly obtuse (approximately 95 degrees).

Dashed lines on drawings of PASS-#1 and #2 , show positions of cross-beams, according to the remains of cross-beam sockets, in the decorative-inset, just beneath the capstones.

There are no cross-beam sockets in Pass-#3. (1) Enough plaster and mortar remains to obscure the shapes of these capstones, (2) beyond here all capstones are collapsed, (3) missing lip of stone (or plaster) veneer in Rm-#5.

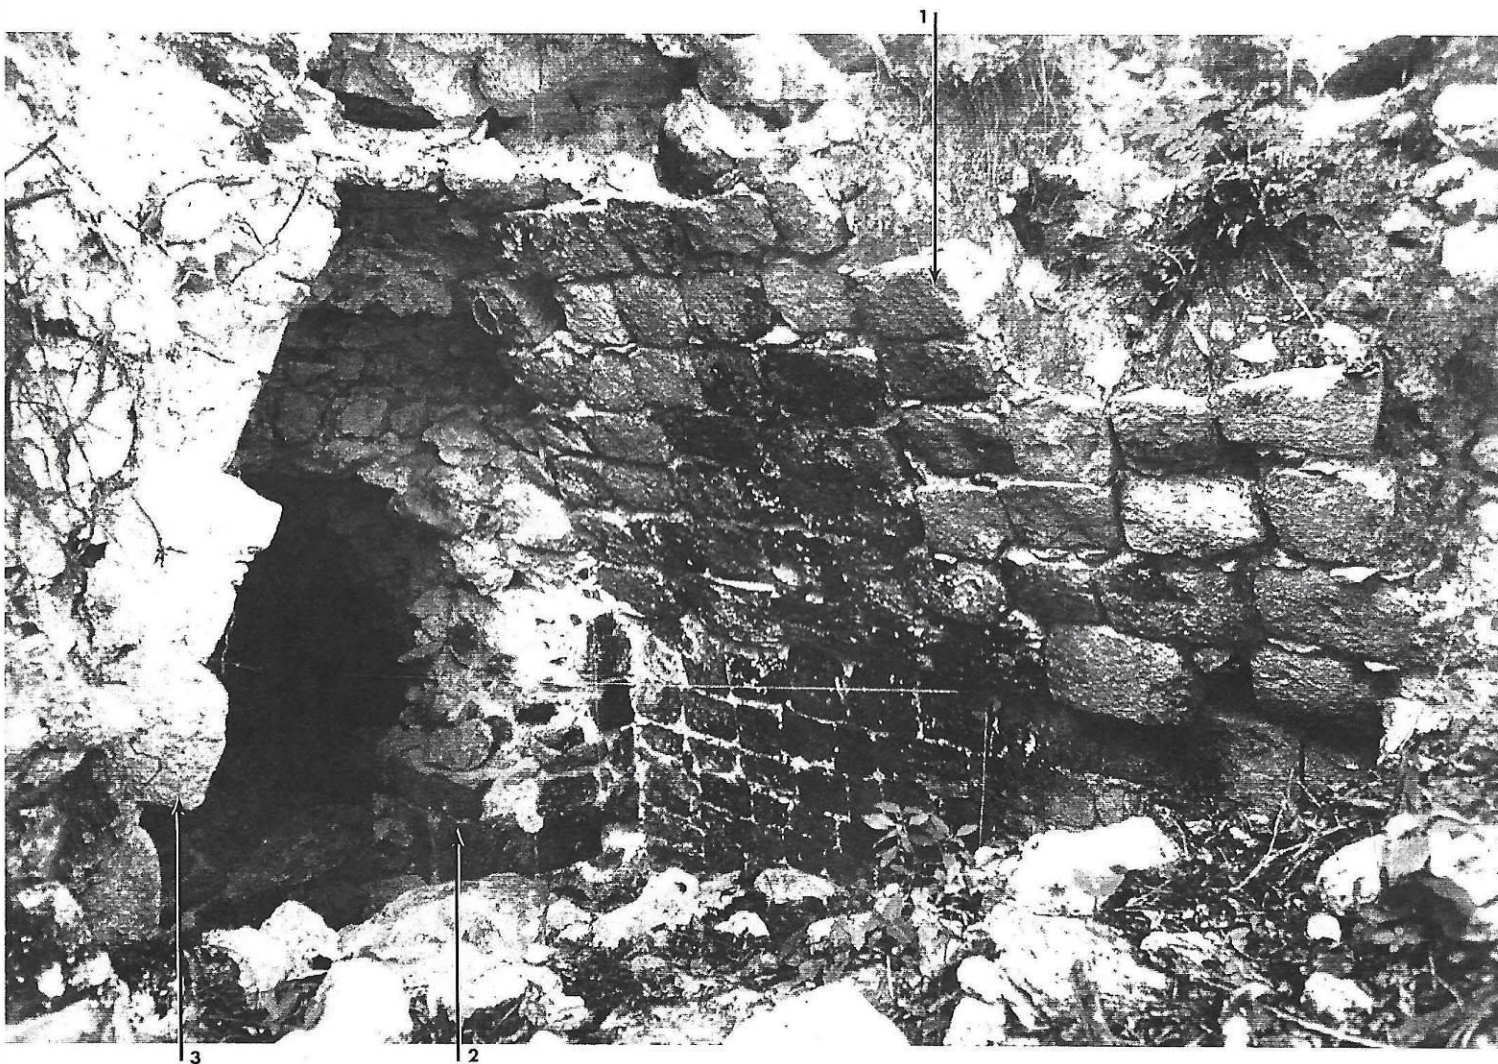
Fig. 31a - ROOM-"A" looking south-east, at south-wall and vault and showing rubble, covering most of lower room, (1) wedge-shaped vault-stones, (2) south jamb of Drwy-#2, (3) offset vault-course.

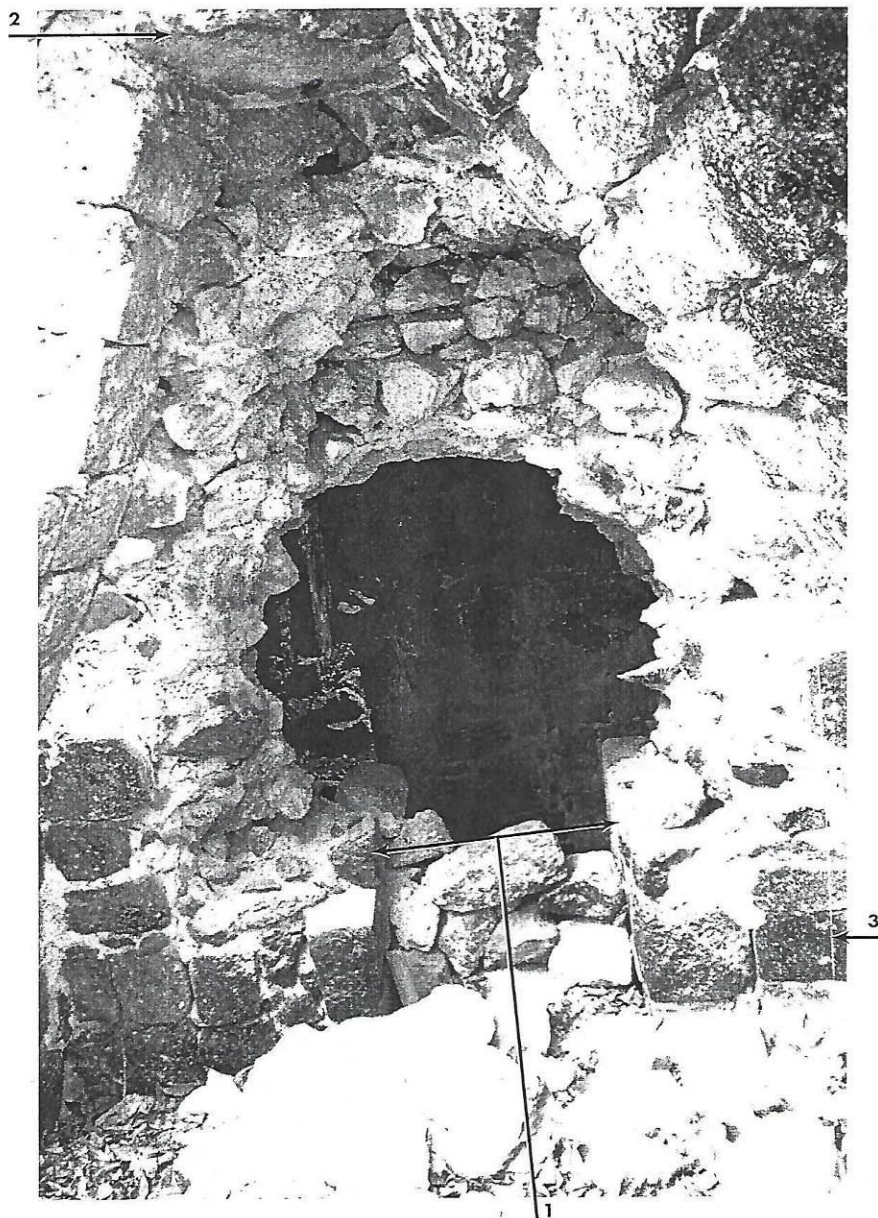
Fig. 31b - ROOM-"A," looking east toward Drwy-#2 and the collapse above it. (1) Drwy-#2 (upper most corner-stones of north jamb are fallen), (2) only remaining capstone, (3) plumb-line.

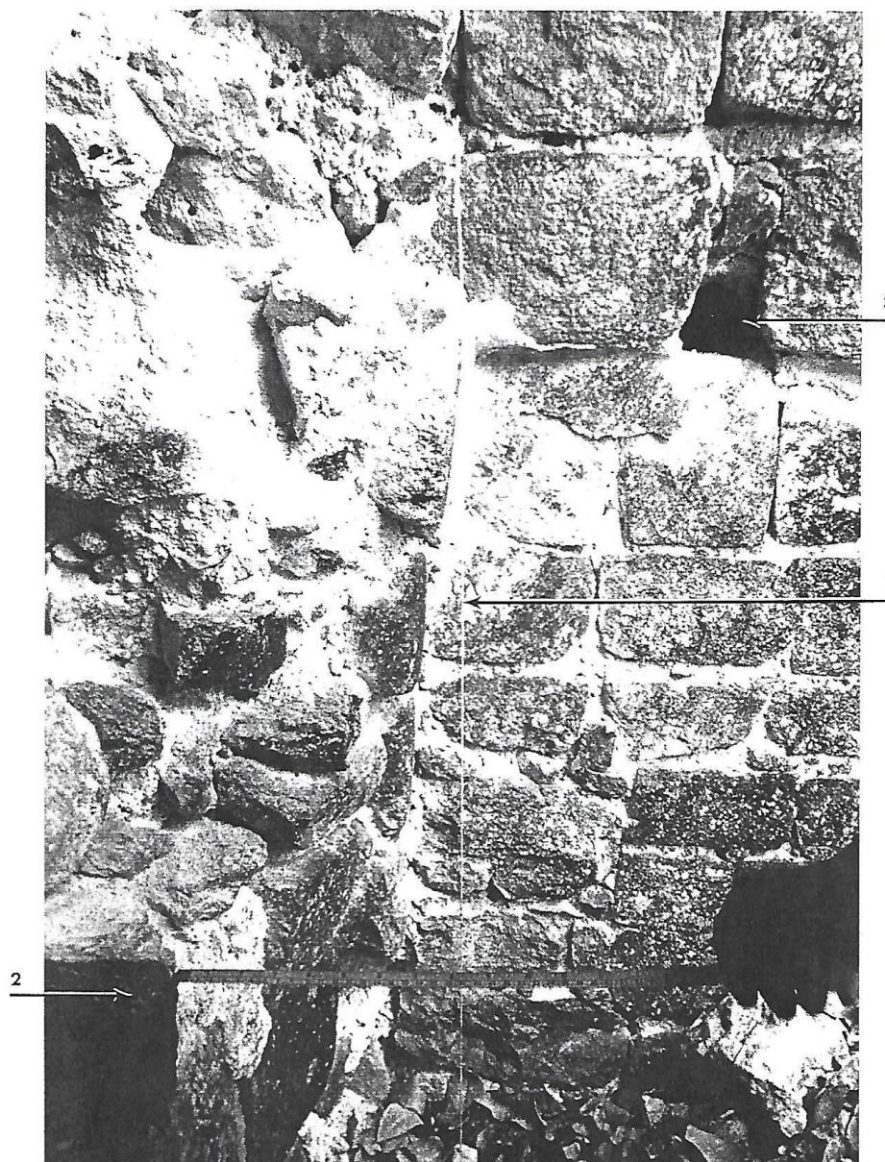
Fig. 32 - ROOM-"A" looking south (edge-wise) along east end-wall. Measuring tape is held against the corner of the Drwy-#2 jamb. Photo shows that the end-wall is thicker at the side-wall than at the door jamb and slants inward (to the right) as it goes upward. (1) Plumb line hanging from height of vault-spring (also shown in Fig. 31b), (2) upper corner of south jamb of Drwy-#2, (3) cross-beam socket.

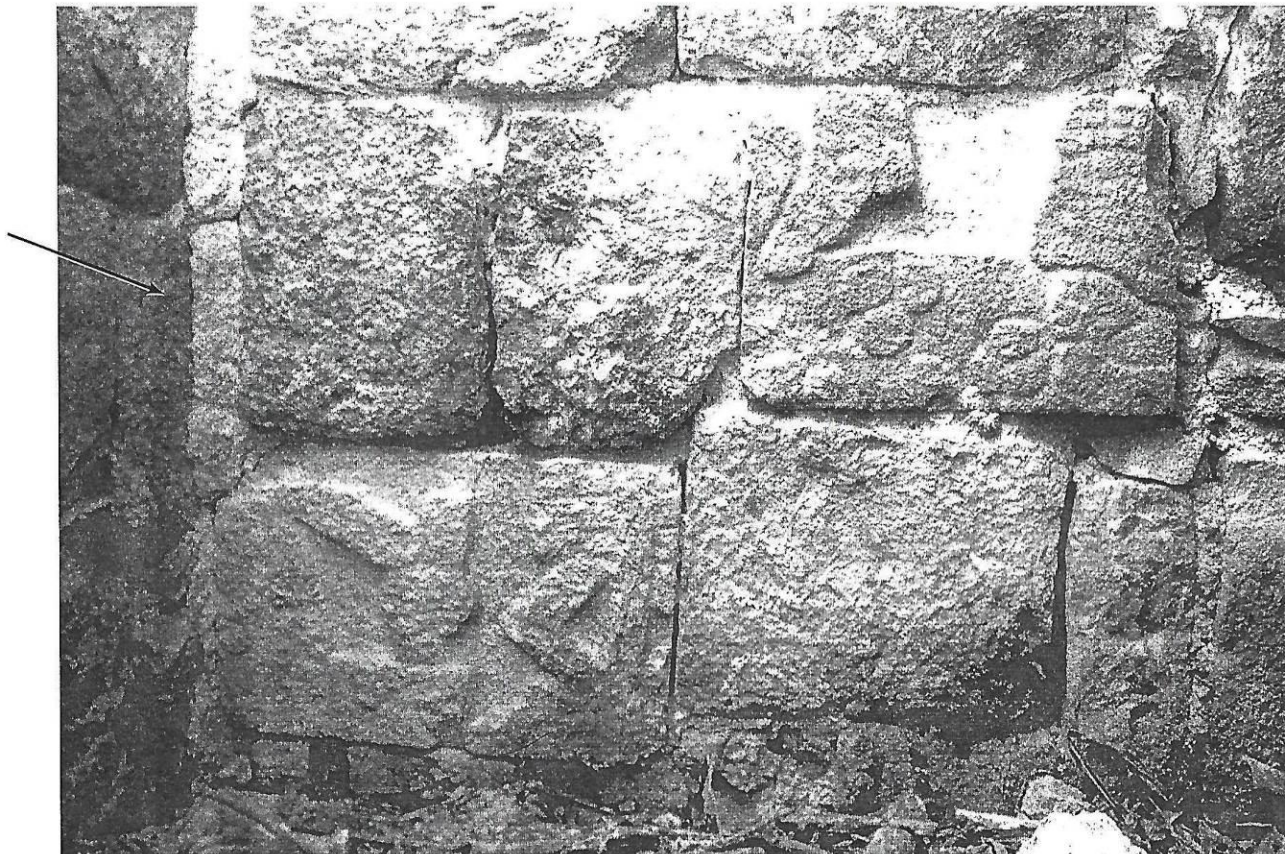
Fig. 33 - "REUSED-SCULPTED-STONES" used as interior-veneer, located in the west-wall of Pass-#2, in the south-west corner. One is "dancing" feet and the other seems to be part of a kings scepter or ceremonial spear. Veneer-stones of earlier construction (arrow) are seen going behind the west-wall.

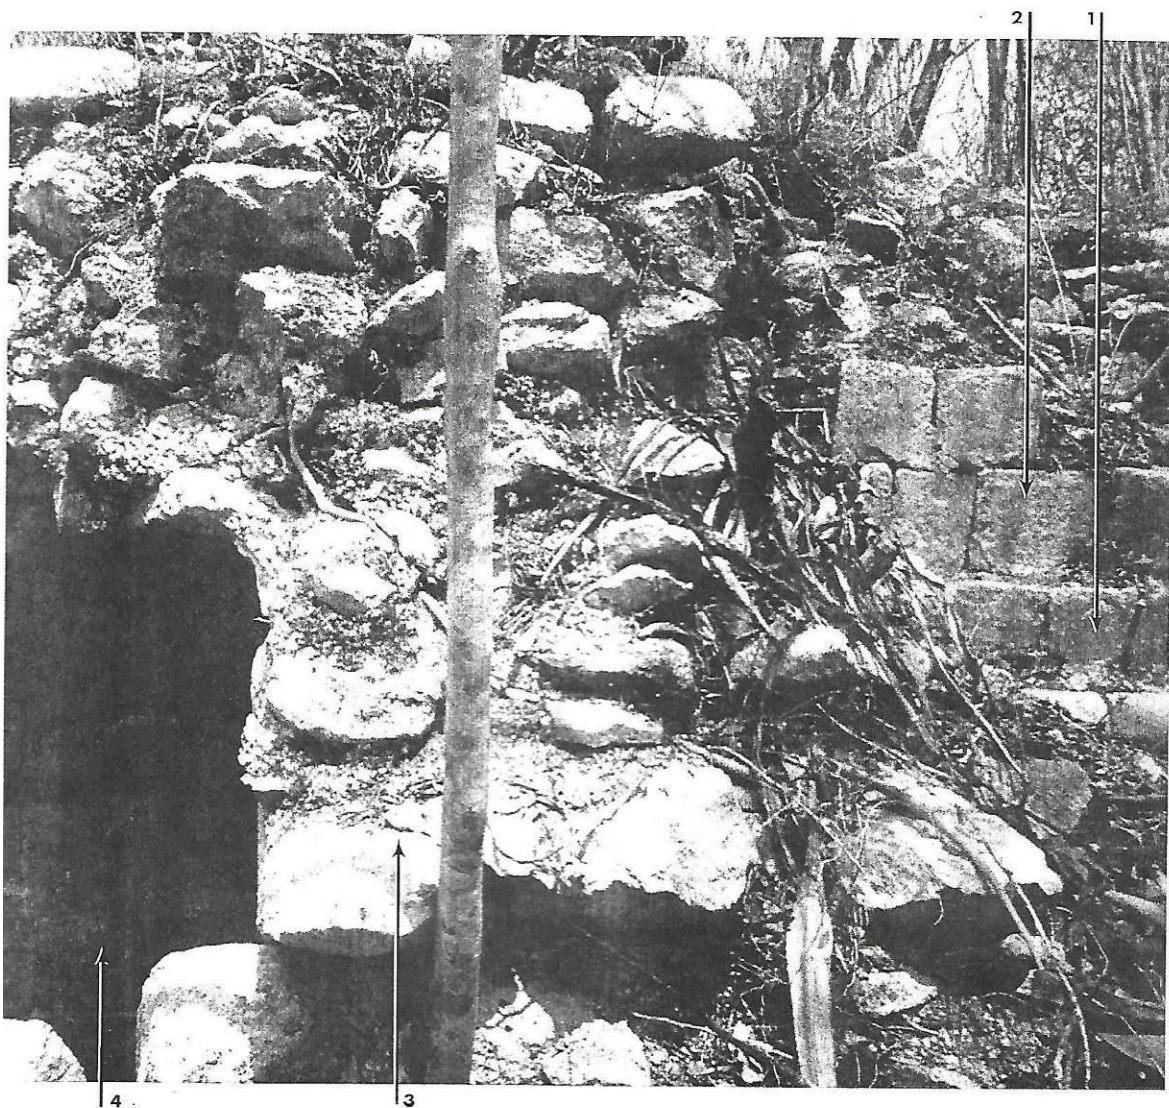
Fig. 34 - Looking west from outside the plaza, at the back of Pass-#3 and the south wing of the East-Range. On the right are (1) the remains of a three-part medial-molding, which looks the same as on top the end-column, at the north end of Rm-#3 (Fig. 14), lowest member is not visible, (2) just above the medial-molding can be seen two courses of plain veneer-stones, (3) in the center are the exposed ends of the boot-shaped vault-stones of Pass-#3, (4) looking through the collapsed east vault, into Pass-#3 (north/south arm).

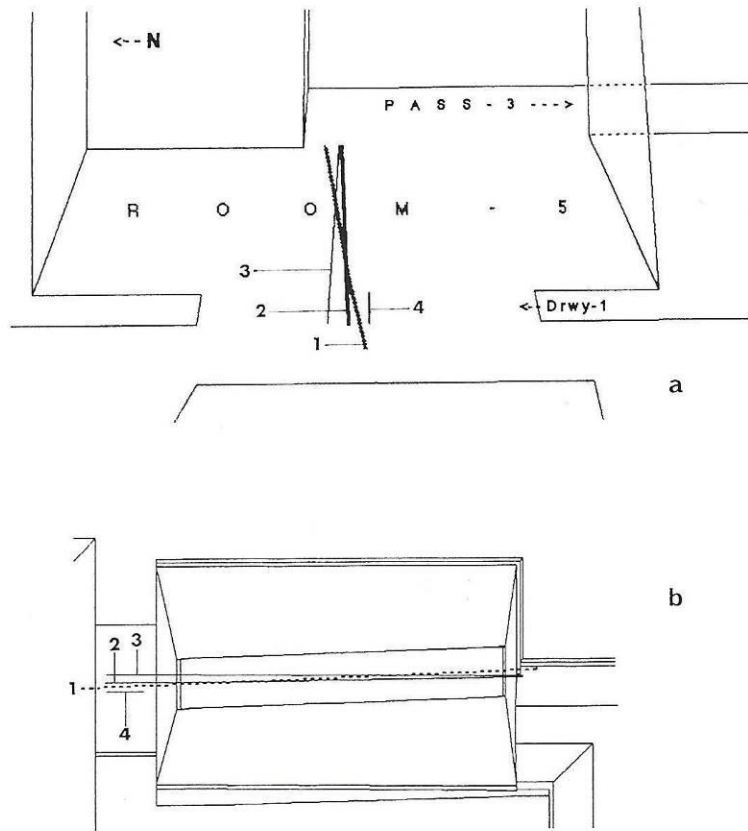
Fig. 35 - ROOM-#5, comparison of the center-line axis, of capstones, with the center-lines of the other long axes features. (1) center-line of capstones, (2) center-line of floor, (3) center-line of vault-springs, (4) center of Drwy-#1.

(a) Perspective view looking east

(b) Plan view

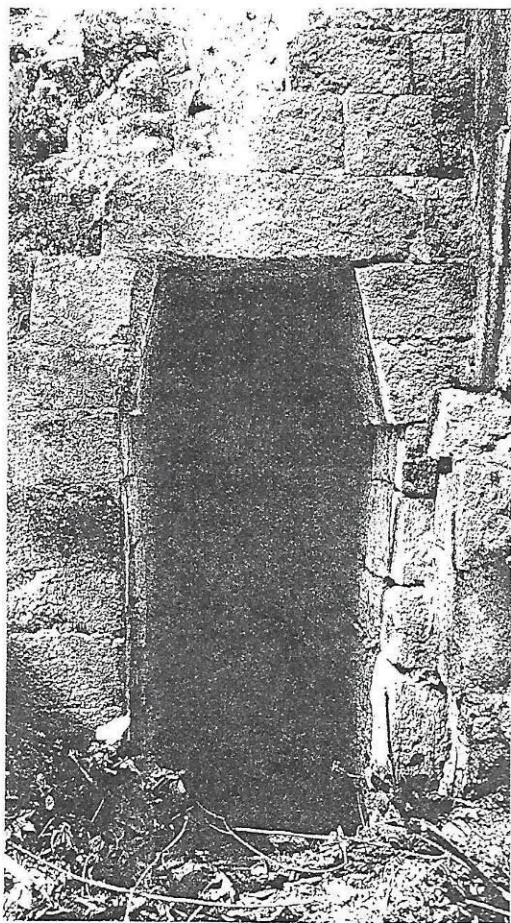
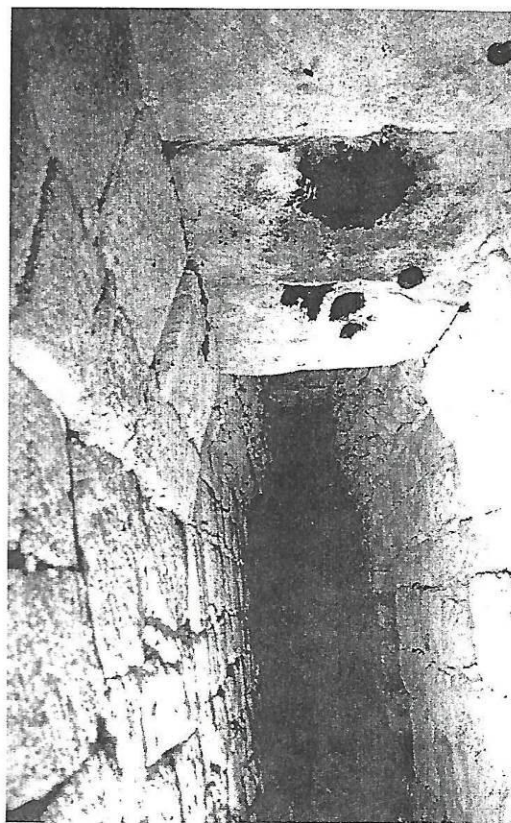
Fig. 36 - This passageway, somewhat similar to Pass-3, is at "Manos Rohas," Group "C," main structure (to the left of the main stairway). It's not as large and has no right-angle-turn.

(b) Well finished vault-stones continue for a short distance then ceiling is raised and vault-stones switch to more typical "Rio Bec" style, rounded vault-stones, without offset vault-springs.

(c) Cross-section of each arm of Pass-3.

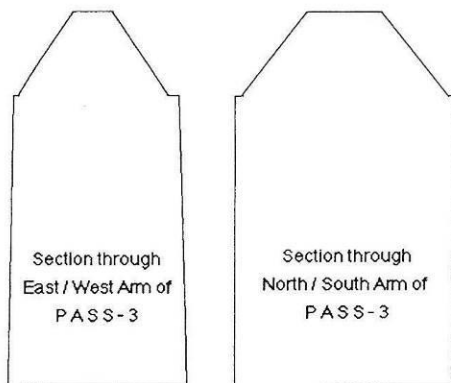
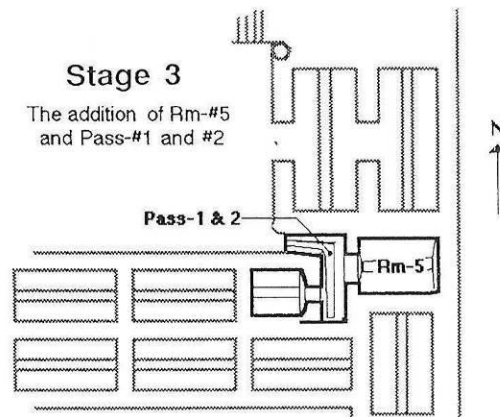
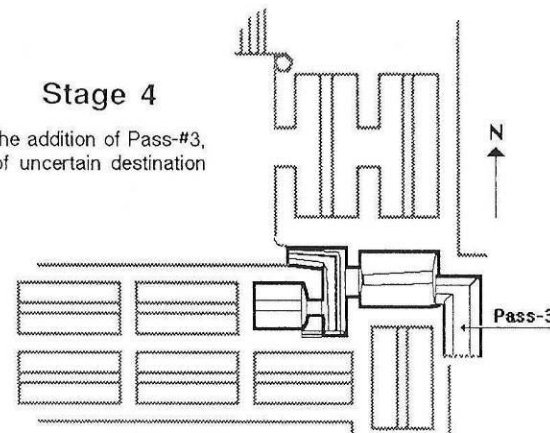
Fig. 37 - POSSIBLE CONSTRUCTION SEQUENCE of the "Rm-#5-Suite," in the
south-east corner of the "South-East Quadrangle."

Stage 1

East-Range in place and some
(at least) of the South-Range
including the exposed exterior wall,
(Rm-"B") and probably Rm-"C."
Also the north-half of the South-Range
may not have existed.

Stage 2

The addition of Rm-"A" and
possibly the rest of the north-half
of the South-Range.

Stage 3

The addition of Rm-#5
and Pass-#1 and #2

Stage 4

The addition of Pass-#3,
of uncertain destination

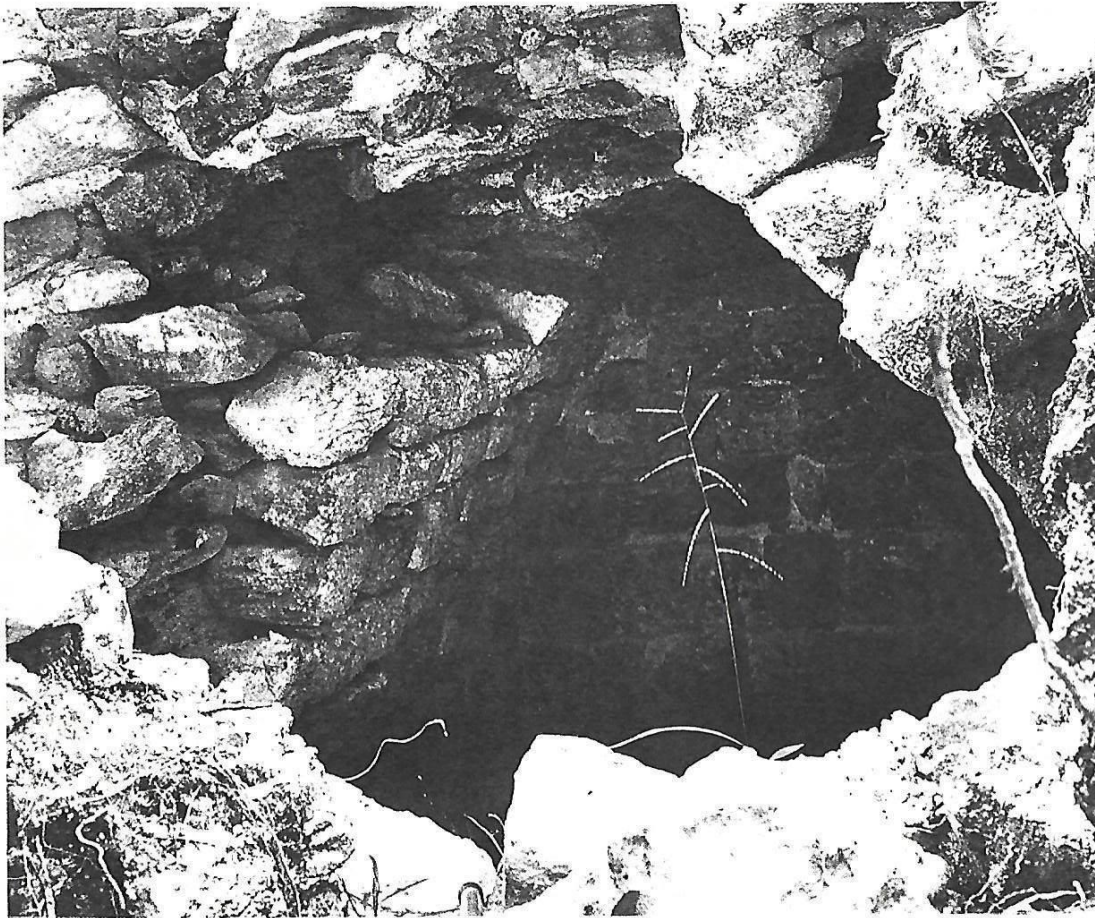
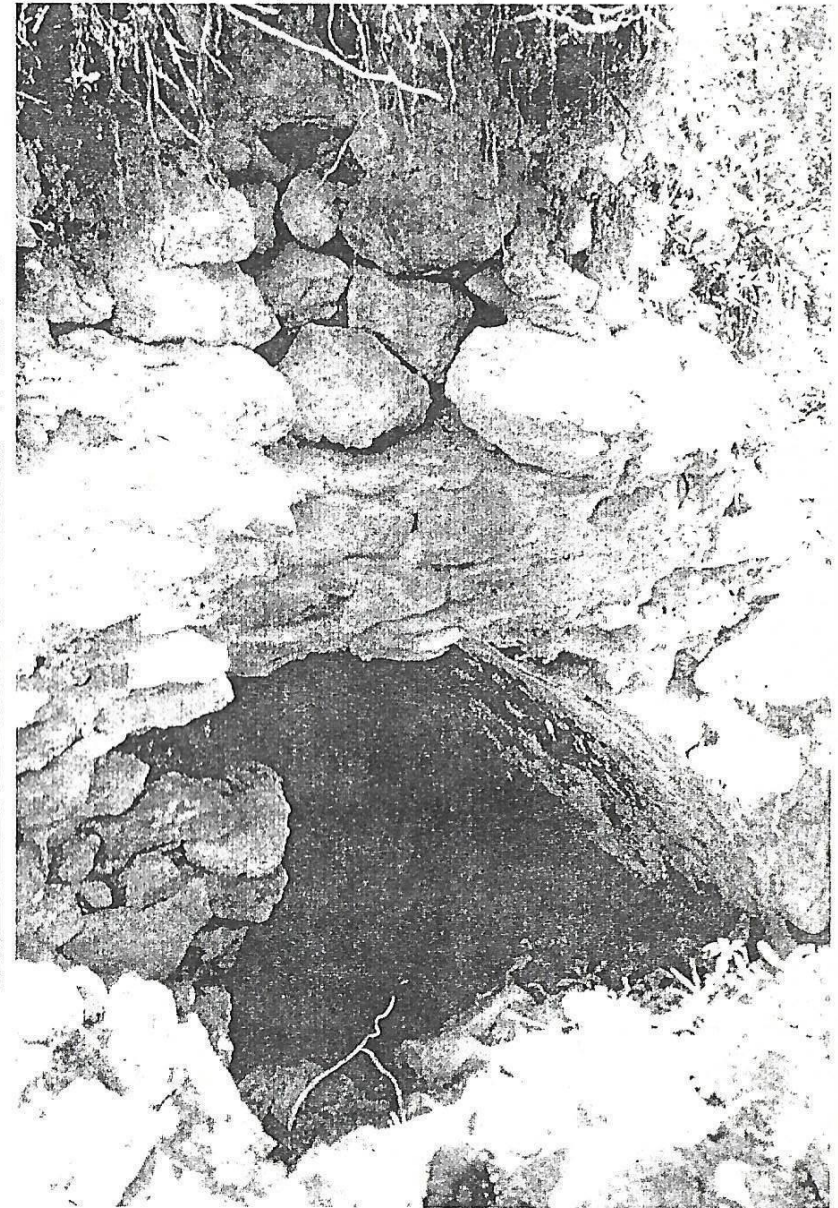
(a) Shows wedge-shaped vault-stones and no decorative-inset at capstones.

(b) Shows considerable thickness over vault.

Fig. 38 - ROOM-"C," two views looking north, into the collapsed remains.
