WOOD  
THAT HAS LASTED ONE THOUSAND YEARS:

Lintels and Vault Beams  
in Maya Temples and Palaces,  
the Example of the Main Palace, Santa Rosa Xtampak, Campeche

June 1989

Nicholas M. Hellmuth

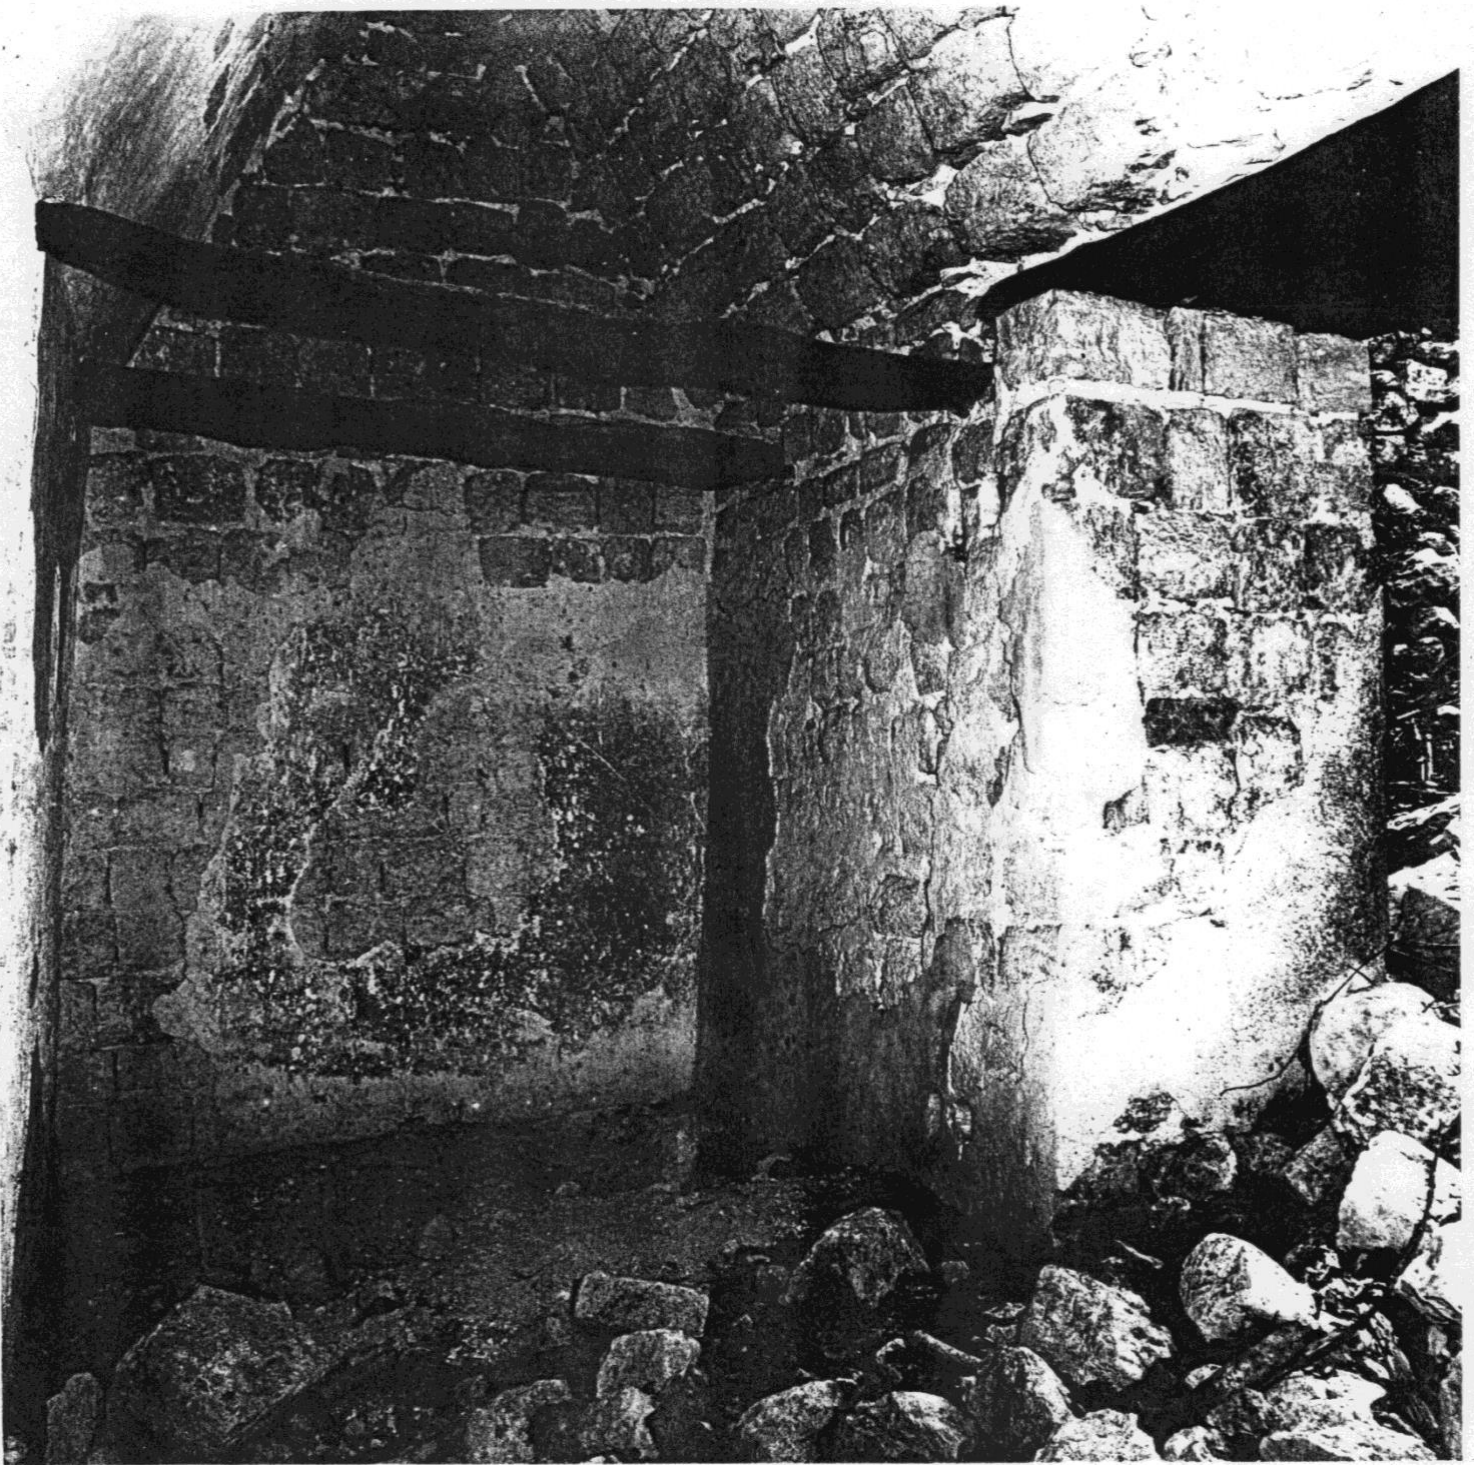
Fig. 2. Santa Rosa Xtampak, Main Palace, east side, inner room 8, view from inside looking out (looking northeast). The wall beams are actually three in number, one near the door lintel butt, two almost next to each other against the north end wall.

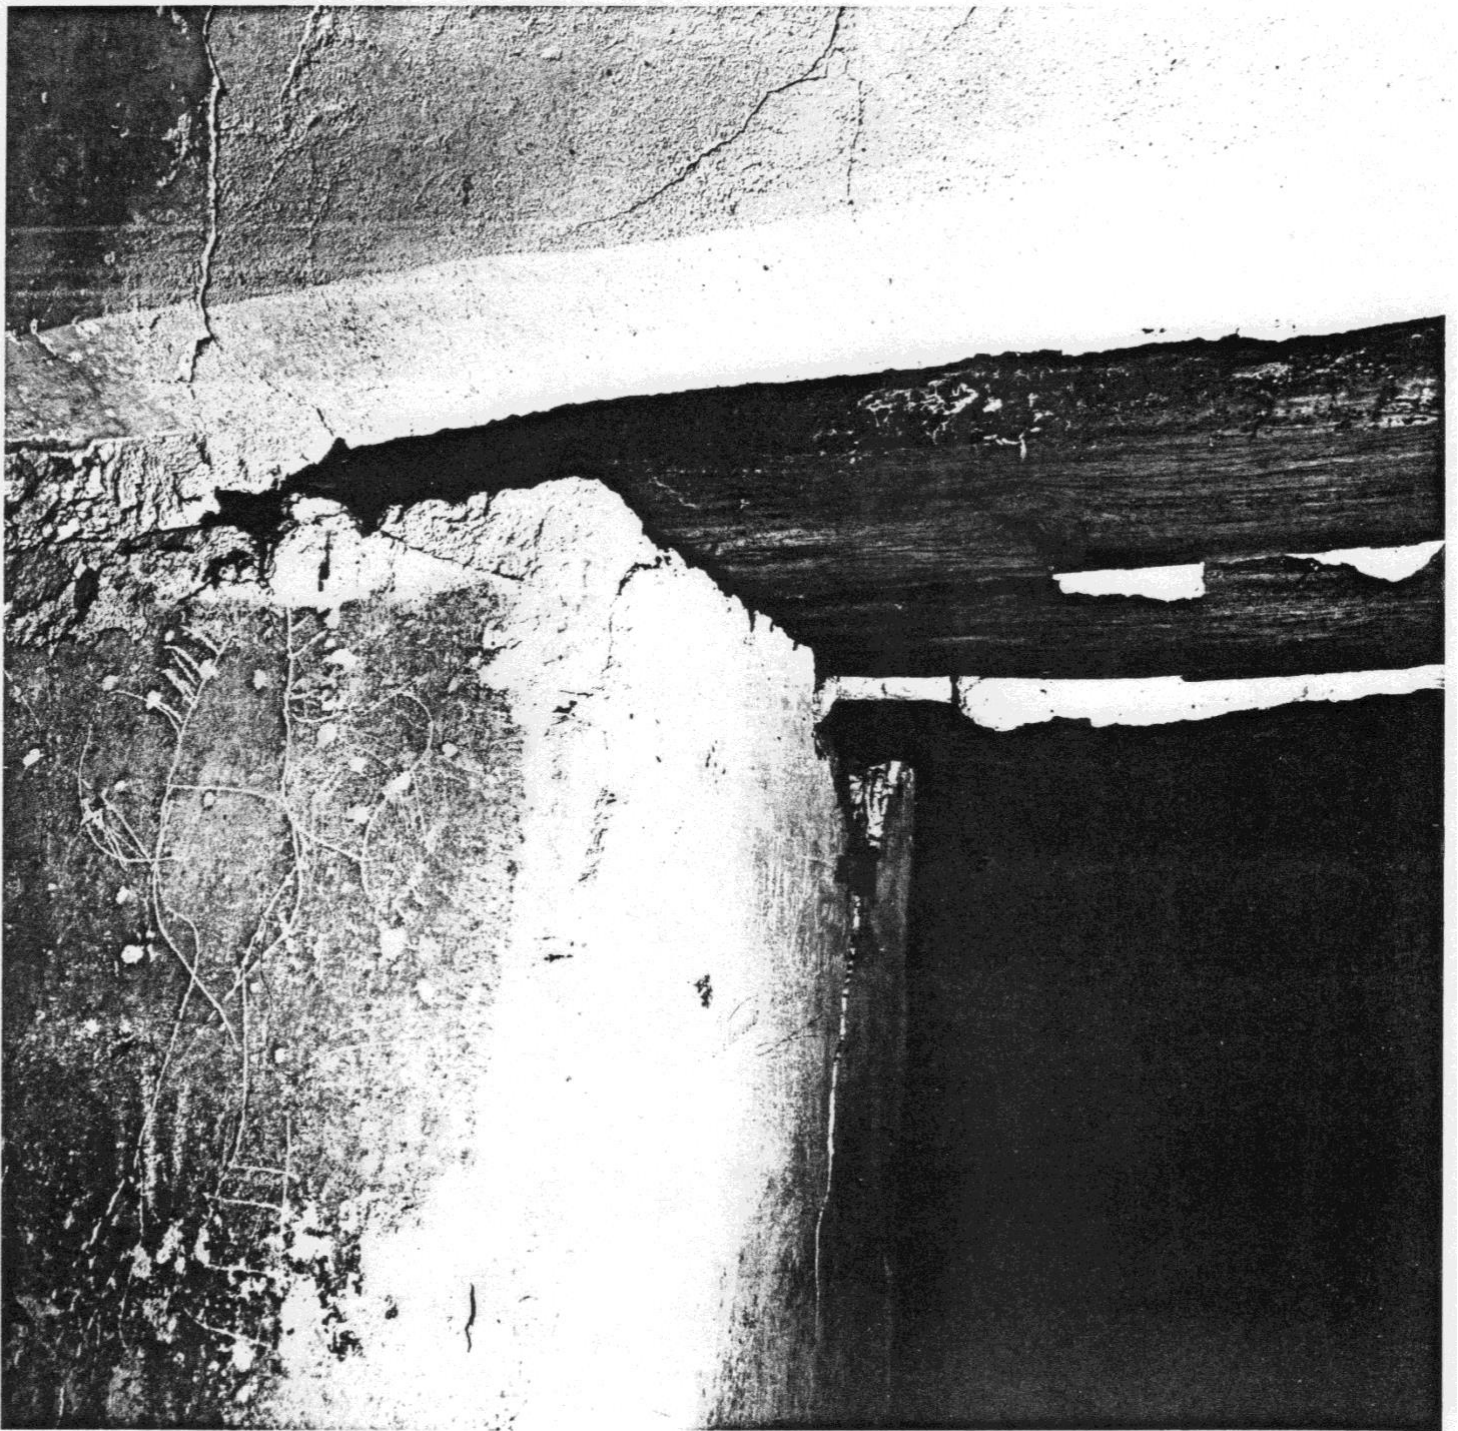
Fig. 5. Santa Rosa Xtampak, Main Palace, west side, inner room (24 or 26, Andrews' 1988 numeration). The wall plaster is still in amazing original condition. The degree of shrinkage can be measured as the distance the wood has retreated from the plaster; the plaster forms a mold of the wood at its original 7th-9th century size.

photographs for lectures or books. Yet the minute I looked at the lintels of Xtampak I was struck by the degree to which the lintels had shrunk, indeed shriveled. The butts have withdrawn several centimeters--you can still see this where a mold has been created by the mortar around where the fresh beam once extended. And looking at the beams from below you can see how the beam has retracted, leaving wide white space in between the beams.

Fig. 5. Santa Rosa Xtampak, Main Palace, west side, inner room (24 or 26, Andrews' 1988 numeration). The wall plaster is still in amazing original condition. The degree of shrinkage can be measured as the distance the wood has retreated from the plaster; the plaster forms a mold of the wood at its original 7th-9<sup>th</sup> century size.

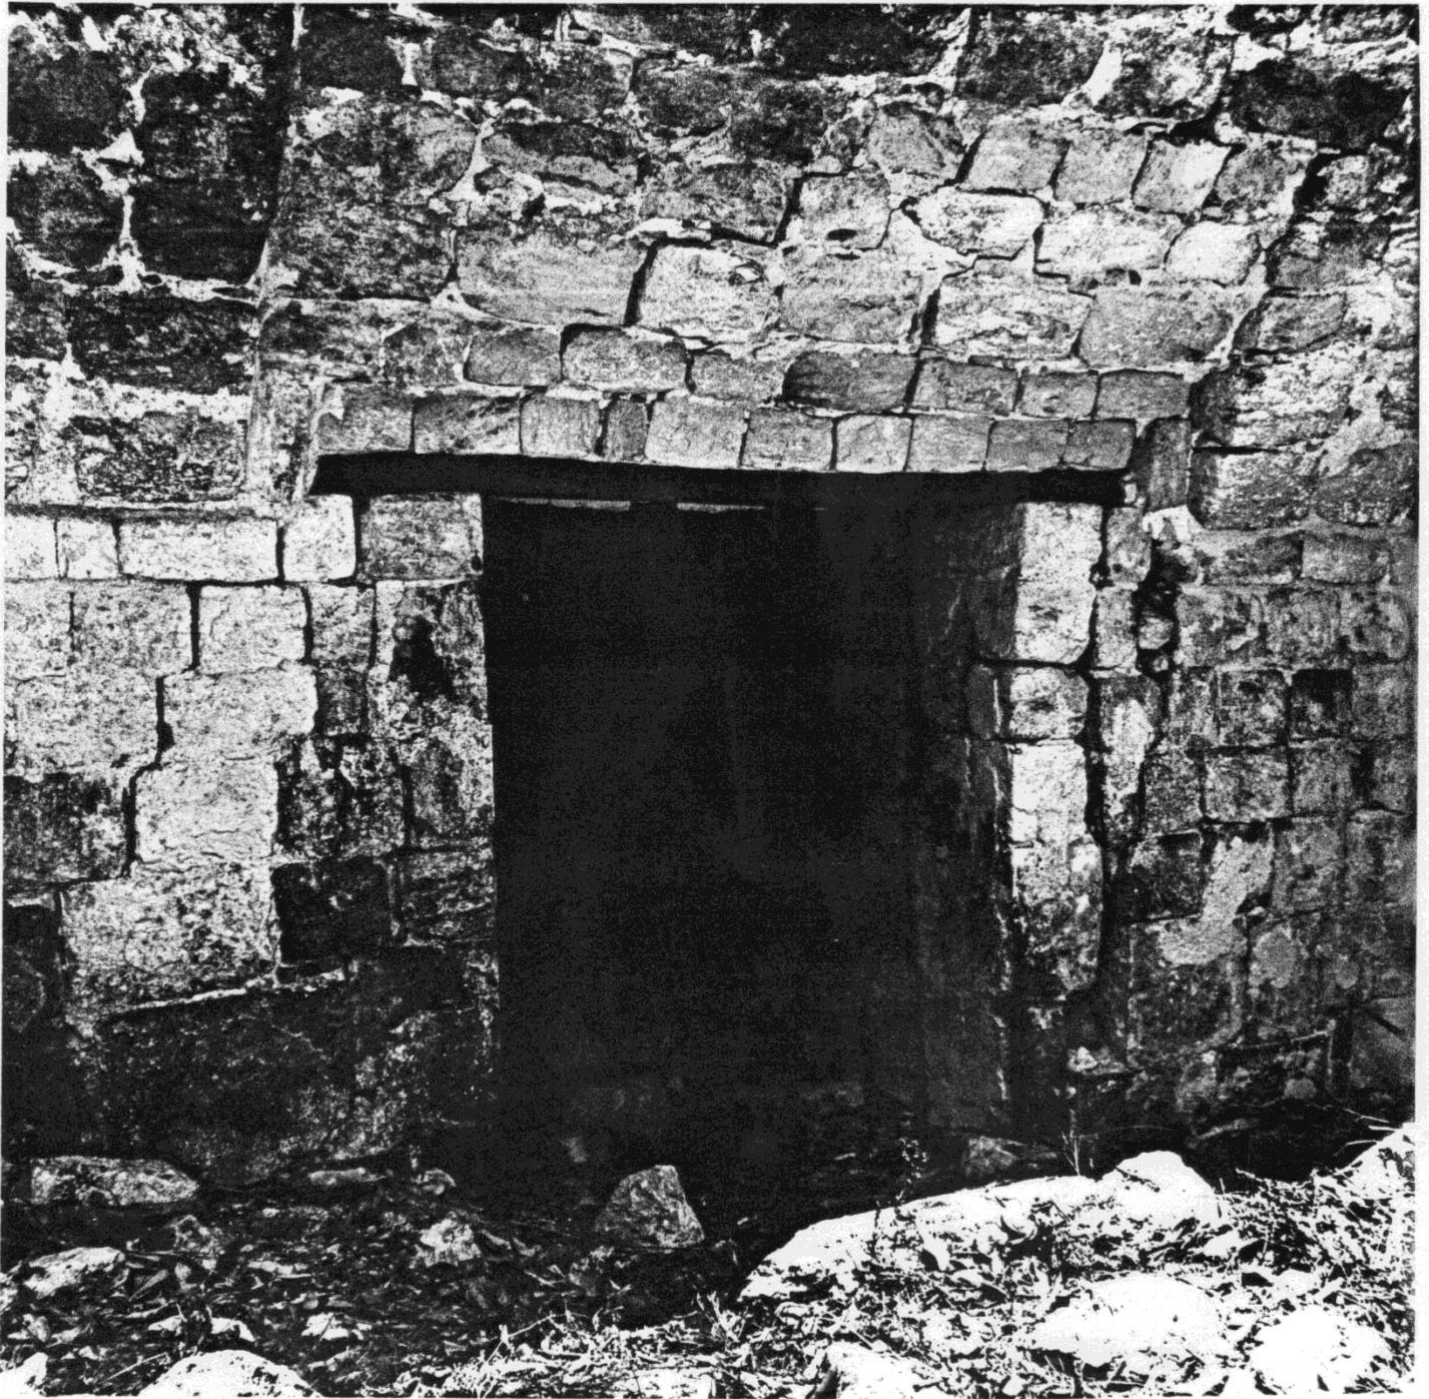
Fig. 8. Santa Rosa Xtampak, Main Palace, east side, probably Room 6. These planks are so well preserved that the stress has transferred to the jambs, causing them to sheer away from the wall. In this instance the jambs will buckle out before the lintels rot or break causing far more destruction than if the lintels alone broke.

What causes entire rooms and whole facades to crumble is the physical disintegration of the jambs. An entire wall can collapse even when the lintel is in perfect condition. This results from the sheer factor along the edge of the doorway from the accumulated weight forcing down on the ends of the lintels. This enormous weight over the centuries is actually crushing the jamb portion of the wall. You can see the expanding cracks alongside more than half the doors of the palace. This manner of major structural failure has not previously been considered, since it was commonly thought that it was lintel failure alone which brought down the vaults above. That also is certainly also a factor, when in fact a lintel rots before the adjacent wall is crushed. Ironically it is the strong lintels that seemingly transfer sheer to the adjacent jamb area. It will be necessary either to inject an impressively strong binding mortar into the cracked jambs, or disassemble them completely, clean the joints, then restore them.

Fig. 8. Santa Rosa Xtampak, Main Palace, east side, probably Room 6. These planks are so well preserved that the stress has transferred to the jambs, causing them to sheer away from the wall. In this instance the jambs will buckle out before the lintels rot or break causing far more destruction than if the lintels alone broke.

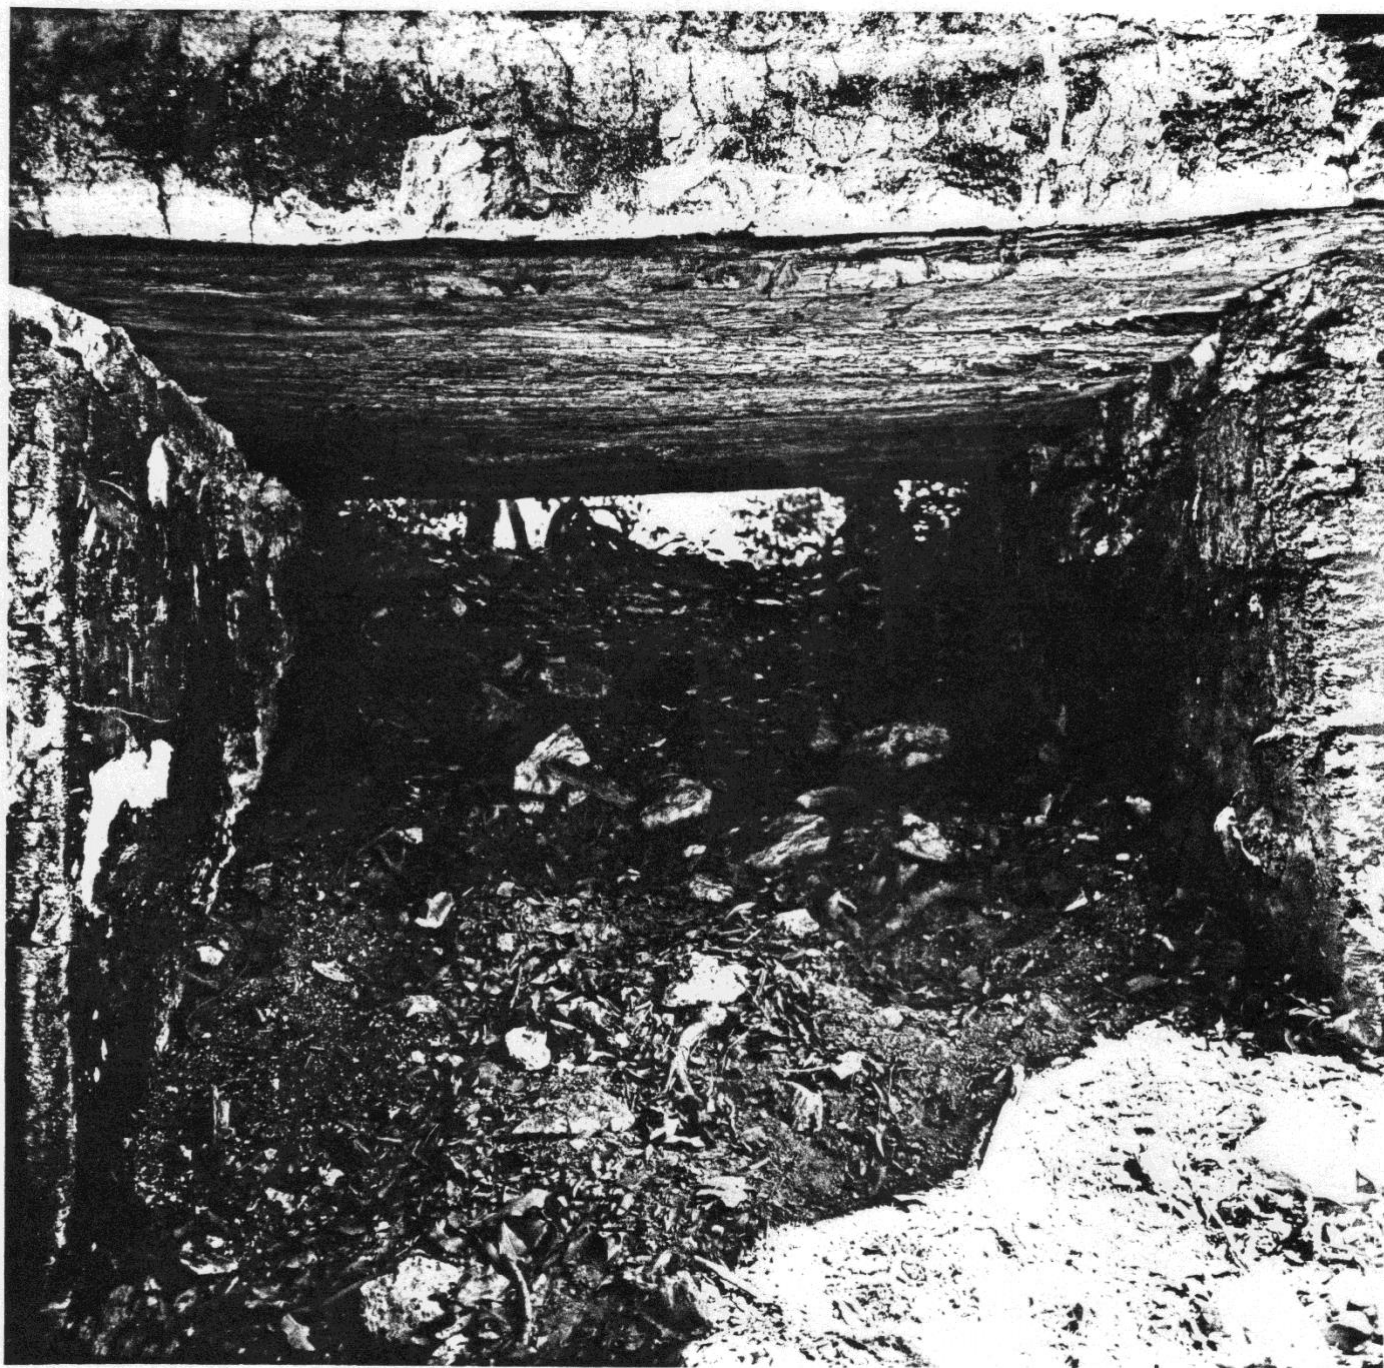
Fig. 11. Tzikin Tzakan, Peten (near Belize border), an unusually wide and deep doorway, seemingly five beams. Science's opportunity to study these beams was lost forever because the entire palace was crushed by the weight of rain water seeping into the vault mass. Palace after palace are being lost throughout Guatemala and Mexico; crumbling before anyone bothers to record them. These F.L.A.A.R. photographs may be the only record of this entire structure before it collapsed. For this reason, we are photographing at Santa Rosa before the Tzikin Tzakan fate befalls Xtampak.
